# INDIANA UNIVERSITY

## ON-SITE AIR BAG INVESTIGATION

CASE NUMBER - IN97-028  
LOCATION - TEXAS  
VEHICLE - 1997 TOYOTA CAMRY LE  
CRASH DATE - August, 1997

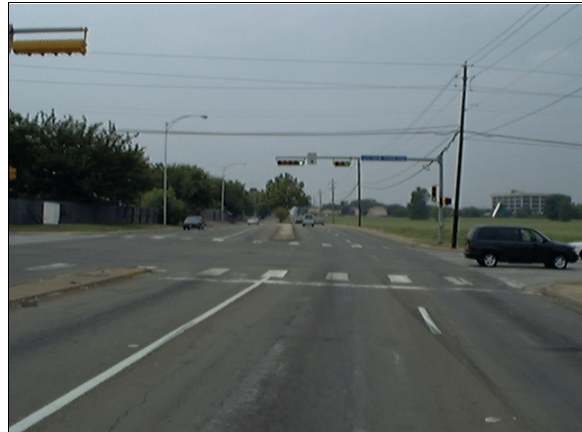
The case vehicle was traveling west in the inside westbound through lane (**Figure 1**) of a five-lane, divided, city trafficway and intended to continue its westbound path of travel through an intersection [i.e., both the east and west roadways had two through lanes and one (opposing) left-hand, turn lane on both the west and east legs of the four-leg intersection]. The Chrysler had been traveling east in the left-hand turn lane of the eastbound roadway (**Figure 2**) and was making a left turn attempting to travel north on an intersecting trafficway. The case vehicle's driver braked, attempting to avoid the crash. The crash occurred in the inside through lane of the westbound roadway in the four-leg intersection of the two trafficways (**Figure 3**); see **CRASH DIAGRAM** below.

**Figure 1:** Case vehicle's westward travel path in inside through lane of westbound roadway (case photo #02)

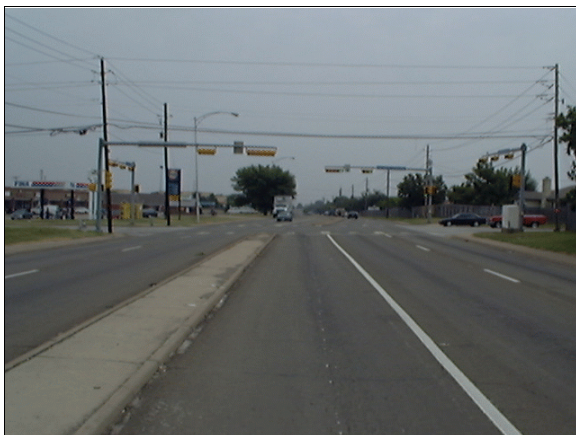
**Figure 2:** Chrysler's eastward travel path in left-hand turn lane of eastbound roadway (case photo #05)

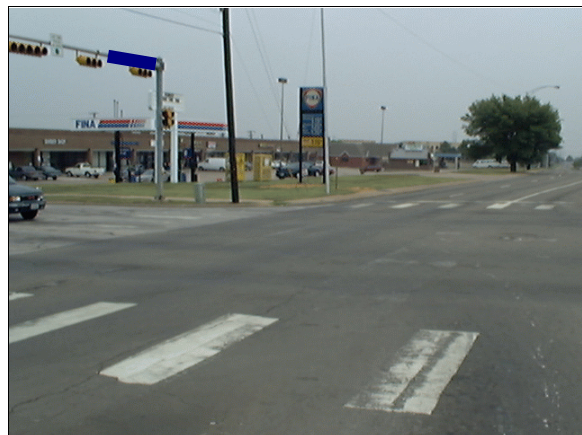
**Figure 3:** Chrysler's northeastward travel path during left-hand turn across westbound roadway just prior to impact (case photo #07)

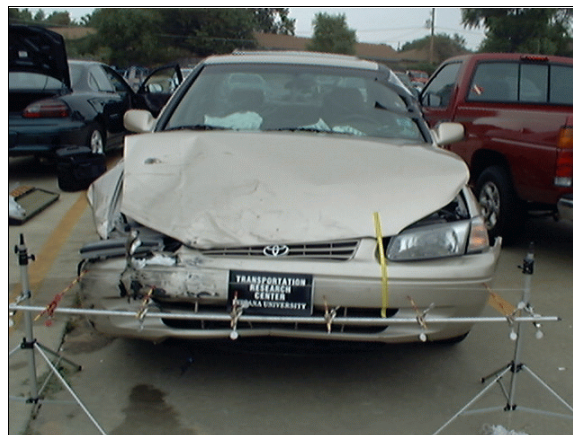
**Figure 4:** Case vehicle's frontal damage with contour gauge present; Note: direct damage extends along front from front right corner to yellow tape (case photo #16)

The case vehicle's contact with the Chrysler involved the right two-thirds of the Camry's front bumper. Direct damage began 40 centimeters (15.75 inches) left of center (**Figures 4 and 5** above) and extended across the bumper to the right bumper corner, a measured distance of 107 centimeters (42.1 inches). Maximum residual crush was measured as 15 centimeters (5.9 inches) at C<sub>6</sub>; however, the residual crush was only 1 centimeter (0.4 inches) at C<sub>1</sub>. The wheelbase on the case vehicle was not altered. The case vehicle's front bumper, bumper fascia, bumper reinforcement bar, grille, right headlight and turn signal assemblies, right fender, and hood were directly damaged and crushed rearward. The front bumper fascia, bumper reinforcement bar, and right fender were slightly shifted to the right due to the 340 degree Direction of Principal Force. The uneven damage pattern indicates an obtuse angle impact such as in this crash, consistent with the Chrysler's turning across the Camry's path of travel. The case vehicle's right front tire was physically restricted but not deflated. The right fender and hood sustained induced damage as well.

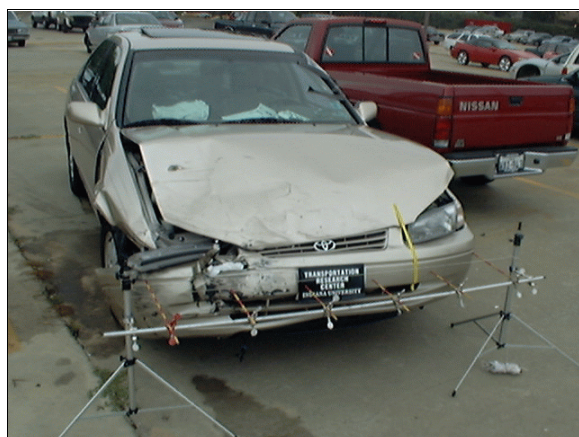
**Figure 5:** Case vehicle's damaged front viewed from right of front with contour gauge present; Note: yellow tape highlights end point of direct damage (case photo #09A)

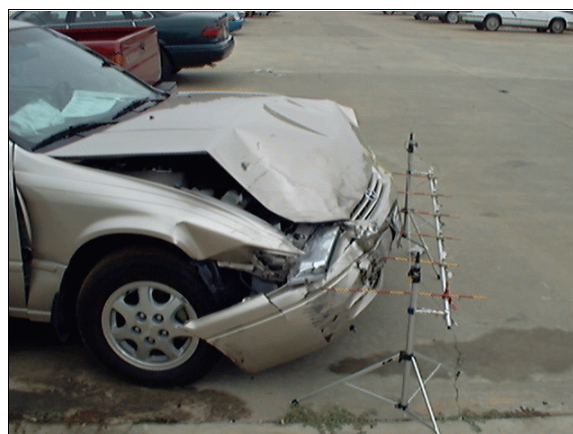
**Figure 6:** Case vehicle's frontal damage viewed along reference line from right with contour gauge present (case photo #15)

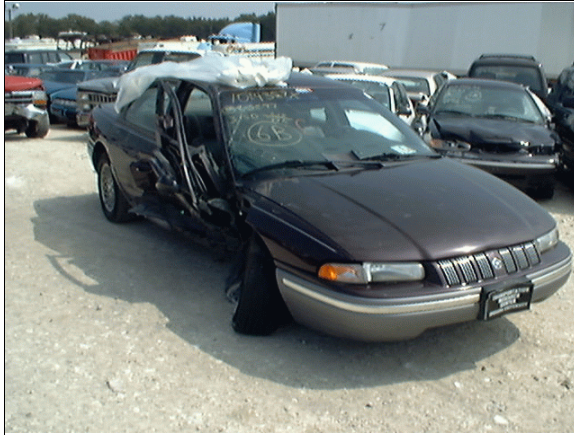
**Figure 7:** Chrysler's damaged right side viewed from right of front (case photo #63)

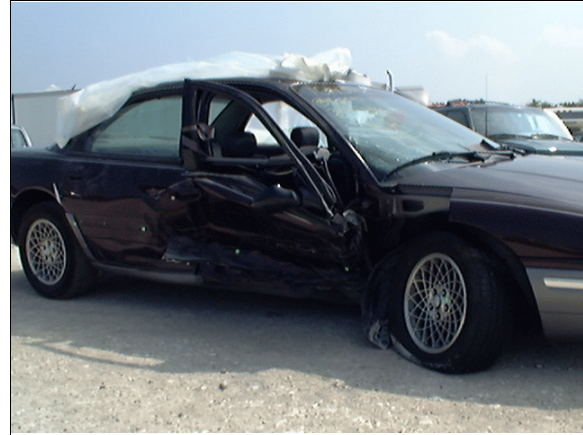
**Figure 8:** Chrysler's right side damage viewed from front of right (case photo #62)

The Chrysler's contact with the case vehicle involved the right side between the axles. Direct damage began 86 centimeters (33.9 inches) forward of the right rear axle and extended forward, a measured distance of 196 centimeters (77.2 inches), to just rearward of the right front axle (**Figures 7** and **8** above). Maximum crush was measured as 29 centimeters (11.4 inches) at C<sub>5</sub>. The Chrysler's right fender, right front and rear doors, and right quarter panel were directly damaged and crushed inward. The right front door glazing was disintegrated from the side impact. There was moderate lateral intrusion [15-24 centimeters (6-9 inches)] to the right door panel, sill, and side panel forward of the right front door's "A"-pillar (**Figure 8** above). There

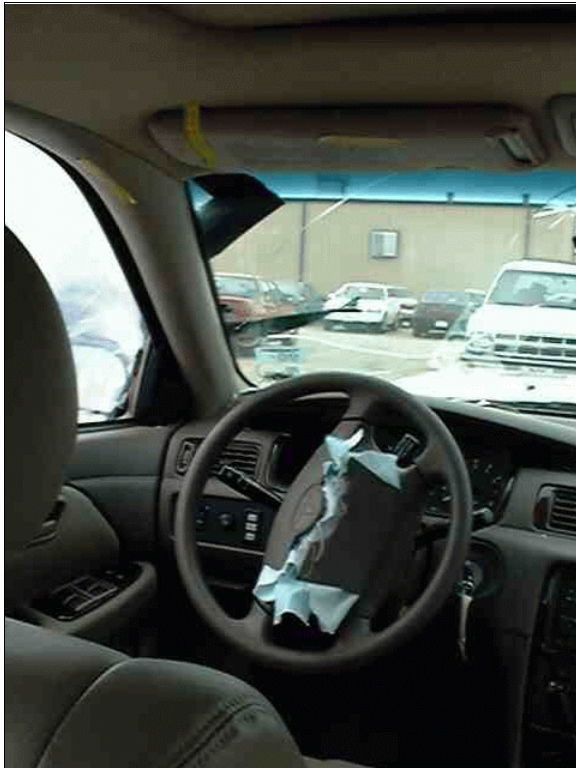
**Figure 9:** Vertical view of case vehicle's driver seating area showing deployed driver air bag module's cover flaps, remainder of cutout driver's air bag, and probable air bag exhaust gas residue on left "A"-pillar and on left sun visor (case photo #21)

The Inspection of the case vehicle's interior revealed an area of what was most likely air bag exhaust gas residue on the upper portion of the left "A"-pillar and on the left sun visor (**Figure 9**). The driver's door glazing was disintegrated during the Camry's air bag deployment sequence. The energy absorbing steering column showed no evidence of compression. Further, there was a possible skin or cloth transfer on the right side of the steering column and a scuff on the right side of the center console. There were scuff marks on (**Figure 10**): the right side of the lower portion of the center instrument panel, the right knee bolster, the glove box door (**Figure 11** below), and the right sun visor (**Figure 12** below). The mirror on the back side of the right sun visor had been cracked from its compression against the front right header as a result of contacted by the front right passenger. In addition, the windshield glazing, just to the left of the rearview mirror, had been cracked when the lower right corner of the rearview mirror was contacted by the front right passenger's air bag, knocking it backwards and to its left into the windshield. The front right passenger air bag's fabric had been compressed backwards and upwards by loading from the front right occupant. The rearview mirror was also broken out. Further, the lower portion of the right windshield's glazing was cracked by the front right air bag module's top cover flap. Finally,

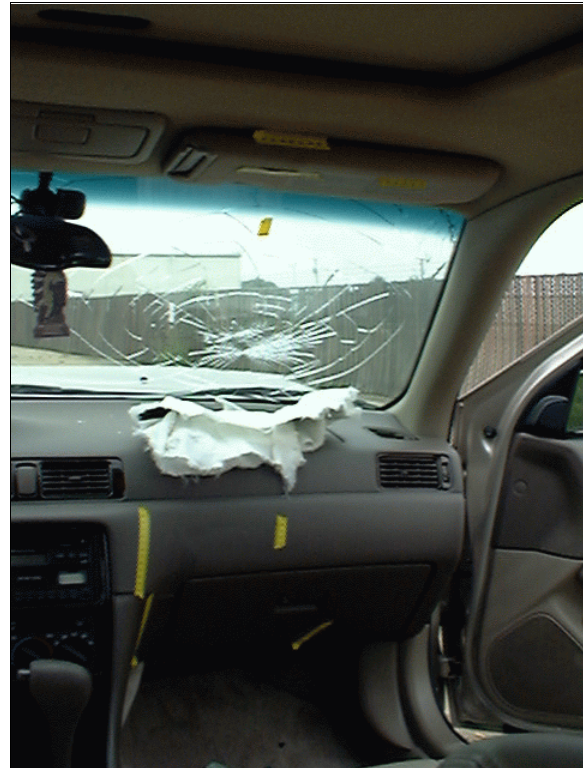
**Figure 10:** Vertical view of case vehicle's front right seating area showing contacts to instrument panel area (i.e., yellow tape) and sun visor by front right passenger; Note: windshield glazing was cracked by front right module's top cover flap (case photo #32)

there was a scuff near the top of the right windshield's glazing that most likely came from the front right air bag's fabric.

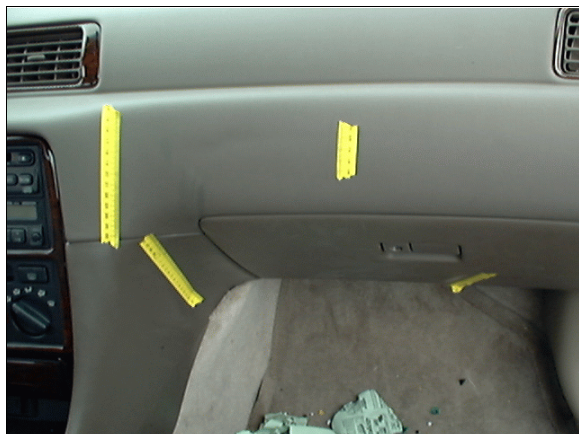
**Figure 11:** Close-up of contact evidence on case vehicle's center instrument panel and front right knee bolster and glove box door (case photo #34)

<sup>2</sup> In this contractor's opinion, the left foot most likely snagged on and smudged the right side of the center instrument panel as she was moving forward in response to the Direction of Principal Force. When her face contacted the front right passenger's air bag, she was lifted upwards. As a result, the proximal portion of her left leg impact the right knee bolster. Because of the snagging a twisting force was created causing the spinal fractures. Therefore, the distal fracture was assigned to the center instrument panel and the proximal fracture was assigned to the knee bolster.

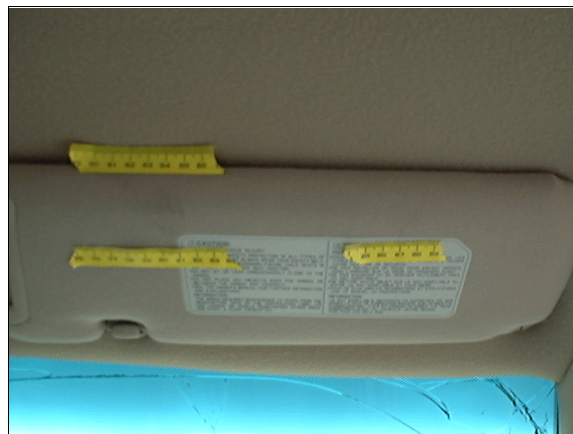
**Figure 12:** Close-up of case vehicle's right sun visor showing contact evidence from front right passenger's head (case photo #36)

<sup>1</sup> It is entirely possible that the right frontal subdural hematoma resulted from contact with the front right passenger's air bag; however, it could also have resulted from the front right sun visor. On the other hand, the subdural hemorrhage over the left occipital pole most likely came from the contact with the front right sun visor. Because these lesions are aggregated in the AIS, the contact mechanism was assigned to the front right sun visor as the “best fit”.

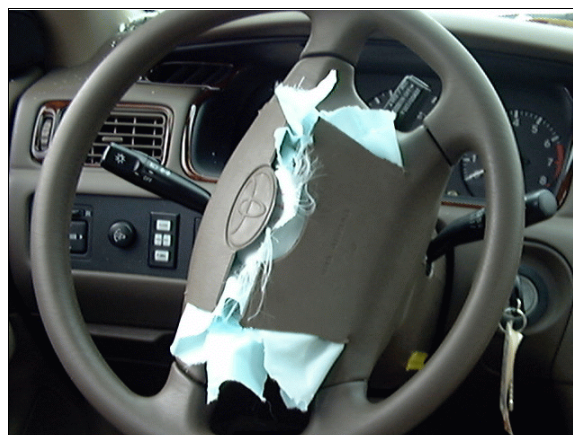
**Figure 13:** Close-up of case vehicle's steering wheel showing deployed driver air bag module's cover flaps and remainder of cutout driver's air bag (case photo #23)

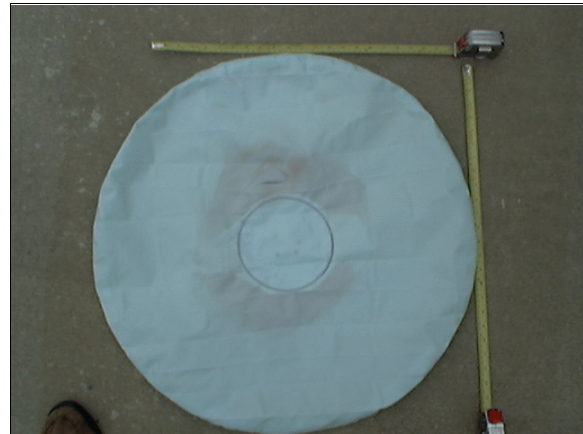
**Figure 14:** Overhead view of case vehicle's cutout driver air bag showing sewn center tether and contact evidence (case photo #38)

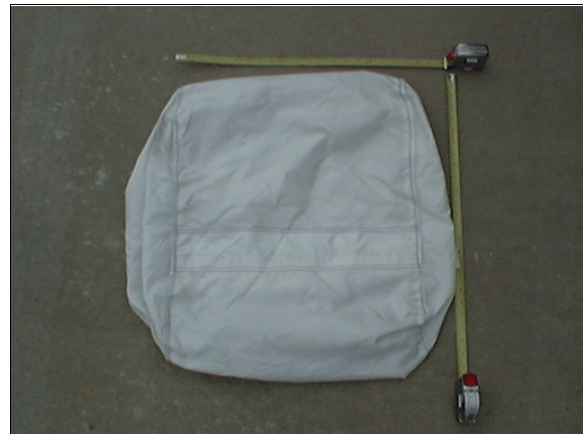
**Figure 15:** Overhead view of front surface of case vehicle's cutout, front right passenger air bag showing, no visible contact evidence, dimensions, and tether straps (case photo #43)

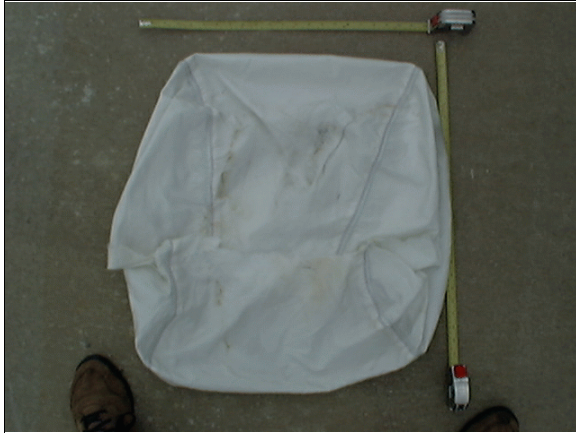
Examination of the front right passenger's air bag revealed a large amount of transfer marks (e.g., areas of skin) to the top surface and a small amount to the under side of the air bag (**Figure 16** below). The transfers on the under side most likely came from the front right passenger's legs (**Figure 17** below). The transfer evidence on the top of the front right passenger's air bag consisted of three heavy streaks of what appeared to be dark skin transfers. There was also an unknown fluid stain on the left side of the air bag, towards the top. The skin transfers to the

bottom portion were approximately 13 centimeters (5.1 inches) wide and 11 centimeters (4.3 inches) long, starting at the left edge. The other transfer was 8 centimeters (3.1 inches) wide and 16 centimeters (6.3 inches) long, starting 13 centimeters (5.1 inches) inward from the right edge.

**Figure 16:** Overhead view of case vehicle's cutout and folded over, front right passenger air bag showing skin evidence on top and underside surfaces (case photo #47)

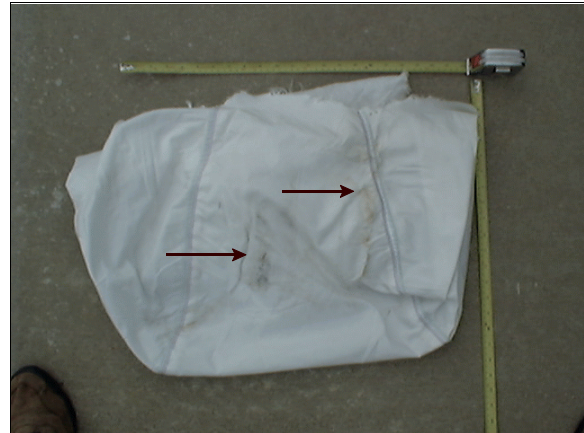
**Figure 17:** Overhead view of underside surface of case vehicle's cutout, front right passenger air bag showing skin transfers (case photo #44)

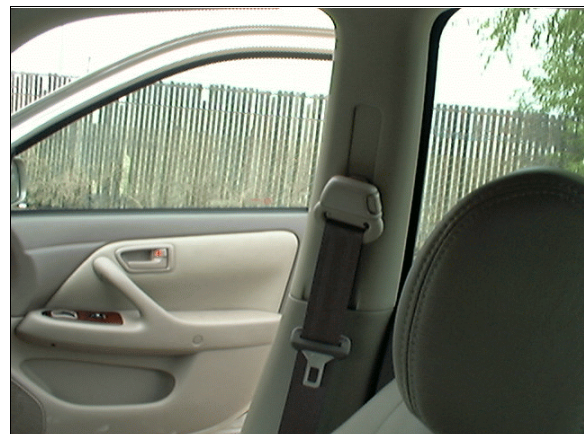
The case vehicle's front right passenger [117 centimeters and 23.2 kilograms (46 inches, 51 pounds)] was not using her available, active, three-point, lap-and-shoulder, safety belt system. Furthermore, there was no indication of belt pattern bruising and/or abrasions to the front right passenger's body. In addition, the inspection of the front right passenger's seat belt webbing, "D"-ring, and latch plate showed no evidence of loading. The front right safety belt's adjustable upper anchorage was located in its down-most position (**Figure 18**).

**Figure 18:** Case vehicle's unused front right passenger safety belt system; Note: adjustable upper anchorage located in down-most position (case photo #37)

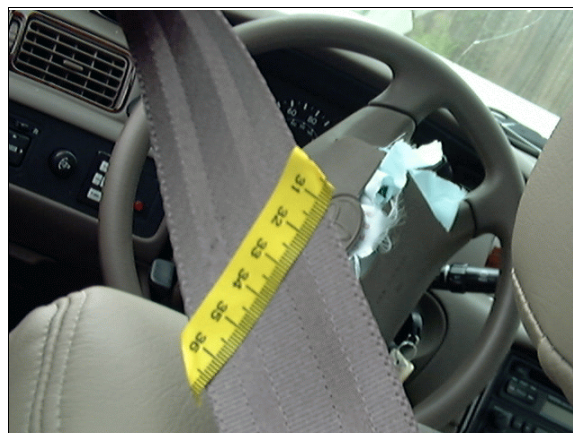
**Figure 19:** Close-up of loading evidence on case vehicle's driver safety belt (case photo #25)

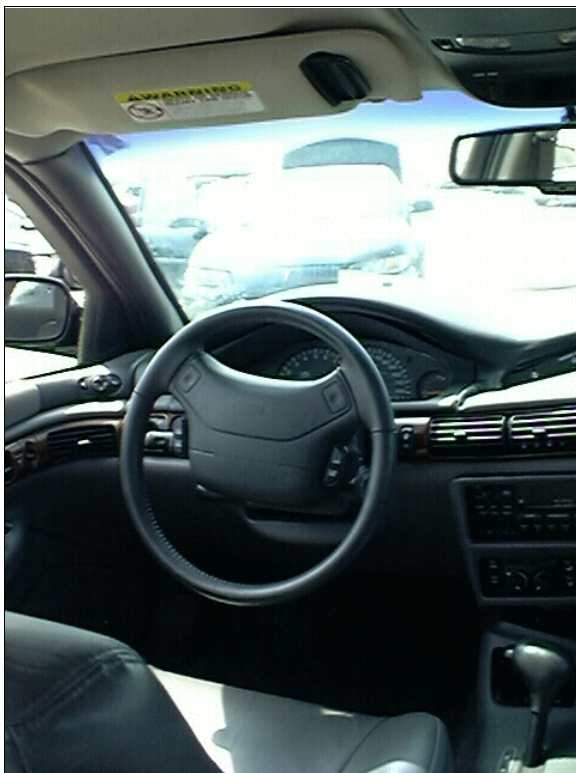
**Figure 20:** Vertical view of Chrysler's driver seating area showing non-deployed driver's air bag; Note: steering wheel is inverted (case photo #67)

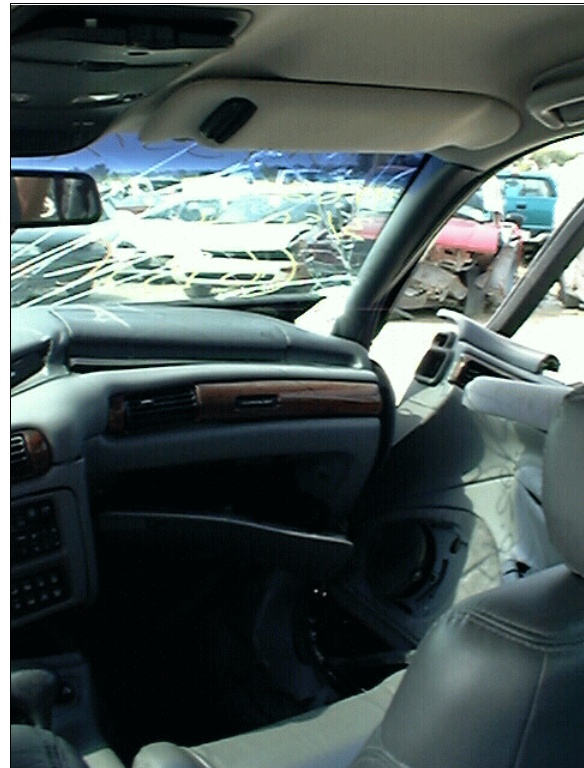
**Figure 21:** Vertical view of Chrysler's front right passenger seating area showing deformed front right instrument panel and non-deployed front right passenger's air bag (case photo #69)

was also minor lateral intrusion to the right front dash board and right B-pillar (**Figure 21** above). The Chrysler's right front was physically restricted and deflated as a result of the crash.
