## ON-SITE AIR BAG INVESTIGATION

CASE NUMBER - IN97-030

VEHICLE - 1997 DODGE NEON LE

CRASH DATE - September, 1997

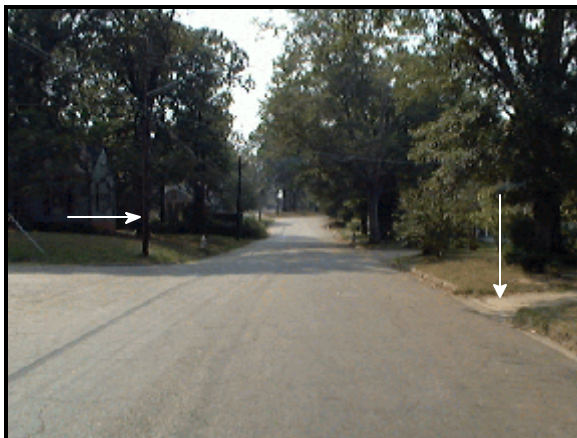
**Figure 1:** Case vehicle's westward travel path on residential, city street; Note: driveway (arrow on right), from which noncontact vehicle came, and utility pole (arrow on left), which was impacted (case photo #02)

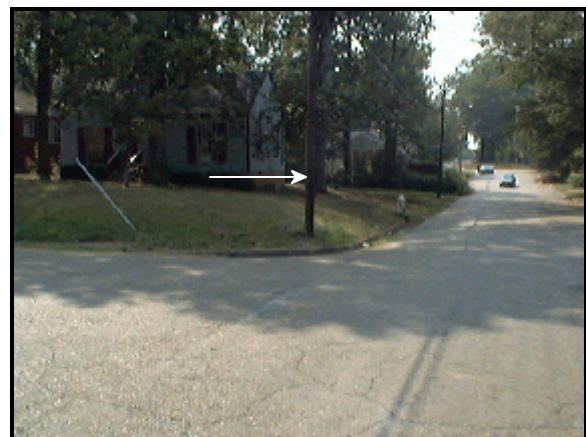
**Figure 2:** Utility pole located off southwest corner of offset, four-leg intersection that was impacted by case vehicle when driver swerved to miss a noncontact vehicle that had back from a driveway in northeast quadrant of intersection and was attempting to turn left and go southward on the intersecting roadway (case photo #03)

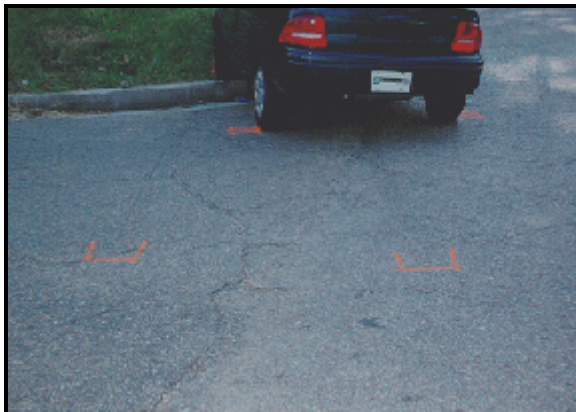
**Figure 3:** On-scene view showing police marked front tire skids of case vehicle at final rest; Note: curb impacted by left front wheel and vehicle's counterclockwise rotation to final rest position (case photo #47)

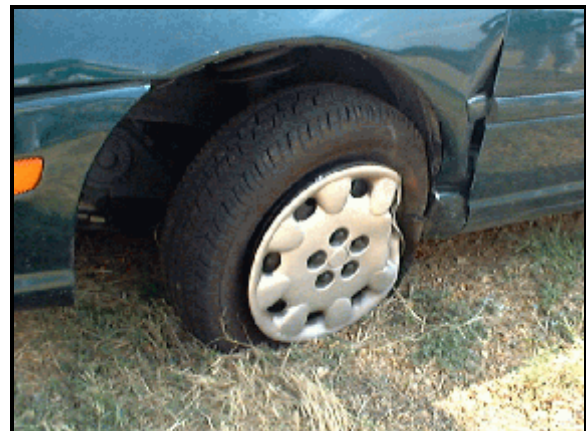
**Figure 5:** Damage to case vehicle's left front tire and wheel assembly from impacting curb (case photo #16)

The case vehicle’s left front tire (**Figure 5** above) impacted a raised curb [20 centimeters (7.9 inches)], damaging the rim and shortening the wheelbase on the driver’s side 15 centimeters (5.9 inches) and causing the case vehicle’s driver and front right passenger supplemental restraints (air bags) to deploy. Almost simultaneously the front bumper (**Figure 6**) impacted a wooden utility pole. The case vehicle rotated approximately 20 degrees counterclockwise and moved slightly backward before coming to rest near the point of impact (**Figure 7**).

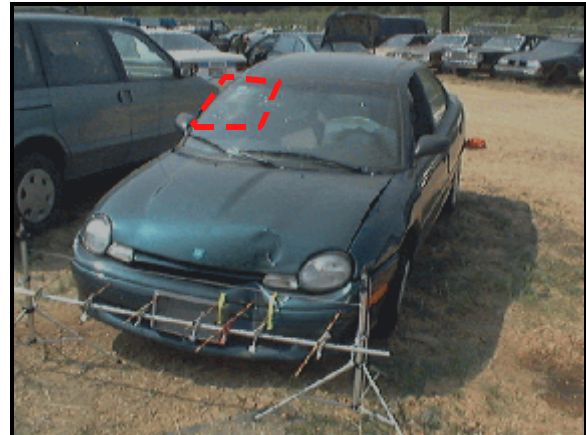
**Figure 6:** Overhead left view of case vehicle’s direct and induced frontal damage from pole impact; Note: windshield glazing on passenger side near header damaged from contact by “On-Lap” front right passenger’s head (case photo #13)

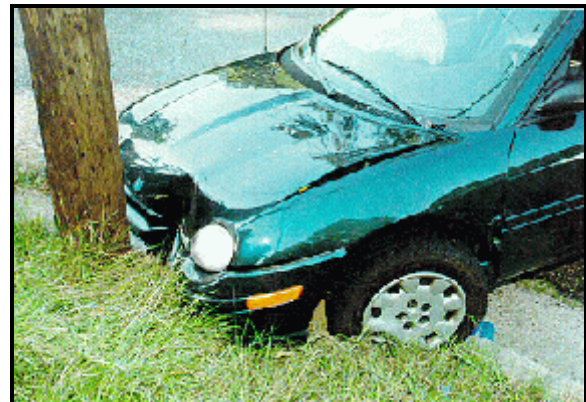
**Figure 7:** On-scene view of case vehicle at final rest; Note: case vehicle struck curb with the left front tire and wooden utility pole with front left (case photo #44)

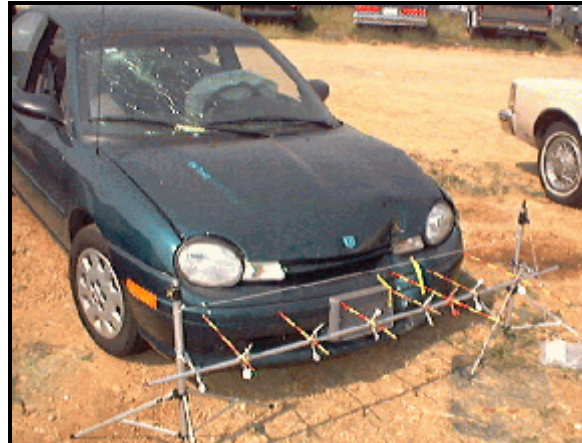
The case vehicle's initial contact with the barrier curb involved direct damage to the left front tire and wheel rim. The direct contact with the wooden utility pole involved the Neon's front bumper and hood, left of center. Direct damage along the front bumper was located 15 centimeters (5.9 inches) left of center and 31 centimeters (12.2 inches) inward from the front left bumper corner and extended, a measured distance of 21 centimeters (8.3 inches), along the front bumper. The field L was 134 centimeters (52.8 inches). Maximum crush was measured as 17 centimeters (6.7 inches) between C<sub>2</sub> and C<sub>3</sub> (**Figure 8**). The wheelbase on the case vehicle's left side was shortened 15 centimeters (5.9 inches) from the curb impact, while the right side was not shortened. The case vehicle's left front wheel rim was severely deformed and the tire deflated (**Figure 9**) from the curb impact. The case vehicle's front bumper, bumper fascia, grille, and hood were directly damaged and crushed rearward from the utility pole impact. The left fender sustained induced damage and the right front door's glazing was disintegrated as a result of the crash (**Figure 8**).

**Figure 8:** Overhead right view of case vehicle's front left damage with contour gauge present and tape indicating width of direct damage; Note: disintegrated right front door glazing and spider web type impacts to windshield (case photo #20)

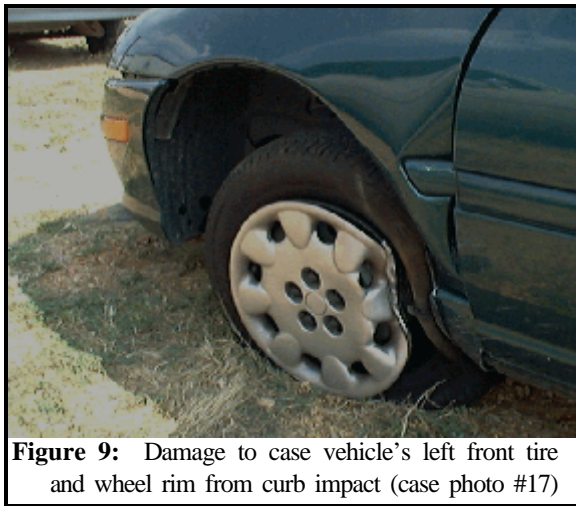
**Figure 9:** Damage to case vehicle's left front tire and wheel rim from curb impact (case photo #17)

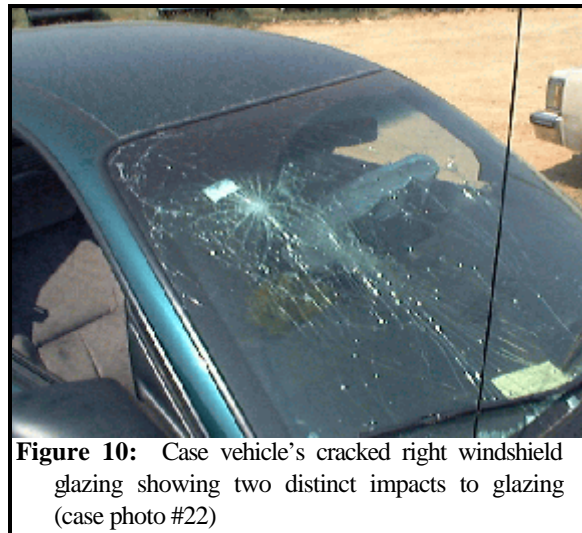
**Figure 10:** Case vehicle's cracked right windshield glazing showing two distinct impacts to glazing (case photo #22)

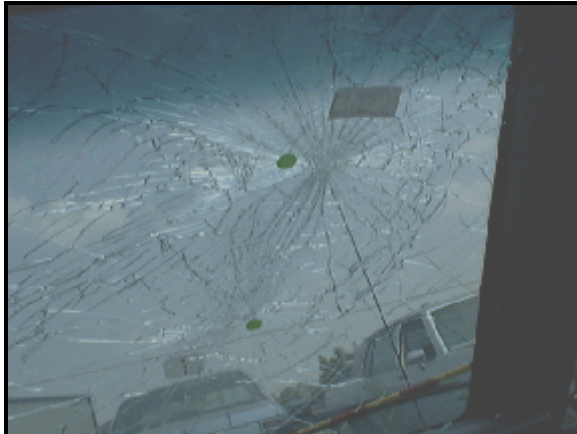
passenger. Above this contact was another spider web-type contact with skin, curly black hair, an oil smear, and blood transfers to the windshield, header, and forward edge of the sun visor on the front right side from impact by the “on-lap” front right passenger’s anterior and posterior head (**Figure 11** and **Figure 12**).

**Figure 11:** Close-up of spider web-type damage to case vehicle’s right upper windshield (upper dot) from impact by “On-Lap” front right passenger; Note: lower dot most likely represents contact by air bag’s fabric during deployment (case photo #31)

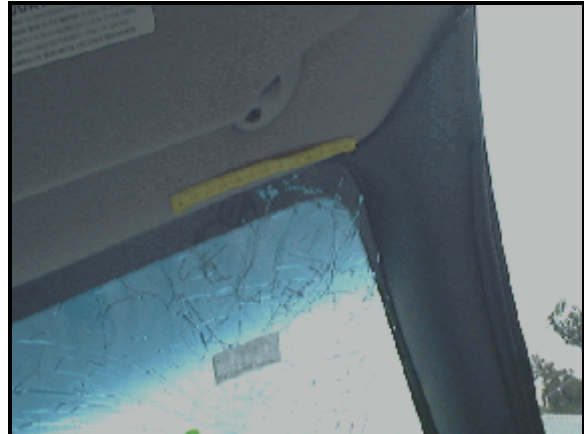
**Figure 12:** Close-up of head contact to case vehicle’s right upper windshield and header, near right “A”-pillar (i.e., hair and skin stuck in crease) from back of “On-Lap” front right passenger’s head (case photo #32)

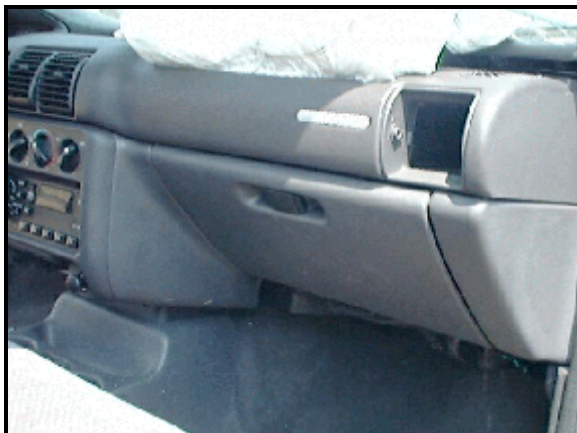
**Figure 13:** Case vehicle’s center and front right instrument panel, right knee bolster, and glove box door showing no evidence of occupant contact; Note: right air vent knocked out (case photo #30)

bag module was broken out (Figure 13), and there was a scuff on interior surface of the right front door near the door handle, either from the child passenger's torso or from the adult front right passenger. In addition, the driver's sun visor showed a dark skin and oil transfer from impact by the driver (Figure 14 above and Figure 15).

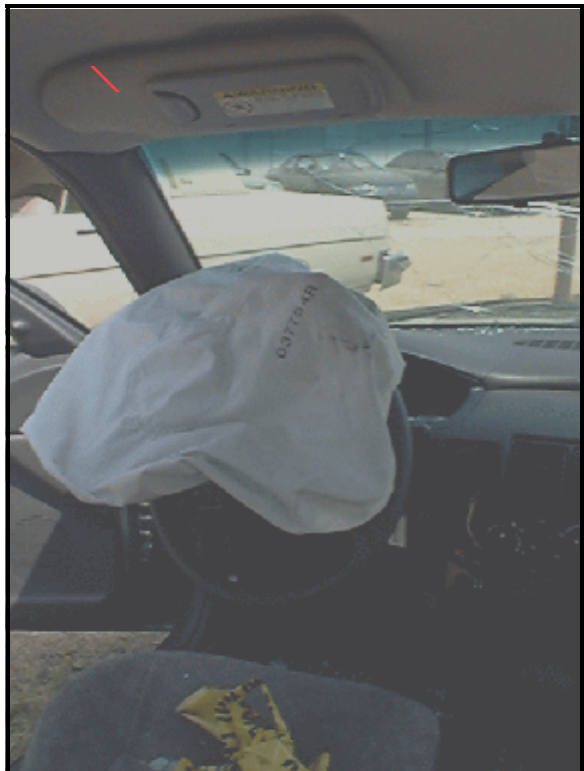
**Figure 14:** Vertical view of case vehicle’s driver seating area showing no visible contact evidence on driver’s air bag and a head contact (highlighted) to the left side of driver’s sun visor (case photo #25)

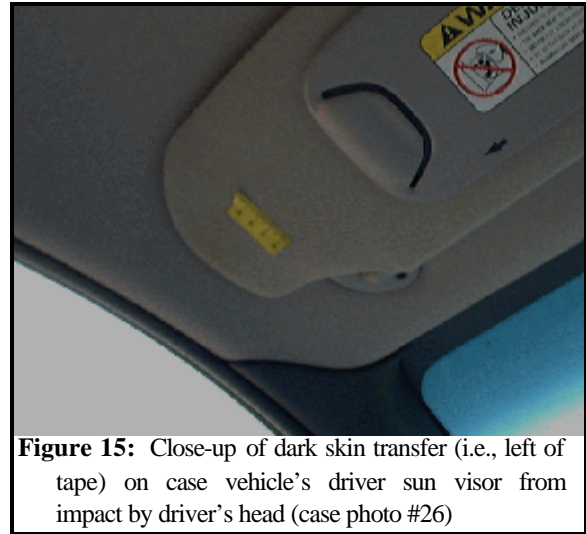
Figure 15: Close-up of dark skin transfer (i.e., left of tape) on case vehicle's driver sun visor from impact by driver's head (case photo #26)

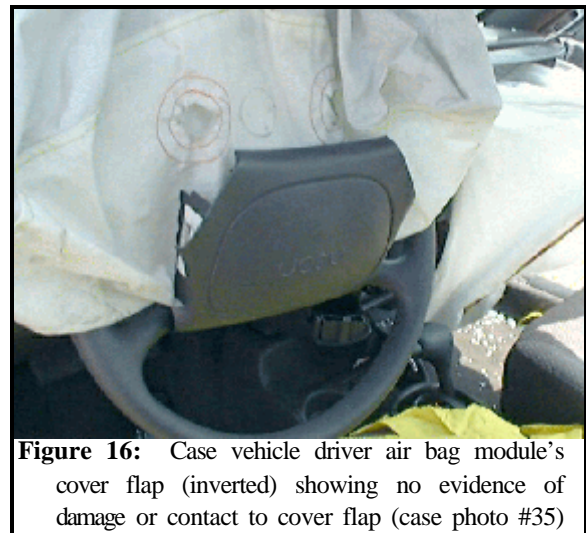
Figure 16: Case vehicle driver air bag module's cover flap (inverted) showing no evidence of damage or contact to cover flap (case photo #35)

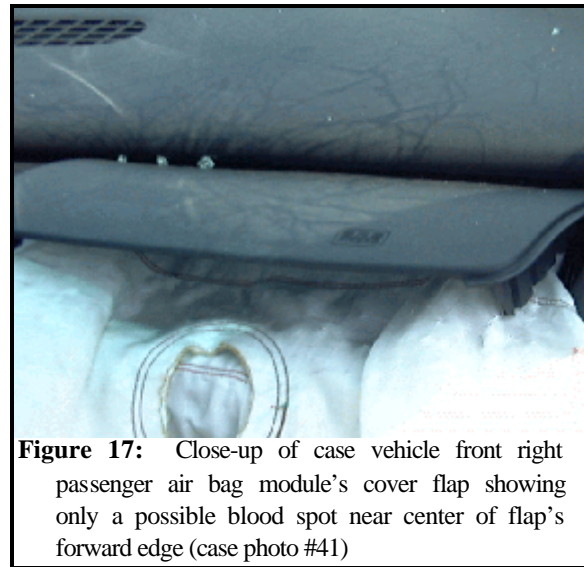
capable, due to its height and placement, of contacting the windshield. An inspection of the front right air bag module's cover flaps and air bag revealed that the cover flap opened at the designated tear points, and there was no evidence of damage during the deployment to the air bag or the cover flaps (**Figure 17**).

**Figure 17:** Close-up of case vehicle front right passenger air bag module's cover flap showing only a possible blood spot near center of flap's forward edge (case photo #41)

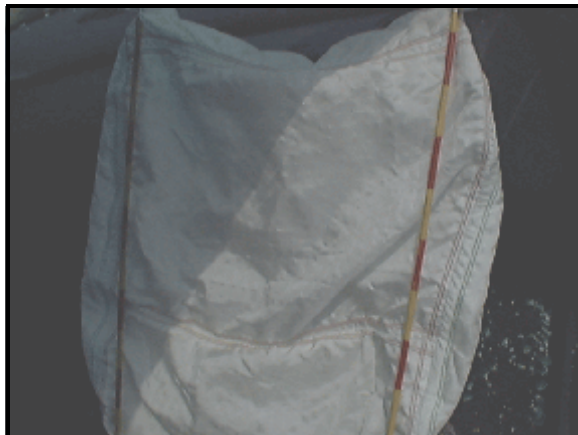
**Figure 18:** Frontal view of case vehicle's front right passenger air bag showing no visible evidence of contact (case photo #37)

position (**Figure 17**). The deployed front right air bag was rectangular (**Figure 18**) with a height of approximately 63 centimeters (24.8 inches) and a width of approximately 47 centimeters (18.5 inches). Examination of the front right passenger air bag revealed one area of dark skin transfer to the top right portion and blood splatter to the top left portion which extended onto the front surface (**Figure 19** above). In addition there was a dark skin transfer to the right side of the air bag towards the top. The skin evidence to the top right portion of the air bag was approximately 6 x 6 centimeters (2.4 x 2.4 inches) square and was located along the top right corner and top forward edge (**Figure 20**). The skin evidence on the right side extended downwards 17 centimeters (6.7 inches) from the top edge, approximately, and angled back from the front surface approximately 5 centimeters (2.0 inches) at its beginning and 7 centimeters (2.8 inches) at its end (**Figure 21**). The area of blood spots on the top surface began 11 centimeters (4.3 inches) back from the leading edge and continued down onto the front surface a measured distance of 8 centimeters (3.1 inches). This area of blood spots were located approximately 7-8 centimeters (2.8-3.1 inches) inward from the left edge.

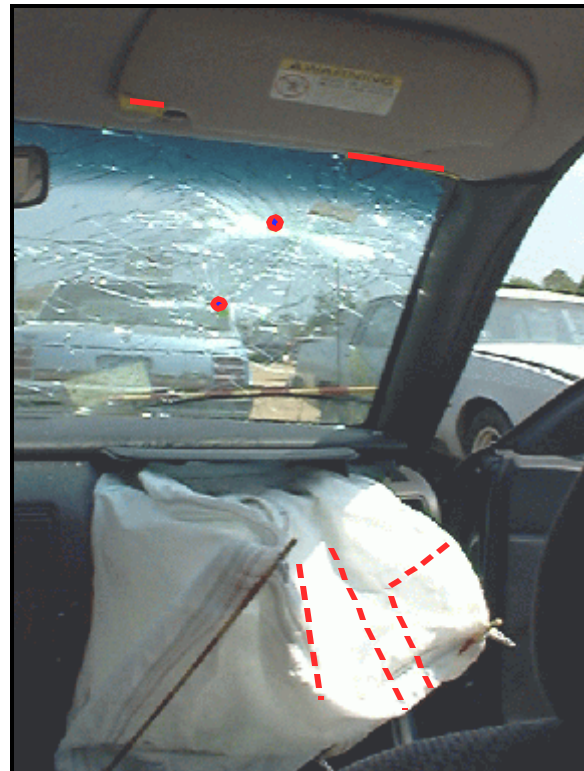
**Figure 19:** Vertical view of case vehicle's front right passenger seating area; Note: highlighted contacts to top of front right air bag, windshield, and right header (case photo #40)

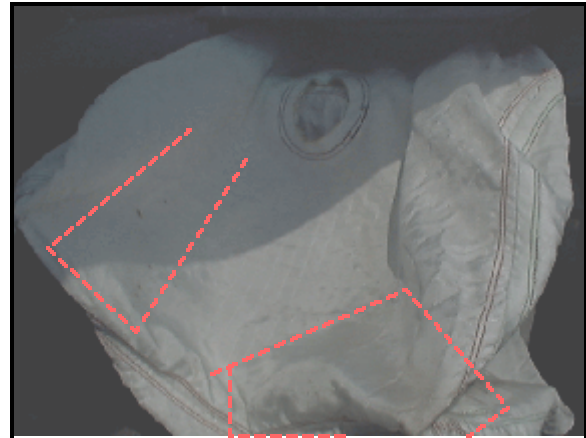
**Figure 20:** Close-up view of top portion of case vehicle's front right passenger air bag showing blood splatter to left side and barely visible dark skin transfer to top right corner towards front portion (case photo #38)

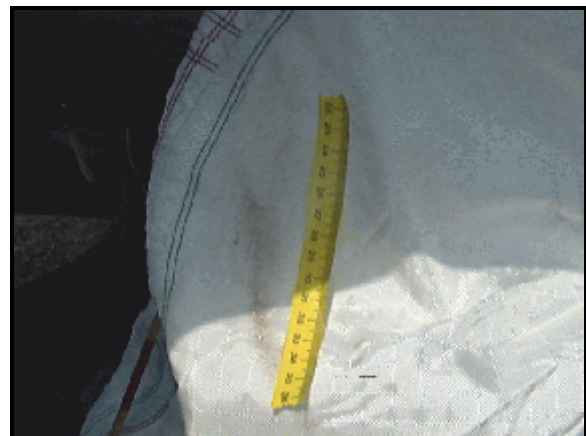
**Figure 21:** Dark skin transfer on right side near top front corner of case vehicle's front right passenger air bag (case photo #40)

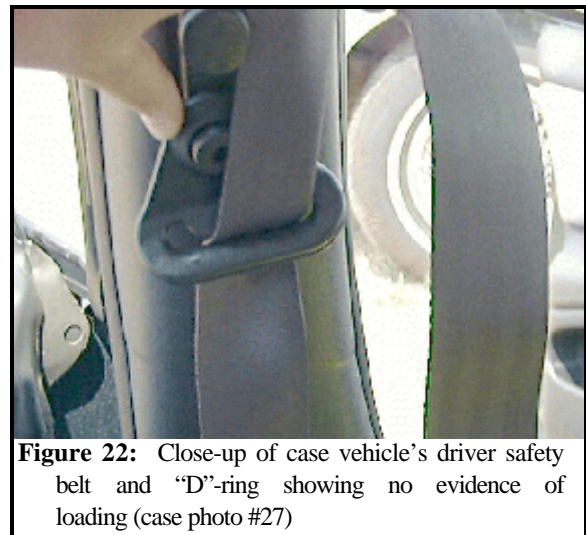
**Figure 22:** Close-up of case vehicle’s driver safety belt and “D”-ring showing no evidence of loading (case photo #27)
