**TRANSPORTATION SCIENCES
CRASH RESEARCH SECTION**

**CALSPAN ON-SITE SIDE IMPACT AIR BAG DEPLOYMENT INVESTIGATION
CALSPAN CASE NO. CA97-037
VEHICLE: 1998 BMW 740iL
LOCATION: MISSOURI
CRASH DATE: OCTOBER, 1997**

CALSPAN ON-SITE SIDE AIR BAG DEPLOYMENT INVESTIGATION

CALSPAN CASE NO. CA97-037

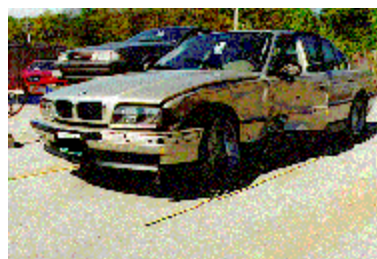
This on-site side impact air bag deployment crash investigation focused on a front-to-side impact configuration that involved a 1998 BMW 740iL and a 1993 Pontiac Grand Am. The BMW was equipped with an Advanced Side Airbag Protection (ASAP) system that consisted of four door mounted side impact air bags and two Inflatable Tubular Structures (ITS) head bags. The left side impact (**Figure 1**) deployed

Figure 1. Left side damage to the BMW 740iL.

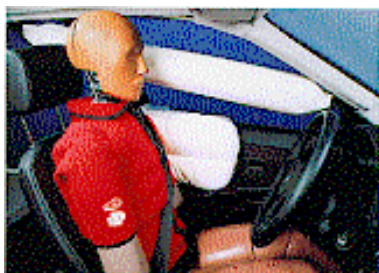
Figure 2. Test image of the deployed side impact air bags.

the left side impact air bags and head bag (**Figure 2**) as a result of the impact with the Pontiac. The BMW was occupied by the 45 year old

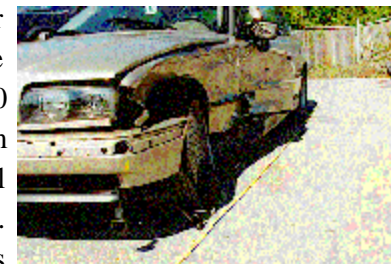
Maximum crush was 23.1 cm (9.1") located on the left front door panel 214.6 cm (84.5") forward of the left rear axle position. The crush profile at the mid door level (**Figure 5**) was as follows: C1 = 0 cm, C2 = 14.2 cm (5.6"), C3 = 13.3 cm (5.25"), C4 = 18.4 cm (7.25"), C5 = 22.6 cm (8.9"), C6 = 0 cm. Maximum crush at the sill of the vehicle was 9.5 cm (3.75") located at the base of the A-pillar. The sill crush was documented at the locations of C1-C3 and was as follows: C1 = 0 cm, C2 = 4.1 cm (1.6"), C3 = 9.5 cm (3.75"). The Collision Deformation Classification (CDC) for this damage pattern was 10-LYEW-3.

Figure 5. Longitudinal view of the left side damage to the BMW.

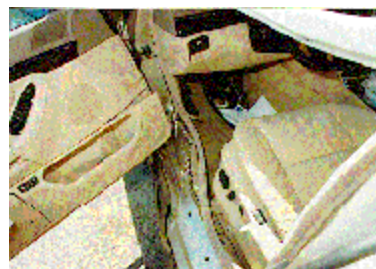
Maximum intrusion involved 8.6 cm (3.4") of lateral displacement of the left lower A-pillar/sill juncture point (**Figure 6**). The lower and forward aspect of the left front door panel intruded approximately 5.1 cm (2.0") into the driver's position. There was no intrusion into the left rear occupant space.

Figure 6. Intrusions of the left front occupant space.

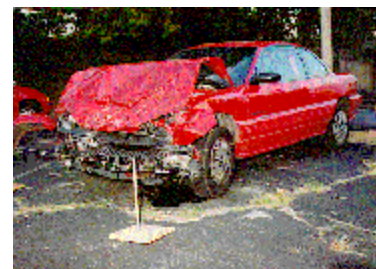
The 1993 Pontiac Grand Am sustained severe frontal damage (**Figure 7**) as a result of its impact sequence with the left side of the BMW. The front bumper fascia separated from the frontal structure of the vehicle, therefore the crush profile was documented at the honeycomb bumper reinforcement bar. The direct contact damage was 138.4 cm

Figure 7. Frontal damage to the Pontiac Grand Am.

(54.5") in length which spanned the full width of the fascia. The combined induced and direct contact damage length of the deformed frontal structure was 120.7 cm (47.5") which extended across the full width of the reinforcement bar. Maximum crush was 42.5 cm (16.75") located on the bumper reinforcement bar 36.2 cm (14.25") left of the centerline. The crush profile documented at the bumper reinforcement bar was as follows: C1 = 41.7 cm (16.4"), C2 = 42.5 cm (16.75"), C3 = 36.6 cm (14.4"), C4 = 31.8 cm (12.5"), C5 = 26.0 cm (10.25"), C6 = 5.7 cm (2.25"). The left wheelbase was reduced by 8.9 cm (3.5") while the right wheelbase was elongated by 3.6 cm (1.4") due to the lateral displacement to the left. The CDC was 01-FDEW-2.

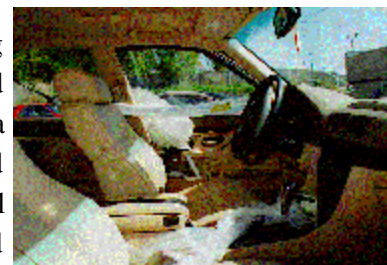
Figure 9. Deployed side impact and ITS bags for the driver's position.

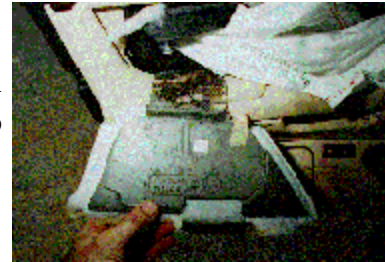
The side impact air bags were incorporated into the mid rear aspect of the four door panels. The respective side impact air bags were designed to deploy only in the event of a direct side impact crash. The off-side bags do not deploy. The door mounted side air bags were concealed by the leather door panel trim that was identified by the word AIRBAG embossed in the upper rear aspect of the cover. A dense foam backer panel was affixed to the leather outer cover flap and attached to the module assembly by a synthetic mesh tether. The side air bag membrane subsequently deployed from a plastic, four panel module cover flap assembly that concealed the bag membrane within the module assembly. The inflator/air bag was an independent component from the exterior (leather) trim module compartment cover. The left front door mounted leather cover flap was trapezoidal in shape with a top length of 30.5 cm (12.0") and a bottom length of 19.1 cm (7.5"). The overall height of the cover was 14.9 cm (5.9") The foam backer was approximately 7.9 mm (5/16") in thickness and mirrored the exterior shape of the leather cover flap. The backer was tethered to the door mounted inflator assembly by a 10.2 cm (4.0") wide-band mesh tether than extended approximately 10.2 cm (4.0") outward from the vertical surface of the door panel (**Figure 10**). The secondary plastic cover flaps that concealed the air bag membrane within the inflator assembly were rectangular in overall shape and opened in an H-configuration with triangular side flaps, forming four separate cover flaps. The overall dimensions of these cover flaps were 10.2 cm (4.0") vertically and 17.3 cm (6.8") horizontally. The flaps opened at the designated tear points.

Figure 10. Tethered cover flap for the left front door mounted side impact air bag.

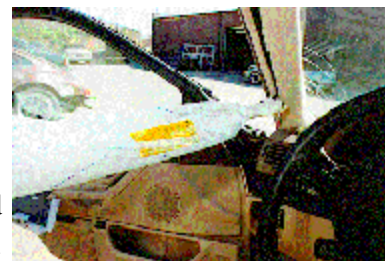
The left front (driver) position was provided head and neck protection by a Head Protection System (HPS) that involved the deployment of the Inflatable Tubular Structure (ITS) head air bag. The ITS bag was concealed within the side rail and retained in place by a series of plastic clips that extended from the A-pillar (**Figure 11**) to the C-pillar. The padded headliner was fitted into the side rail trim which concealed the ITS bag. At deployment, the ITS expanded within the side rail which separated the headliner from the trim panel. This separation acted as the module cover which allowed the ITS bag to deploy and offer protection to the driver.

Figure 11. Forward aspect of the ITS at the left A-pillar.

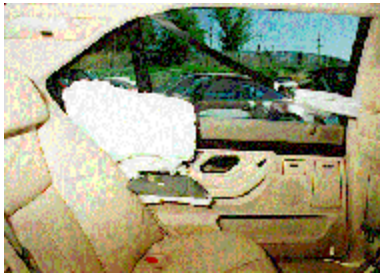
Figure 12. Deployed left rear door mounted side impact air bag.

The left rear door side impact air bag was concealed under a similar leather cover flap to the left front door system (**Figure 12**). The leather cover was backed by the foam panel which was tethered to the inflator assembly. The left rear tether was 10.2 cm (4.0") in width, however, the length was 3.8 cm (1.5") which hinged the external cover flap close to the door panel. The bag membrane was concealed within a secondary cover flap similar to the left front system. The rear secondary flaps were 16.2 cm (6.4") in width and 8.3 cm (3.25") vertically. The deployed left rear side impact air bag was larger than the left front side impact air bag with overall dimensions of 35.6 cm (14.0") vertically and 50.8 cm (20.0") horizontally. The rear bag was tethered

by a single internal tether that was sewn to the center area of the bag in a J-configuration. There were no direct vent ports for the rear side air bag. At the time of our inspection which occurred 17 days post-crash, a small amount of residual gas remained in the bag. There was no contact evidence on the door mounted air bags.
