**DEPOWERED AIR BAG REPORT**

CASE NUMBER - IN97-041  
LOCATION - Texas  
VEHICLE - 1998 CHEVROLET CAVALIER  
CRASH DATE - October, 1997

1. <i>Report No.</i> IN97-041	2. <i>Government Accession No.</i>	3. <i>Recipient's Catalog No.</i>	
4. <i>Title and Subtitle</i> On-site Depowered/Second Generation Air Bag Investigation Vehicle: 1998 Chevrolet Cavalier Location: Texas		5. <i>Report Date:</i>  April 29, 1998

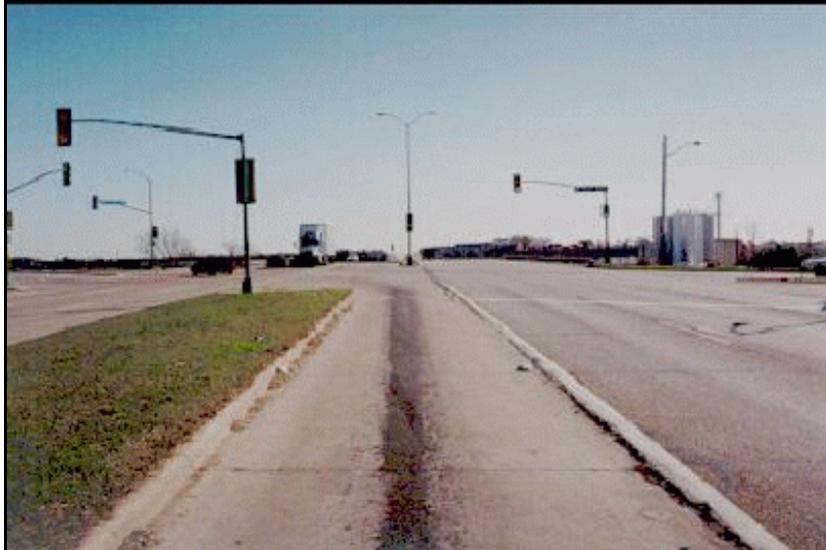
Figure 1: Case vehicle's southbound approach to left turn (case photo #2)

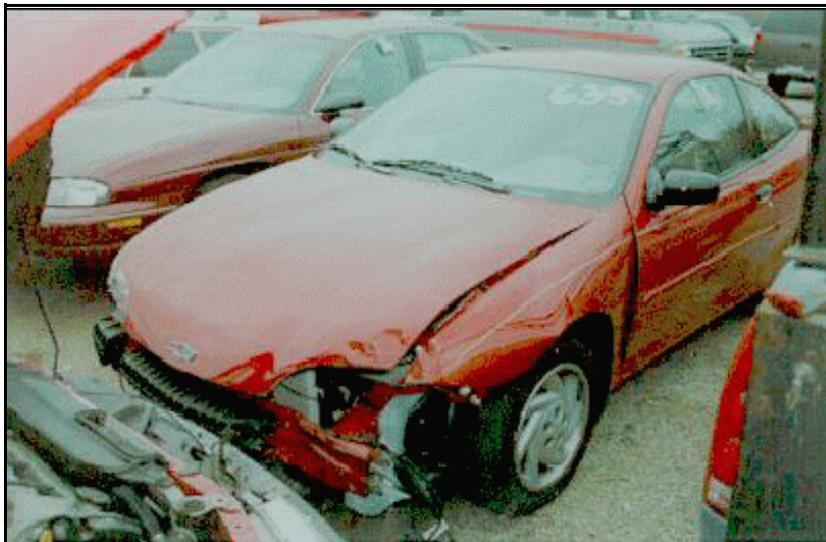
The case vehicle was a front wheel drive 1998 Chevrolet Cavalier two-door coupe (VIN: 1G1JC1244W7-----). The case vehicle was not available to be inspected, but insurance photographs were acquired. The impact was at the front left corner area, with direct contact damage to the bumper, the headlight area, the engine hood and the left fender (see Figure 2). The CDC, estimated from the photographs, was determined to be **01-FYEW-1**. A CDC-only ROLDMIS reconstruction indicated that the Total, Longitudinal, and Lateral Delta Vs were, respectively: 16 km.p.h. (10 m.p.h.), -14 km.p.h. (-7 m.p.h.) and -8 km.p.h. (-5 m.p.h.). This was a crash of low severity for the case vehicle.

Figure 2: Case vehicle, front and left side (case photo #9)
