**CALSPAN ON-SITE AIR BAG CHILD FATALITY INVESTIGATION**

**CALSPAN CASE NO. CA97-42**

**VEHICLE - 1995 TOYOTA AVALON**

**CRASH DATE - OCTOBER, 1997**

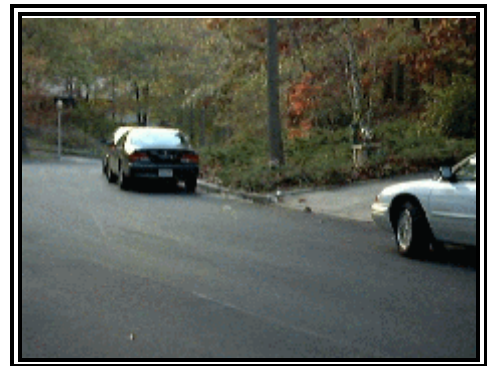
Inspection of the crash scene revealed the crash occurred in a residential neighborhood, in front of the child's home. The east/west road measured 10.2 m (33.5 ft) in width and was constructed of asphalt (re-paved within the last six months). The subject residence was on the north side of the road and the private driveway to the home was circular. The driveway entrances were situated on a right curve and were 32 m (105 ft) apart. Concrete curbs, 15 cm (6 in) in height, bordered the road edges. A negative grade westbound began at the east drive and the grade increased to -8% at the west drive. Further downstream from the crash scene the grade increased to -11%. The roads were damp/wet and leaf covered at the time of the crash. It had recently stopped raining. The road was marked with an advisory speed limit of 24 km/h (15 mph) preceding the curve.

**Figure 1:** Trajectory view of the crash scene.

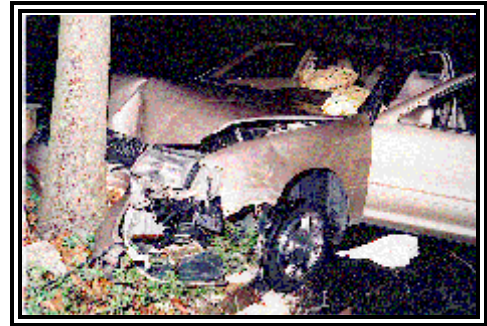
the seven year old right front passenger (the driver's grandson). In addition, the vehicle's trunk was loaded with an estimated 181 kg (400 lb) for a driving vacation. The crash occurred when the driver lost directional control, while the vehicle was in the process of executing a right turn into the driveway. The vehicle entered the northwest intersection quadrant, formed by the driveway and roadway, and struck a 35 cm (14 in) diameter tree located 2.1 m (6.9 ft) west of the driveway and 1.0 m (3.2 ft) north of the curb. A scratch 81 cm (32 in) in length was located on the road just prior to the vehicle's departure and defined the vehicle's trajectory. The center frontal plane of the Toyota impacted the tree (**Figure 2**). The vehicle came to rest in contact with the tree, partially in the northwest intersection quadrant, at a thirty degree angle relative to the road.

**Figure 2:** View of final rest position of the Toyota Avalon.

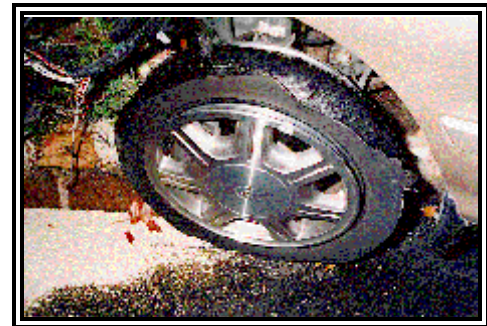
Upon impact, the inboard sidewall of the left front tire (**Figure 3**) came in contact with the curb sidewall. A distinct scuff 25 cm (10 in) in width was noted on the sidewall of the curb. Reportedly, the vehicle's engine continued to run and the front tires continued to rotate after the impact. One of the investigating officers reported that as the tire rotated, the tire rapidly heated and began to separate. The disintegrating tire damaged the inner fender of the left front wheel house and a wiring harness above the wheel area. The officer indicated that only the beads and portions of the tire's sidewalls remained attached to the wheel rim. The balance of the tire was shredded. This tire was removed and a spare tire was in place at the time of the vehicle inspection. A safety check of the vehicle was conducted. No mechanical defects were found in the brake or steering systems. However, low air pressure was measured in the remaining tires. The rear tires each measured 152 kPa (22 psi) and the right front tire measured 138 kPa (20 psi). The left front tire was probably under-inflated in a similar manner. It was the investigating officer's opinion that the low tire pressure may have been a contributing factor in the crash.

**Figure 3:** Post-crash condition of the Toyota's left front tire.

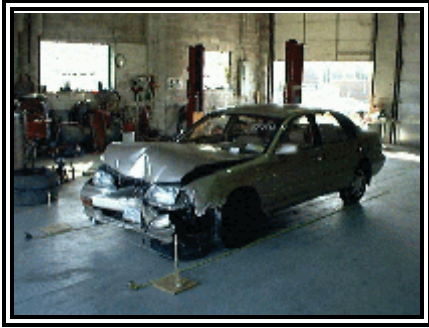
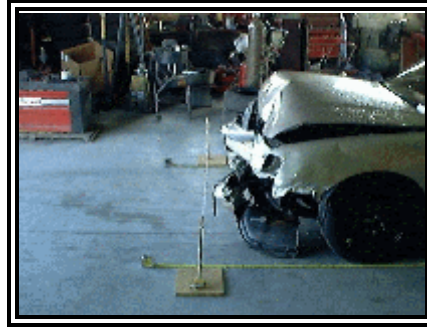
**Figures 4 and 5** are the left front and left lateral view of the Toyota Avalon taken during the inspection, respectively. The Collision Deformation Classification (CDC) of the Toyota Avalon was 12-FCEN-2. The impact deformed the entire front bumper structure of the Toyota into a V pattern when viewed from overhead. The width of the direct contact damage was 35 cm (14 in). There was a maximum deformation of 42.7 cm (16.8 in) measured at C<sub>3</sub>, located 6.4 cm (2.5 in) left of the vehicle's centerline. The deformation extended rearward buckling the hood and the center of the upper radiator support. The delta V of the Toyota was determined to be approximately 32 km/h (20 mph) by a barrier calculation using the WINSMASH algorithm.

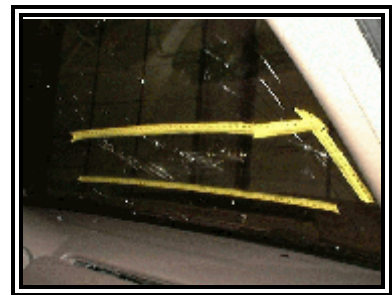
The right side of the windshield exhibited two specific fractures that joined together due to the weakened condition of the laminate (**Figure 6**). The fractures were located 24.1 cm (9.5 in) and 62.2 cm (24.5 in) right of center, approximately 14.0 cm (5.5 in) above the instrument panel. A 35.6 cm (14.0 in) long vinyl transfer was located between the fractures. The transfer was 5 cm (2 in) in width and tapered to 11.3 cm (0.5 in). This fracture pattern and transfer matched to the front passenger air bag module cover flap. Immediately below the fractures was a crack in the top of the instrument panel. The crack was 17.8 cm (7.0 in) long, 6.4 cm (2.5 in) forward of the edge of the instrument panel and centered laterally within the dimension of the front passenger air bag module cover flap. On the edge of the instrument panel were two sets of small fabric abrasions 17.8 cm (7.0 in) apart that matched to the cover flap tethers.

**Figure 6:** View of the right windshield fractures.

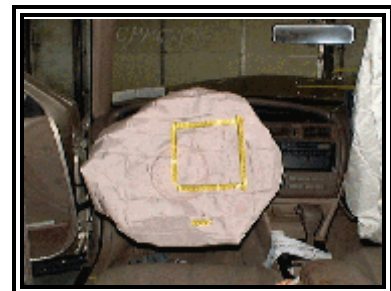
The driver air bag deployed as designed from the center hub of the steering wheel (**Figure 7**). The cover flaps of the driver air bag module were configured in the H-pattern. The upper and lower flaps were symmetrical measuring 17.1 cm (6.8 in) at the center seam by 7.6 cm (3.0 in) vertically. The driver air bag diameter measured 63.5 cm (25.0 in) in its deflated state and was tethered by four internal straps 6.4 cm (2.5 in) wide. The center tether stitching measured 16.5 cm (6.5 in) diameter. Two 2.9 cm (1.12 in) diameter vent ports were located on the back side of the air bag at the 11/1 o'clock positions. The face of the driver bag was lightly blood spattered in the upper left quadrant of the bag and with a single spatter in the lower left quadrant. There were no other interior contacts on the driver side of the vehicle.

**Figure 7:** Driver air bag.

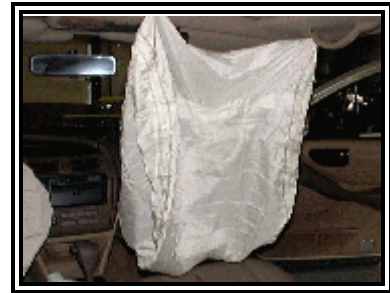
The front passenger air bag was wedge shaped and extended 76 cm (30 in) from the inflator, in its deflated state (**Figure 8**). The top of the bag measured 28 cm (11 in) laterally at the inflator and

increased to 64 cm (25 in) laterally at the extended bag face. The bag face measured 61 cm (24 in) vertically. The air bag was vented by two 3.5 cm (1.38 in) diameter vent ports located in the center of the bag's side panels. The center of the bag was tethered by a 61 cm (24 in) long strap. The center tethering allowed the perimeter of the bag to "billow" beyond the 61 cm (24 in) tethered dimension. The only evidence of occupant contact on the front passenger air bag was a 5 cm (2 in) long blood transfer on the left (inboard) side of the bag. The transfer was located 10 cm (4 in) down from the top of the bag and 10 cm (4 in) forward of the face.

**Figure 8:** Front passenger air bag.
