**CALSPAN ON-SITE AIR BAG DEPLOYMENT/ADULT PASSENGER
SEVERE INJURY INVESTIGATION
CALSPAN CASE NO. CA97-043
VEHICLE: 1995 GEO METRO
LOCATION: PENNSYLVANIA
CRASH DATE: JULY 1997**

Contract No.
DTNH22-94-D-07058

**CALSPAN ON-SITE AIR BAG DEPLOYMENT/ADULT PASSENGER
SEVERE INJURY INVESTIGATION
CALSPAN CASE NO. CA 97-043
VEHICLE:1995 GEO METRO
LOCATION: STATE OF PENNSYLVANIA
CRASH DATE: JULY 1997**

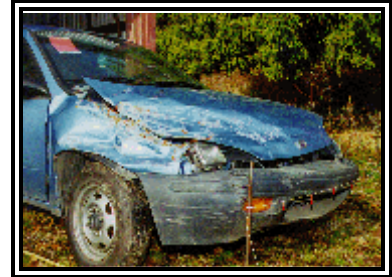
This investigation focused on a single vehicle run-off-road crash that involved a 1995 Geo Metro, 2-door hatchback. The Metro was equipped with frontal air bags for the driver and front right passenger positions that deployed as a result of a frontal impact with a rock embankment (**Figure 1**). The driver of the vehicle had stopped at a T-intersection which was controlled by a stop sign. He initiated a left turn onto a northbound 2-lane asphalt roadway and traveled approximately 400 meters (1,312 feet) when several dogs allegedly ran into the road. The driver took evasive action by steering right and braking to avoid the animals. The vehicle subsequently departed the right side of the road where the front center and right areas of the bumper, hood, and right front fender impacted an overhanging rock embankment. The 12 o'clock direction of force impact deployed the frontal air bags.

Figure 1. Front right view of the vehicle damage.

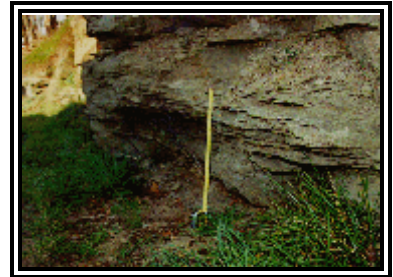
The Geo Metro subsequently departed the right side of the road in a near tracking orientation and impacted an overhanging rock embankment (**Figure 3**) that was located 0.5 meters (1.6 feet) outboard of the northbound travel lane. Initial contact involved the right and center aspects of the hood and right front fender of the vehicle against the overhanging aspect of the embankment. As the Geo continued forward, the bumper engaged against the rock embankment. Due to the overhanging structure and the sheet metal engagement, the crash was borderline for computer reconstruction. The outputs of the WinSMASH program were reasonable, therefore the reconstruction was allowed for this crash. Impact speed was computed by the damage and trajectory algorithm of the WinSMASH program at 36.3 km/h (22.6 mph). The total velocity change for this 12 o'clock direction of force impact was 17.7 km/h (11.0 mph) with a longitudinal component of -17.6 (-10.9 mph). This impact induced deceleration was sufficient to deploy the vehicle's frontal air bag systems, however, due to the overhanging structure, the crash pulse was probably elongated which deployed the air bags late in the crash sequence.

Figure 3. Overhanging rock embankment.

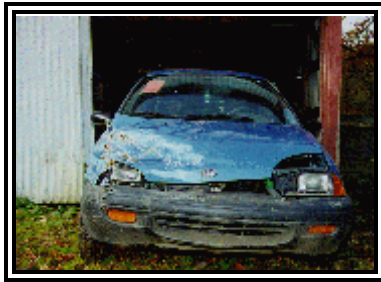
Damage to the Geo was rated as moderate with a maximum crush value of 8.7 cm (3.4") located at the right corner of the upper radiator support panel. Direct contact damage on the hood face began 2.5 cm (1.0") right of center and extended 66.0 cm (26.0") to the front right corner (**Figure 4**). The direct damage on the bumper fascia began 53.3 cm (21.0") right of center and extended 12.7 cm (5.0") to the front right corner. Crush measurements were documented at bumper level and the level of the upper radiator support

Figure 4. Frontal damage to the Geo Metro.

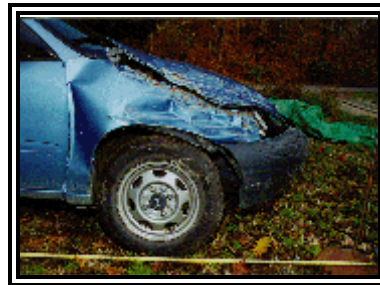
panel and are displayed below in **Table 1** . **Figure 5** is a profile view of the crush depth. The Principle Direction of Force (PDOF) was +5 degrees and the damage yielded a Collision Deformation Classification (CDC) of 12-FZEW-1.

Figure 5. Profile view of the frontal crush.

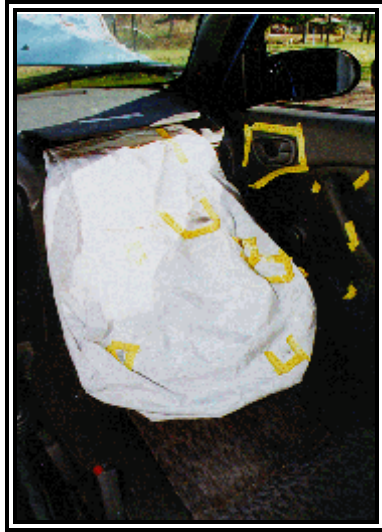
The front right passenger was seated in a forward track position with her arms extended forward of her body at impact. The front right air bag expanded against her arms resulting in soft tissue abrasions and contusions. Tissue fragments were noted to the lower right quadrant of the bag membrane. Several vinyl

transfers were noted to the bag from expansion within the module as the passenger's position restricted the normal deployment path of the bag. A band-like transfer was noted to the lower mid aspect of the bag, wrapping onto the bottom of the membrane. Several blood spatters were also noted to the bag. These points are documented in **Figure 6**.

Figure 6. Air bag contact points.

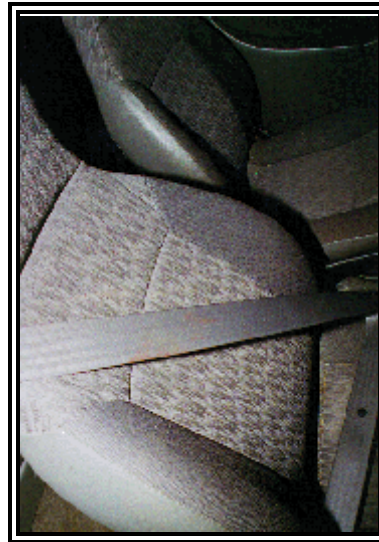
The front right air bag fabric transferred onto the shoulder belt webbing as the bag expanded against the passenger. The subtle transfer was located below a blood stain on the belt webbing (**Figure 7**). There was no contact evidence to the module covers or knee bolsters.

Figure 7. Blood stain on the front right shoulder belt.

The front right passenger shoulder belt webbing was stained with blood at the lower segment above the buckle assembly. Similar stains were noted to the buckle at the release button. Superficial air bag fabric

transfers were noted to the belt webbing in the area that would have extended over the chest area of the passenger. There was no loading evidence on the front right belt system.

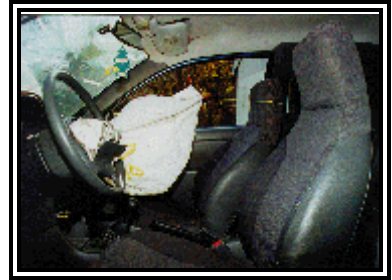
The Geo Metro was equipped with a Supplemental Inflatable Restraint (SIR) system that consisted of frontal air bags for the driver and front right passenger positions (**Figure 8**), a single point sensing and diagnostic (SDM) module with an external sensor mounted to the center radiator support panel, and a instrument panel air bag indicator lamp. The front mounted satellite crash sensor was rotated slightly vertically due to displacement of the upper radiator support panel. There was no damage to the sensor housing. The sensor was identified by the following on a bar coded label: 195524NM3.

Figure 8. Deployed frontal air bags.

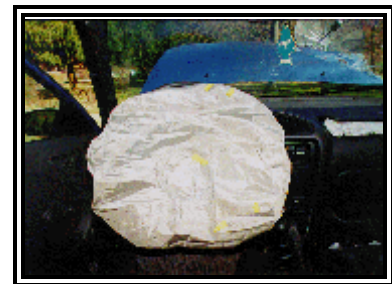
The front left air bag (**Figure 9**) was concealed within the module assembly of a four spoke steering wheel rim and deployed from asymmetrical H-configuration cover flaps. The upper flap measured 15.5 cm (6.1 in) in width and 5.5 cm (2.2 in) in height. The inside surface of the upper flap displayed the identification number 2C1MR2260S6789214. The lower flap measured 15.5 cm (6.1 in) in width and 8.0 cm (3.1 in) in maximum height. Contact evidence was not present to the face or underside of the air bag module cover flaps.

Figure 9. Deployed front left air bag.

Contact evidence on the deployed air bag membrane consisted of several blood spatters which probably resulted from the driver's epistaxis, post-crash.

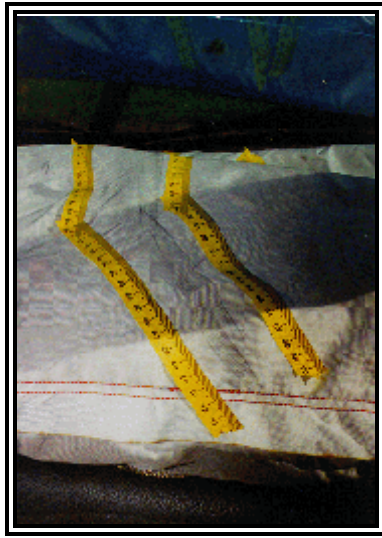
Several areas of vinyl were transferred onto the front right air bag from its restricted deployment path by the forward positioned passenger. The vinyl occurred from its expansion against the module assembly. A band-like transfer was noted to the back side of the bag as documented in **Figure 10**. The front right air bag contained three small tears to the membrane. These appeared to be deployment related from expansion against the interior surfaces of the module assembly and/or the leading edge of the cover flap.

Figure 10. Band-like vinyl transfer to the back side of the front right air bag .

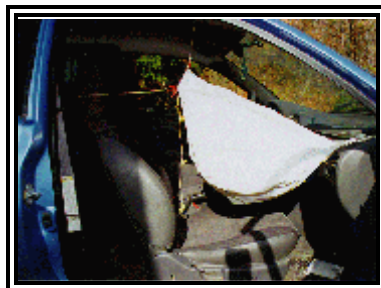
The forward positioned passenger was within the deployment path (**Figure 13**) of the non-tethered front right air bag. The bag membrane initially expanded against the extended arms of the passenger which resulted in bilateral abrasions and contusion. The bag displaced her arms rearward as the passenger moved forward into the expanding air bag as she responded to the frontal impact force. The combination of bag and belt loading compressed the passenger chest which resulted in multiple bilateral rib fractures (unspecified ribs) with plural edema. Tissue fragments (**Figure 14**) were present on the face of the bag at the lower right quadrant. This tissue transfer resulted from the arm contact as the passenger had no other soft tissue injury.

Figure 13. Deployment of the front right air bag from the top mount position.

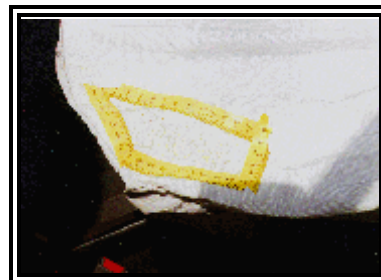
Figure 14. Tissue fragments on the lower right aspect of the bag membrane.
