ON-SITE AIR BAG INVESTIGATION

CASE NUMBER - IN97-047
LOCATION - LOUISIANA
VEHICLE - 1995 FORD WINDSTAR GL
CRASH DATE - November, 1997

1. <i>Report No.</i> IN97-047		2. <i>Government Accession No.</i>		3. <i>Recipient's Catalog No.</i>	
4. <i>Title and Subtitle</i> On-Site Air Bag Fatality Investigation Vehicle - 1995 Ford Windstar GL Location - Louisiana			5. <i>Report Date:</i> December 31, 1999; November 2, 2001

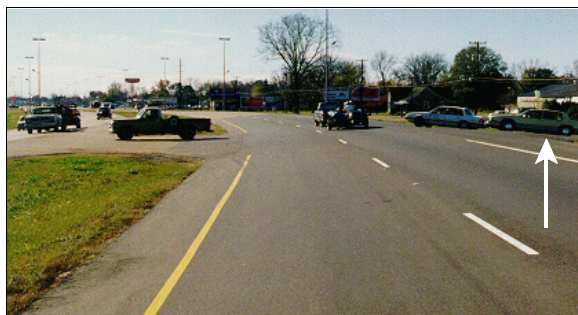
Figure 1: Case vehicle's southbound travel path in inside lane of left-hand curve; Note: roadway's +8% superelevation and the 8% positive grade on the west leg (arrow) as Chevrolet attempted to cross the roadway from right-to-left, heading eastward (case photo #01)

bordered by a solid yellow edge line on the east side and a solid white edge line on west side (Figure 1 above). The west side of the southbound road had a 3.5 meter (11.6 feet) paved shoulder and the east side had a 1.3 meter (4.3 feet) paved shoulder, prior to the 8.3 meter (27.2 feet) wide unprotected grassy median (Figure 2 above). The southbound roadway for the case vehicle at the point of impact was level (i.e., actual slope was 0.1%, negative to the south). The roadway was bituminous, and the ambient conditions were dry, cloudy, and dark, but there were street lamps for illumination at the time of the crash. There was no precipitation at the time of the crash. The posted speed limit for the case vehicle was 80 km.p.h. (50 m.p.h.). The Chevrolet was traveling east in the eastbound lane of an intersecting, two-lane, undivided roadway and was attempting to cross the southbound roadway in order to turn left and go north on the northbound roadway. The Chevrolet's approach to the southbound roadway involved crossing a frontage road and then driving up a incline (i.e., 8.5% slope, positive to the east; Figure 1 above) of approximately 14.0 meters (46 feet) prior to reaching the crest of the southbound roadway's superelevation, which was located on the west shoulder of the southbound roadway. The west leg of the intersection was controlled by a regulatory YIELD sign (Figure 3). Presumably the driver of the Chevrolet yielded prior to accelerating over the crest and driving down the southbound roadway's superelevation (i.e., 8.1% slope, negative to the east), attempting to cross the roadway. It should be noted that this contractor attempted this same crossing maneuver and found it awkward due to the upward slope and line-of-sight. The case vehicle's driver made no avoidance maneuvers prior to the crash. It is unknown if the Chevrolet's driver saw the case vehicle or attempted any evasive action prior to the crash. The crash occurred in the inside, southbound lane in the intersection of the two roadways; see CRASH DIAGRAM below.

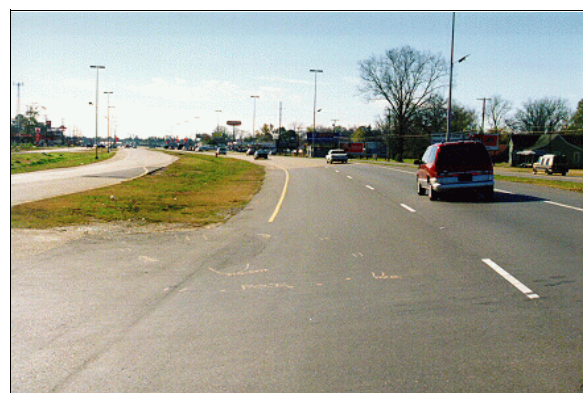
Figure 2: Case vehicle's southbound travel path in inside lane of left-hand curve just prior to impact; Note: police marked tire and impact positions (case photo #02)

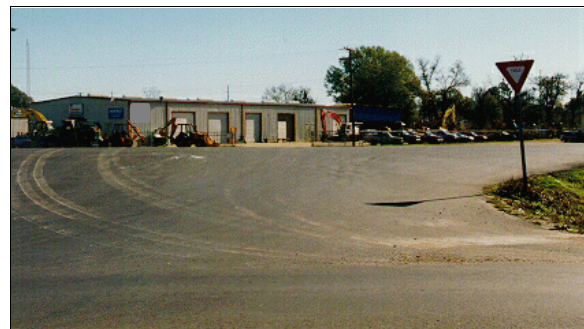
Figure 3: Chevrolet's eastward travel path across frontage road and up 8% positive grade of west leg of four-leg intersection; Note: case vehicle was traveling southward (i.e., left-to-right) in photo (case photo #07)

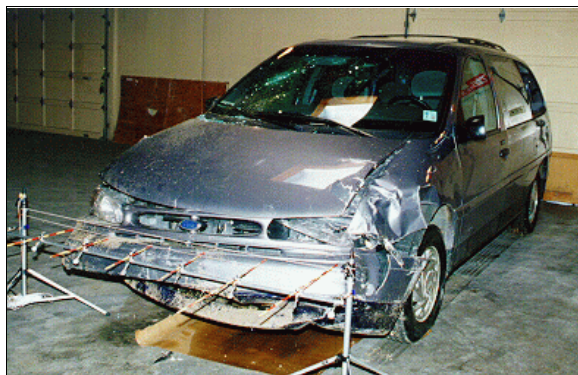
Figure 4: Case vehicle's frontal damage viewed from left of front with contour gauge present (case photo #15)

The front of the case vehicle (**Figures 4 and 5** above) impacted the left side center of the Chevrolet (**Figures 6 and 7**), causing the case vehicle's driver and front right supplemental restraints (air bags) to deploy. The impact caused the case vehicle to become embedded into the left side of the Chevrolet, causing both vehicle's to remain attached for a short distance. The impact sent both vehicles in a southeasterly direction off the roadway onto the unprotected grassy median that separated the trafficway's two roadways. The case vehicle drove the Chevrolet sideways a short distance before the case vehicle's counterclockwise yaw enabled it to separate from the Chevrolet. Upon separation, the case vehicle corrected itself back clockwise approximately 15 degrees prior to coming to an abrupt stop in the median heading essentially southward. The case vehicle came to rest approximately 19.2 meters (63 feet) southeast of the point of impact. After separating from the case vehicle, the Chevrolet rotated approximately 65 degrees counterclockwise before coming to rest in the median heading northeastward. The Chevrolet came to rest approximately 27.1 meters (89 feet) southeast of the point of impact.

Based on the vehicle inspection, the CDC was determined to be: **12-FDEW-1 (10)** for the case vehicle [maximum crush was 9 centimeters (3.5 inches) at C₁]. The WinSMASH reconstruction program, damage only algorithm, was used on the case vehicle's highest severity impact. The Total, Longitudinal, and Lateral Delta Vs are, respectively: 29.7 km.p.h. (18.5 m.p.h.), -29.2 km.p.h. (-18.1 m.p.h.), and -5.2 km.p.h. (-3.2 m.p.h.).

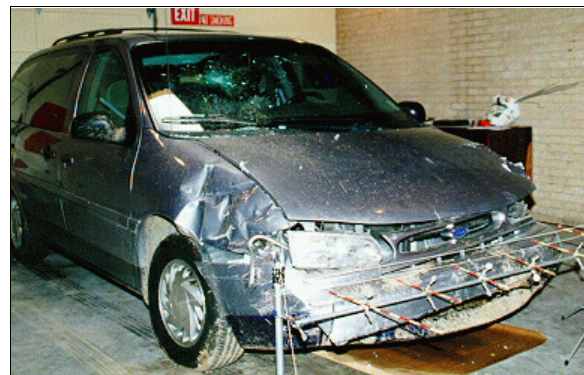
Figure 5: Case vehicle's frontal damage viewed from right of front with contour gauge present (case photo #21)

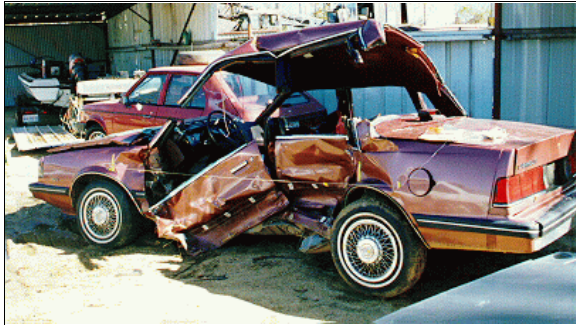
Figure 6: Chevrolet's left side damage (case photo #56)

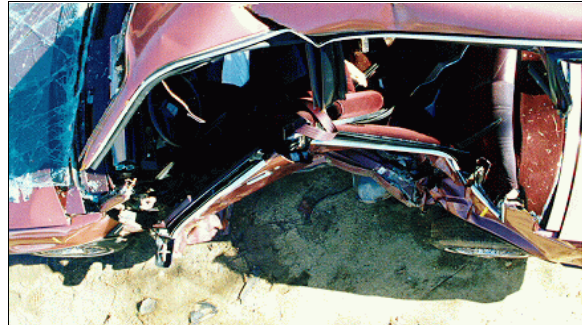
Figure 7: Overhead view of crush to Chevrolet's left side showing extensive intrusion into driver's space (case photo #57)

The crush to the Chevrolet's left side was concentrated primarily to the passenger compartment (i.e., between left "A" and "C" pillars) causing massive intrusion (**Figures 6 and 7** above). The left impact was severe enough to bow the vehicle. All three left side pillars on the Chevrolet were cut by emergency crews and the roof was subsequently peeled over to the right side in order to extricate the restrained driver. Direct damage started 18 centimeters (7.1 inches) behind the left front axle and extended rearward 213 centimeters (83.9 inches) to the left "C"-pillar. The maximum crush was measured at 69 centimeters (27.2 inches) next to C₃. The total field L was measured at 252 centimeters (99.2 inches). The Chevrolet was towed due to damage. Based on the vehicle inspection, the CDC for the Chevrolet was determined to be: **10-LPEW-4 (290)**. The WinSMASH reconstruction program, damage only algorithm, was used on the Chevrolet's highest severity impact. The Total, Longitudinal, and Lateral Delta Vs are, respectively: 46.4 km.p.h. (28.8 m.p.h.), -15.9 km.p.h. (-9.9 m.p.h.), and +43.6 km.p.h. (+27.1 m.p.h.).

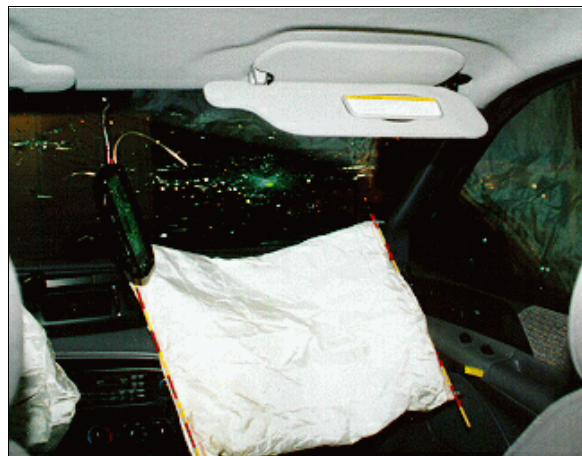
Figure 8: Contacts to case vehicle's front right windshield (i.e., spider web with hair) and header/sun visor; in addition, there were blood spots on upper left side of front right air bag (case photo #29)

An examination of the case vehicle’s interior revealed the following evidence of occupant contact. There was a contact (i.e., a spider web with hair in it; **Figure 8** above) to the windshield and a contact to the windshield (front) header (i.e., scuff with clump of hair) and sun visor (**Figures 9** and **10**). There was a scratch/scuff on the glove compartment door (**Figure 11**) and an unknown white fluid on the right front door’s armrest. The right front door’s glazing revealed contact evidence (i.e., oil/grease smear with unknown fluid; **Figure 12** and **Figure 13** below). In addition, there was a scuff to the backside of the front right seat back and an oil smear on the

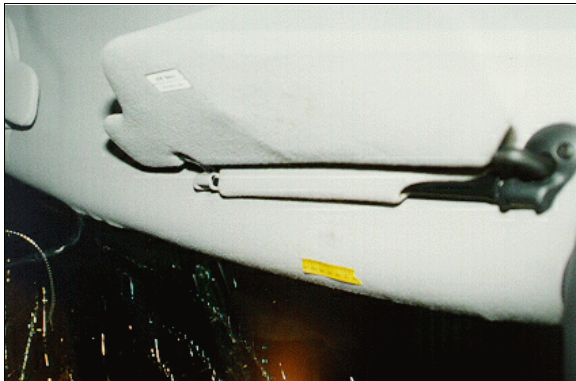
Figure 9: Case vehicle’s right sun visor (in raised position) and front right header showing occupant contact evidence on header (case photo #32a)

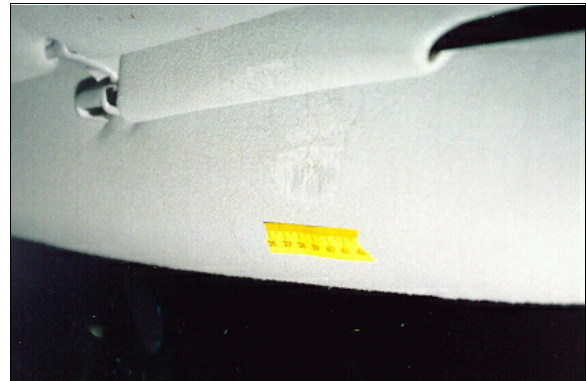
Figure 10: Close-up of case vehicle’s front right header showing evidence (i.e., hair, scuff) of contact (case photo #32b)

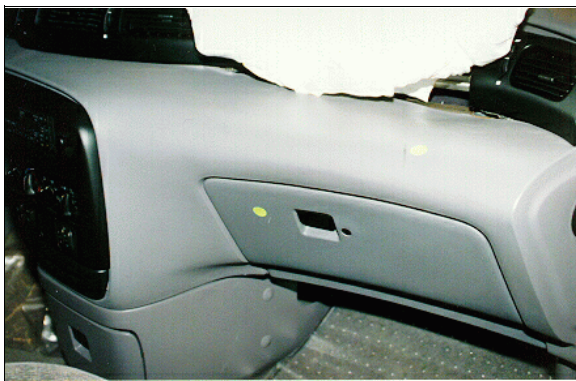
Figure 11: Case vehicle’s front right seating area showing scuffs to glove box door and a black scuff to top of dash (case photo #31)

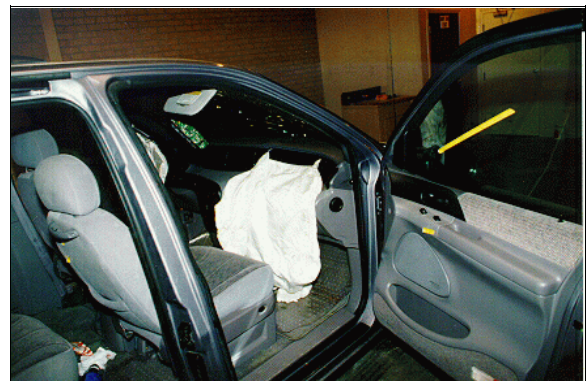
Figure 12: Case vehicle’s front right seating area and interior view of right front door showing deployed front right air bag and oil smear (i.e., yellow tape) to right front door’s glazing from contact by “on-lap” front right passenger (case photo #33)

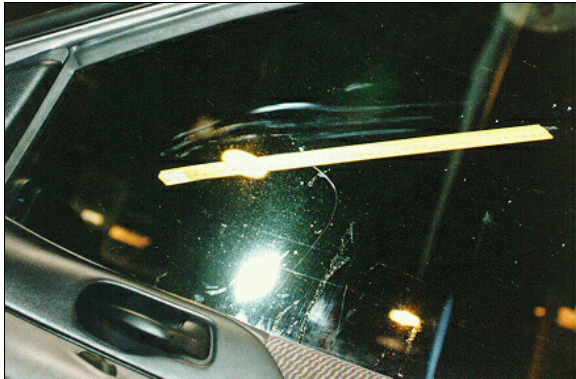
Figure 13: Close-up interior view of case vehicle's right front door glazing showing oil smears and fluid on glazing (case photo #34)

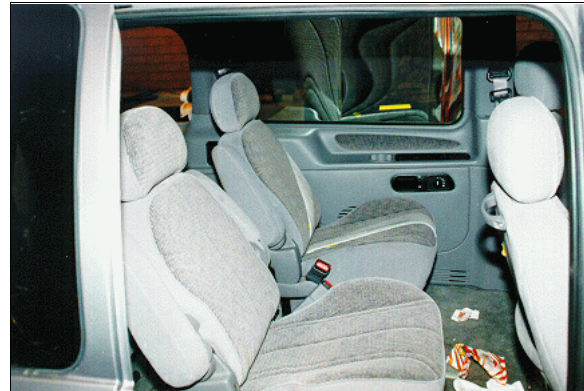
glazing near where the second seat left passenger was sitting (**Figures 14, 15, and 16**). The inspection of the case vehicle's interior also revealed the following noncontact-related evidence. There was broken glass on the floor in front of the front bucket seats from the cola bottle that broke spraying the driver's air bag. In addition, there was a crack in the windshield near the driver's side caused by contact from the rearview mirror, and the rearview mirror was broken and hanging down after being struck in the lower right corner and forced it into the windshield by the deploying front right air bag. The energy absorbing steering column showed no evidence of compression. The left rear glazing popped off the case vehicle while being towed from the scene.

Figure 14: Case vehicle's second seating area; Note: contact to glazing by second seat left passenger (case photo #46)

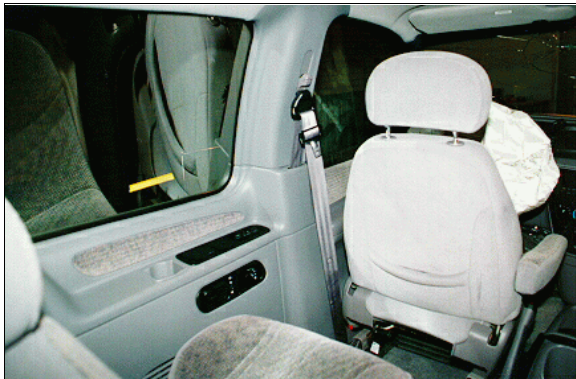
Figure 15: Seating area of case vehicle's second seat left passenger showing contact to side glazing; Note: driver's safety belt, box-mounted seat, and deployed air bag (case photo #49)

The case vehicle's driver made no known pre-crash avoidance maneuvers. As a result and independent of the use by the second seat left passenger of any safety restraints, the grandmother's pre-impact body position did not change just prior to impact. The case vehicle's impact with the Chevrolet enabled the second seat left passenger to continue forward and upward as the case vehicle decelerated. The passenger's safety belt locked-up during the vehicle's deceleration restricting the passenger's forward movement but preventing her from contacting the backside of the driver's seat back with her legs. The second seat left passenger moved from the locked restraint toward to the right as the vehicle rotated approximately 20 degrees counterclockwise after impact. She may have contacted the backside of the front right seat back at this time. The case vehicle's subsequent clockwise rotation following its separation from the Chevrolet caused her to shift back to the left contacting the side glazing leaving a make-up smear (**Figures 15 and 16** above).

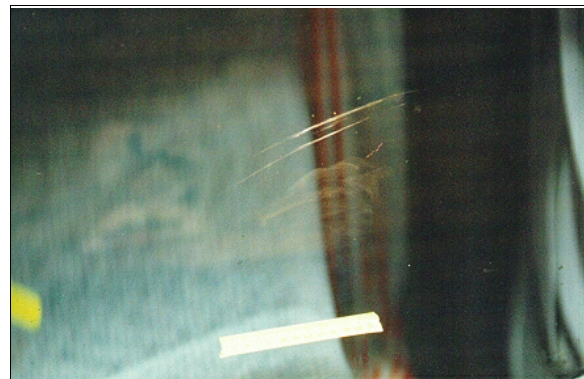
Figure 16: Close-up of make-up and oil smear on interior of left glazing for case vehicle's second seating area (case photo #51)

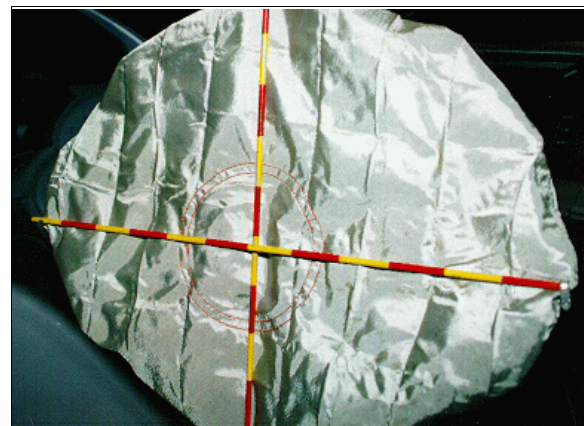
Figure 17: Case vehicle's deployed driver air bag showing no visible contact evidence, but there was sprayed cola on right half (case photo #37)

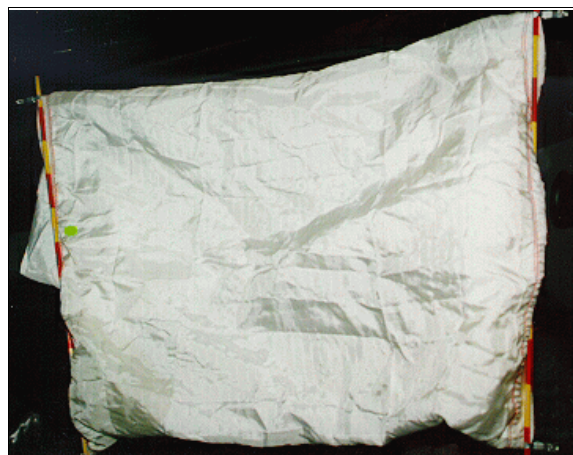
Figure 18: Case vehicle's deployed front right passenger air bag showing blood spots near green dot on left middle portion (case photo #41)

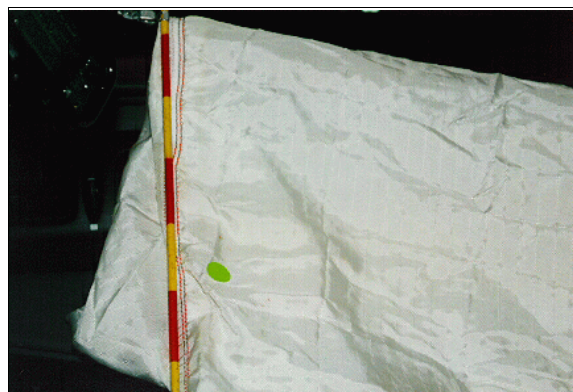
Figure 19: Close-up of blood spots on front surface of case vehicle's deployed front right air bag near left middle portion (case photo #42)

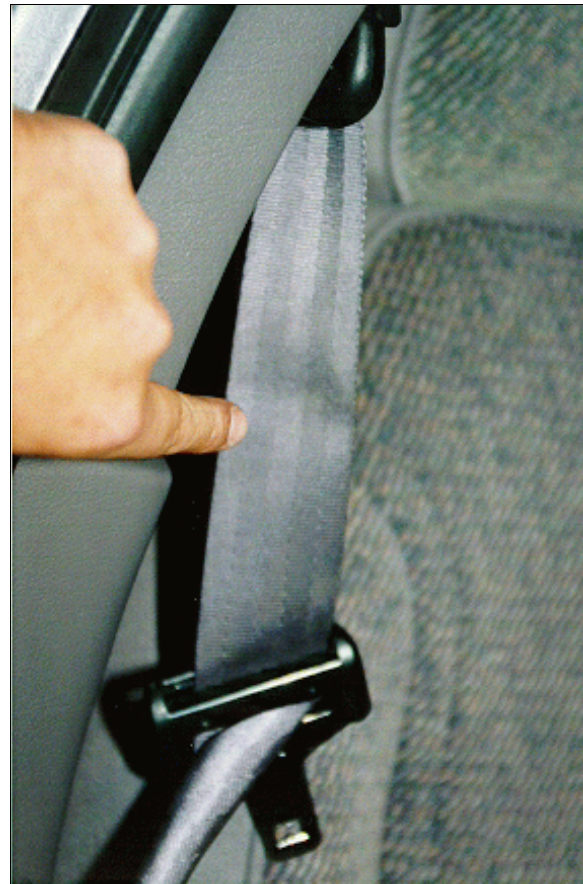
Figure 20: Close-up of case vehicle’s front right safety belt showing heat abrasion on webbing from “D”-ring (case photo #44)

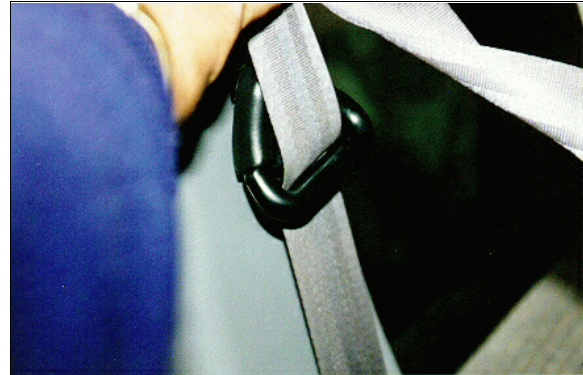
evidence of loading on the “D”-ring, and there was sprayed cola drink on the webbing (**Figure 21**).

Figure 21: Case vehicle’s driver safety belt showing heat abrasion to “D”-ring (case photo #50)
