REMOTE REDESIGNED AIR BAG REPORT

CASE NUMBER - IN97-048

VEHICLE - 1998 FORD RANGER XL PICKUP TRUCK

CRASH DATE - November, 1997

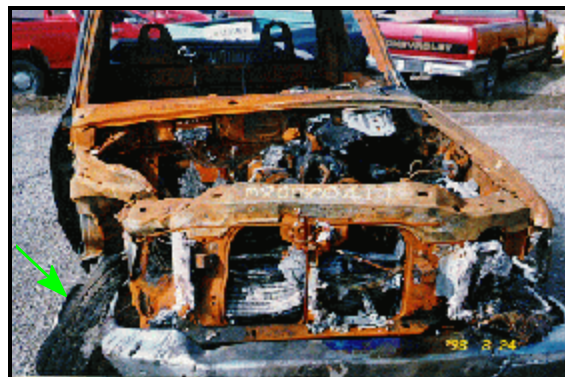
Figure 1: Case vehicle's frontal damage; Note: position of right front tire and right fender damage (case photo #01)

In this contractor's opinion, the case vehicle struck an orange construction barrel¹ (interviewee) located on the west roadside. As a result, the driver steered left in an attempt to reenter the roadway, but instead, the case vehicle slid on the wet road/roadside, rotated counterclockwise, and traveled off the west side of the road. The front right corner and undercarriage (**Figure 1** above) of the case vehicle

impacted a tree stump² (Police Crash Report), causing the case vehicle's driver and front right passenger supplemental restraint systems (air bags) to deploy. The available evidence suggests that the case vehicle's deployment impact resulted from striking the tree stump because the right front axle was snagged and displaced rearwards toward the lower "A" pillar (**Figure 2**). After its impact with the tree stump, the case vehicle rotated counterclockwise and slid down into a dry creek bed. Unfortunately, there is no information as to the severity of the elevation change from the roadway surface to the creek bed. The case vehicle caught fire (**Figure 3**), for unknown reasons (a Response Report by the fire department did not identify the fire's cause), and destroyed the vehicle's engine compartment (**Figure 4**) and passenger interior, including any air bag or contact evidence (**Figure 5** below). Unknown as well is the case vehicle's pre-impact travel speed. The posted speed limit for this roadway was 56 km.p.h. (35 m.p.h.).

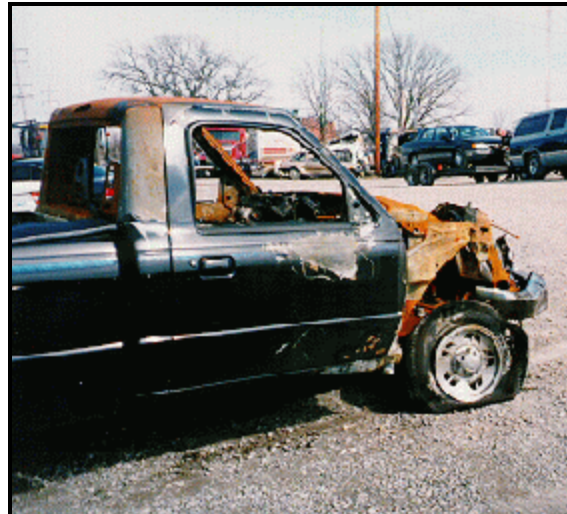
Figure 2: Case vehicle's front right damage; Note: direct damage to right front wheel rim and minimal fire damage to right front door (case photo #05)

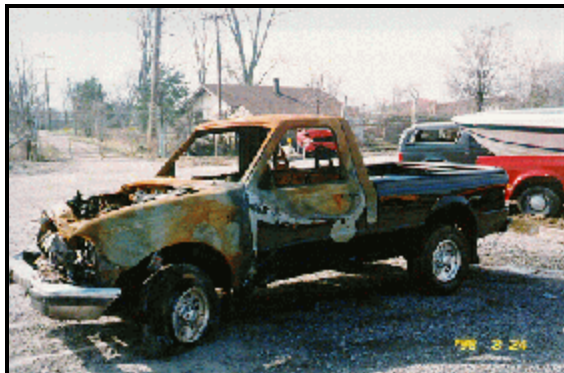
Figure 3: Case vehicle's fire damage; Note: paint on truck bed has only minor damage (case photo #02)

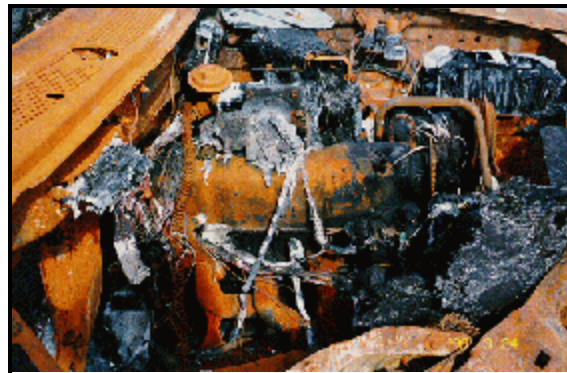
Figure 4: Fire damage to case vehicle's engine compartment, viewed from right side (case photo #06)

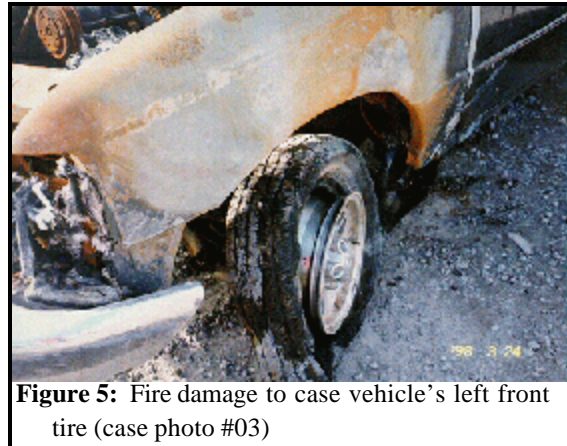
Figure 5: Fire damage to case vehicle's left front tire (case photo #03)

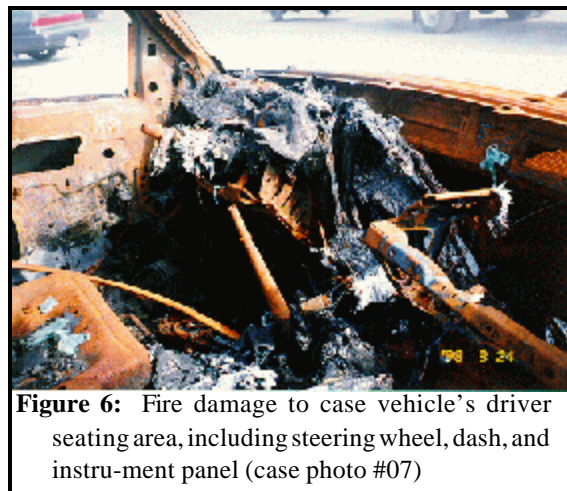
Figure 6: Fire damage to case vehicle's driver seating area, including steering wheel, dash, and instrument panel (case photo #07)

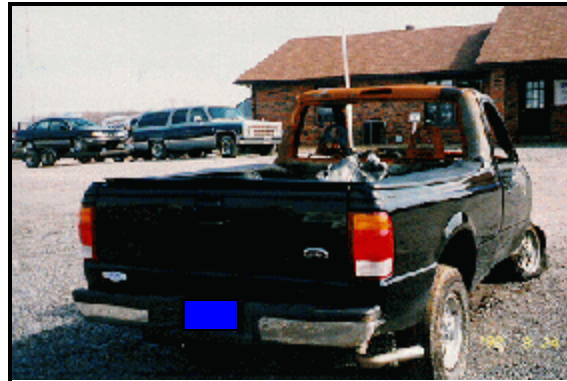
centimeters (111.6 inches), and odometer information was unavailable. The case vehicle was towed due to disabling damage. Available insurance company photographs indicate that the case vehicle had been partially disassembled in the salvage yard; the hood and right front fender were missing (**Figure 1** above). Damage to the case vehicle included: the front bumper, the front grille, the front right headlamp assembly, the radiator frame, the right fender and frame, and the right front wheel (**Figure 2**). The case vehicle's fire began, most likely, under the hood, destroying the engine compartment (**Figure 4**), damaging both front tires (**Figure 2** and **Figure 5**), and gutting the interior: including greenhouse, steering wheel, instrument panel (**Figure 6**), and seating area (**Figure 7**). Those same insurance photographs provided no detectable evidence of passenger compartment integrity loss, nor any intrusion. Both doors remained closed and operational. Most likely all window glass disintegrated because of the fire (**Figure 8** below).

Figure 8: Case vehicle's back and right side; Note: backlite glazing gone and undamaged truck bed (case photo #04)

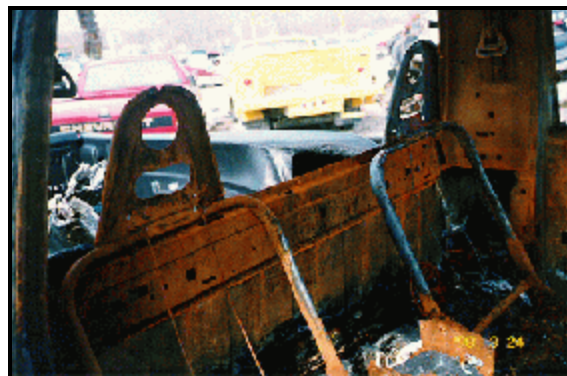
The case vehicle was equipped with front bucket seats and folding backs. The front outboard seat positions were equipped with active, three-point, lap and shoulder belts (**Figure 7**). The case vehicle was equipped with driver and front right passenger supplemental restraints (air bags). From a Ford Motor Company brochure, the driver's air bag was located in the steering wheel hub and the front right passenger air bag was located in the middle of the instrument panel. It was determined from the brochure that the driver module's cover flap is a symmetrical "H" configuration, while the front right passenger air bag module's cover flap is of the single, large variety (unknown if it is hinged or tethered). Because of the fire, it is unknown whether either air bag was vented or tethered, or whether the driver cover flap or air bag fabric contained contact evidence.

Figure 7: Fire damage to case vehicle's front seats; Note: integral head restraint frames and adjustable shoulder belt anchorage (case photo #08)
