TRANSPORTATION RESEARCH CENTER

REDESIGNED AIR BAG REPORT

CASE NUMBER - IN97-053  
LOCATION - TEXAS  
VEHICLE - 1998 NISSAN ALTIMA GXE  
CRASH DATE - November, 1997

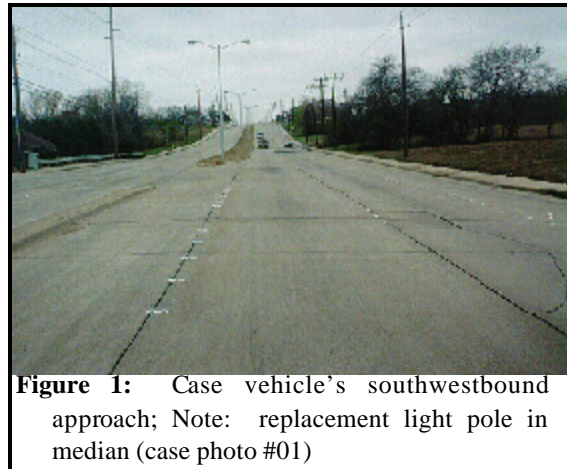
The case vehicle was traveling southwest in the inside, southwestbound through lane of a seven-lane, divided, city trafficway (**Figure 1**) and was approaching a "Tee" intersection, intending to continue on through in its southwesterly travel path (i.e., both the southwest and northeast roadways had three through lanes, while the southwest roadway had a left-turn lane). The southwestbound roadway's dimensions were 10.9 meters (35.8 feet) wide for the three through lanes and 3.9 meters (12.8 feet) wide for the left turn lane. All concrete curbing in the area of interest seemed to be no higher than 10 centimeters (4 inches). Median width varied from 2.6 meters (8.4 feet) to 1.1 meters (3.6 feet), depending on the existence of the left-hand turn lane. The concrete pavement was in fairly new and sharp condition, with an estimated coefficient of friction of 0.80. Raised pavement markers were used to separate all lanes. Ambient weather conditions at the time of the crash were: daylight, clear, no precipitation, and a dry pavement. The roadway was straight, with a slight (2.1%) southwesterly downgrade. There were no reported view obstructions, traffic controls, or roadway defects. A noncontact vehicle (described only as a "van") stopped in the same inside, through lane as the case vehicle, but in the middle of a Tee-

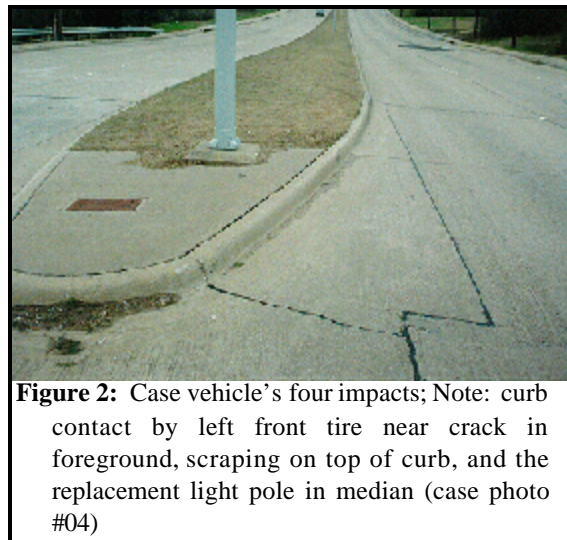
intersection. The case vehicle's driver steered to the left, attempting to avoid the crash. Her estimated pre-impact travel speed was 34-48 km.p.h. (21-30 m.p.h.), while the posted speed limit was 64 km.p.h. (40 m.p.h.). The crash (i.e., the first of four impacts) occurred in the median (**Figure 2** above) between the two roadways southwest of the Tee-intersection. The noncontact van continued on its way.

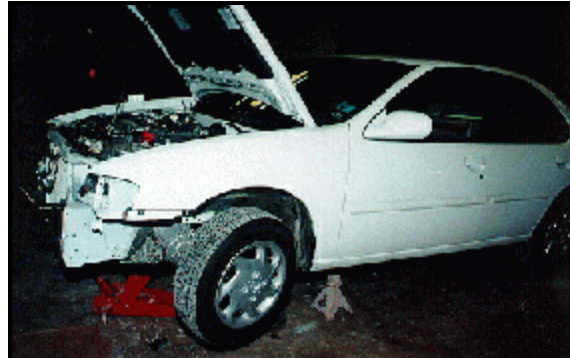
The underneath portion of the case vehicle's front bumper scraped the top of an estimated 10 centimeter (4 inch) concrete median curb (**Figures 3 and 4**). Continuing forward, the case vehicle's left front tire and wheel contacted that same concrete median curb, damaging both the tire and the wheel (**Figure 3**) and causing the case vehicle's driver and front right passenger supplemental restraints (air bags) to deploy. As the case vehicle continued on its forward path, the left rear tire was damaged as it, too, struck the concrete curb. Impact with the light pole occurred shortly thereafter (**Figure 5**) and the case vehicle traveled an estimated two-to-three car lengths further southwest before coming to rest with its left side wheels on the inside, northeastbound through lane and the right side wheels on the raised median. The crash severity for the case vehicle's deployment impact was estimated as low [14-23 km.p.h. (9-14 m.p.h.)].

**Figure 3:** Partially-repaired case vehicle showing frontal damage viewed from approximately 70 degrees left of front (case photo #11)

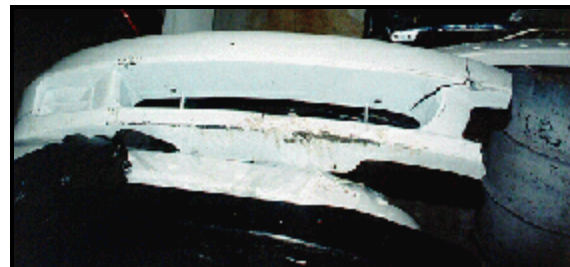
**Figure 4:** Case vehicle's damaged front bumper cover; Note: scrapes on bottom of bumper (case photo #10)

Direct damage was detected to the underneath portion of the case vehicle's front bumper cover (**Figure 4**) from scraping the top of the concrete median curb. The damage extended almost corner-to-corner. Damaged components from this first impact included: the front bumper cover, the front bumper reinforcement bar, and the front bumper absorber. The second impact of the crash sequence deployed the dual front air bags and involved left front tire and wheel contact to the concrete median curb. Direct damage from this impact included: the left front wheel, wheel cover, and tire, the left front lower control arm, and the left front stabilizer bar rod. The third impact occurred when the left rear tire contacted the concrete median curb, damaging the tire. The fourth impact involved the case vehicle's front left corner (**Figure 5** above) contacting and severing the breakaway light pole. Direct damage was limited to the bottom half of the front left bumper corner, cracking the fiberglass bumper cover and damaging the left headlamp lens, the left side marker lamp, and the left inner fender skirt (**Figure 6**).

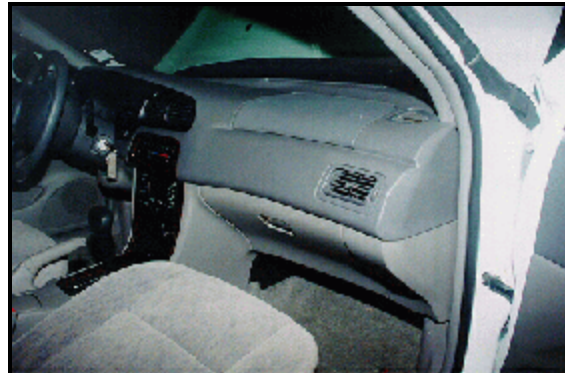
Both driver and front right passenger deployed air bags (**Figure 7** above) in the case vehicle had been replaced before the SCI inspection (**Figure 8**). Although it is known that the driver's air bag was located in the steering wheel hub and that the front right passenger's air bag was located in the top of the instrument panel, it is not known if the cover flaps at either location opened at their designated tear points.

**Figure 8:** Case vehicle's front seating area showing location of deployed driver and front right passenger air bag modules; Note: replacement modules have been installed (case photo #17)

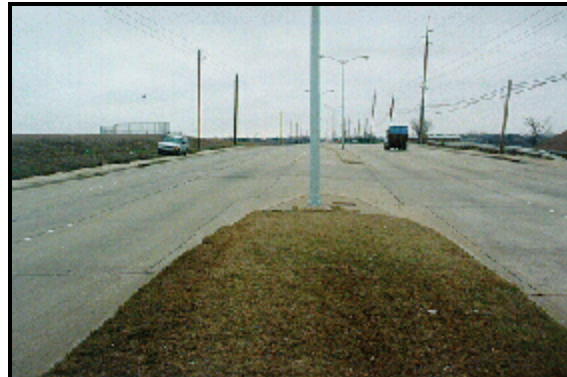
**Figure 9:** Northeastward view from median of case vehicle's southwestbound approach; Note: light pole was replaced post-crash (case photo #09)
