# INDIANA UNIVERSITY

## ON-SITE REDESIGNED AIR BAG REPORT

CASE NUMBER - IN97-061  
LOCATION - TEXAS  
VEHICLE - 1998 DODGE DAKOTA SPORT  
CRASH DATE - December, 1997

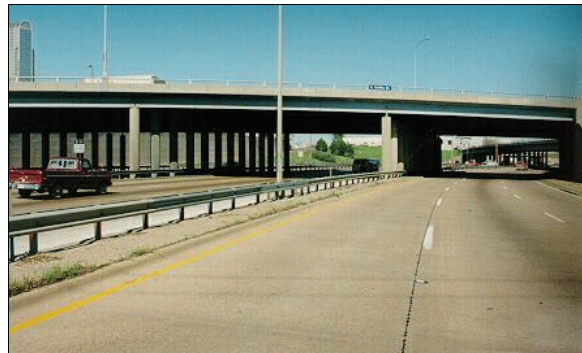
The case vehicle was traversing a right-hand curve (**Figure 1**), traveling essentially northeastward in an unknown lane of a one-way, three-lane, undivided, interstate service road/freeway, and intended to continue in an east-northeasterly travel path through the curve. The service road/freeway was separated from an interstate highway by a double-sided "W-beam" type of guardrail mounted in a paved median that separated the roadways.

**Figure 1:** Case vehicle's northeastward path of travel off road toward Police Crash Report's impact site with guardrail on northwest roadside (case photo #03)

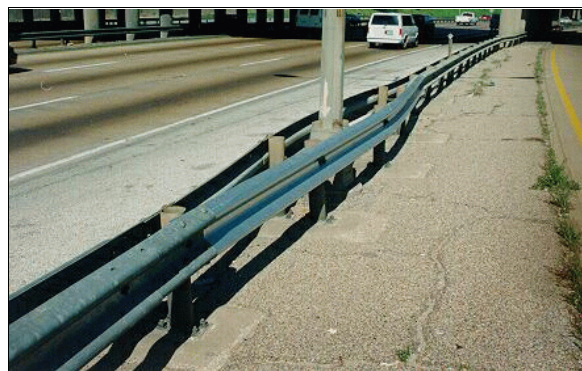
**Figure 2:** Close-up looking northeastward of Police Crash Report's impact site (case photo #05)

posts, approximately 10 centimeters (4 inches) in diameter. Additionally, two sections of the guardrail had been replaced, but the timing of that replacement is unknown (**Figure 2** above). A third scenario was offered to this contractor's consultant by the body shop's personnel. The body shop personnel believe (based on unknown information) that the case vehicle was involved in a right roadside departure and impacted a "pole-like" object west of the final rest area, upstream from the area depicted on the Police Crash Report. The driver left the actual crash scene and continued driving eastward when the case vehicle's engine stopped running, some unknown distance east of the actual impact area. According to the Police Crash Report, the investigating officer found no evidence of a crash at the location where the vehicle was found.

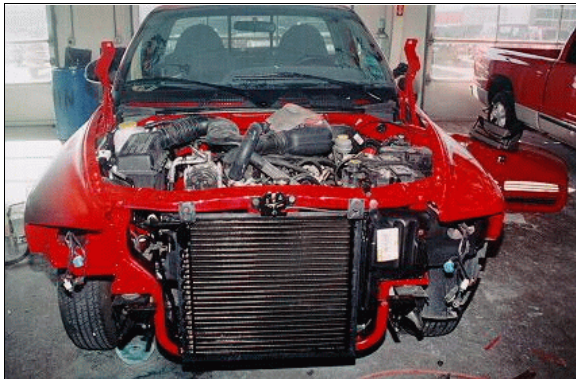
**Figure 3:** Case vehicle's partially repaired frontal damage; Note: new radiator and damaged hood along left side of vehicle (case photo #07)

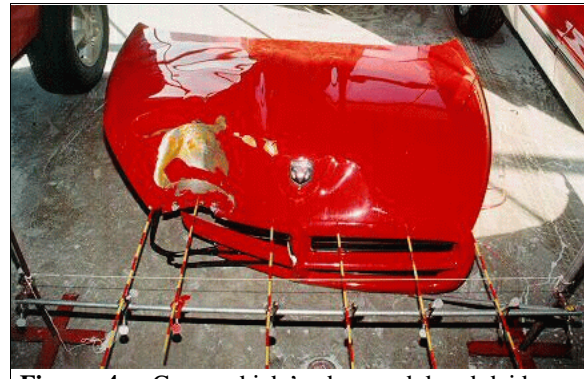
**Figure 4:** Case vehicle's damaged hood laid on repair shop floor; Note: rounded narrow object imprint to front right (case photo #14)

The front of the case vehicle impacted a round, pole-like object (**Figure 4** above and **Figure 5**), causing the driver and front right supplemental restraints (air bags) to deploy. It is not likely at all, given the damage pattern, that the case vehicle impacted a “W-beam” guardrail. Neither is it likely that the case vehicle struck one of the round, metal, guardrail support posts (even with a guardrail section missing) because they are not tall enough to reach the case vehicle’s front hood seam. Therefore, in this contractor’s opinion, the third scenario (i.e., a right roadside departure and impact with a “pole-like” object) seems to conform more closely with the known facts of the case and, thus, the location of this crash should be considered unknown.

The case vehicle’s contact with the unknown object involved the front right one-third of the vehicle. Direct damage began 20 centimeters (7.9 inches) to the right of the case vehicle’s center and extended, a measured distance of 22 centimeters (8.7 inches), along the front bumper (**Figure 4** above). Maximum crush was measured above the bumper as 38 centimeters (14.9 inches) at C<sub>5</sub> (**Figure 5**). It is unknown if the case vehicle’s wheelbase on either the left or right sides was shortened during the crash. The case vehicle’s front bumper, bumper fascia, grille, hood, and radiator were directly damaged and crushed rearward (**Figure 3** above). It is unknown if the case vehicle’s left and right front tires were physically restricted or deflated from the crash. Both the right and left headlight and turn signal assemblies sustained induced damage as well as both the right and left fenders. Furthermore, the leading edge of the driver’s door also sustained induced damage (**Figure 6**), and there was a repaired spot on the right side of the bed of the pickup (**Figure 7** below). In addition, the front of the bed of the pickup was tilted upward and the entire bed was displaced towards the right (**Figure 6** and **Figure 7** below).

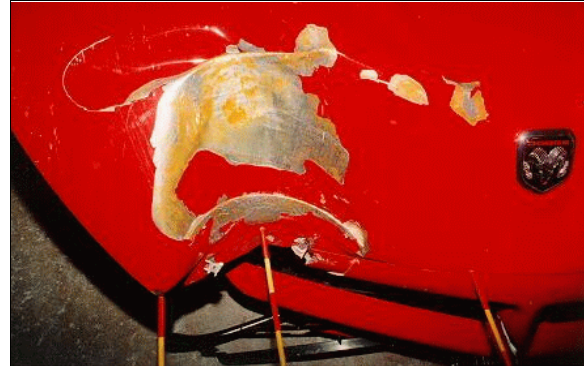
**Figure 5:** Close-up of narrow object impact to right side of case vehicle’s hood (case photo #15)

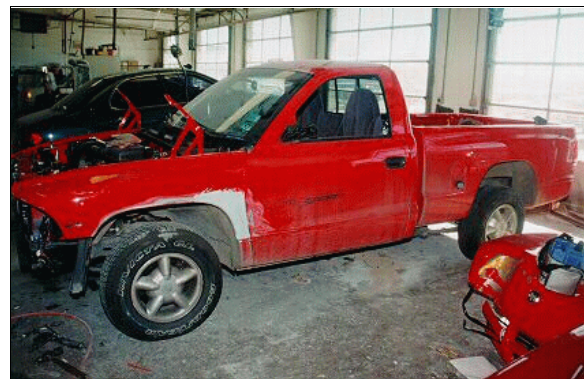
**Figure 6:** Case vehicle’s left side showing repairs to left fender and edge of left front door; Note: induced damage to truck bed (case photo #09)

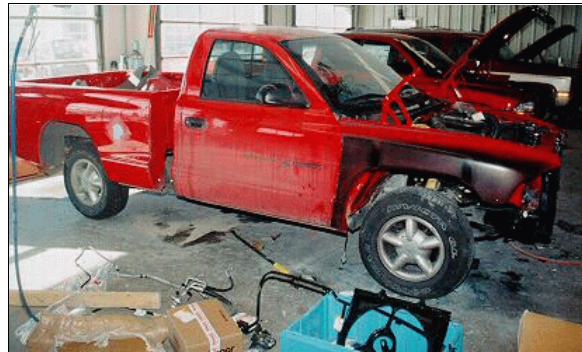
**Figure 7:** Case vehicle's right side showing repairs to right fender and right side of truck bed; Note: rightward shift to truck bed (case photo #12)

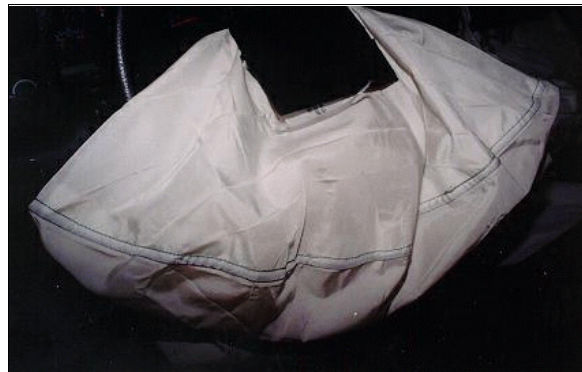
The case vehicle was equipped with a Supplemental Restraint System (SRS) that contained frontal air bags at the driver and front right passenger positions. Both air bags deployed as a result of the frontal impact with the unknown object. The case vehicle's driver air bag was located in the steering wheel hub. The module cover consisted of asymmetrical "H"-configuration cover flaps made of thick vinyl with overall dimensions of 15 centimeters (5.9 inches) at the horizontal seam and 10 centimeters (3.9 inches) vertically for the upper flap and 2 centimeters (0.8 inches) vertically for the lower flap. An inspection of the air bag module's cover flaps and air bag revealed that the cover flaps opened at the designated tear points, and there was no evidence of damage during the deployment to the air bag or the cover flaps. The driver's air bag was designed with two tethers, attached to the center of the air bag. The driver's air bag had no vent ports. The deployed driver's air bag was round with a diameter of 65 centimeters (25.6 inches). There was no contact evidence readily apparent on any of the surfaces (i.e., top, front, bottom, etc.) of the driver's air bag (**Figures 8 and 9** and **Figure 10** below, respectively).

**Figure 8:** Case vehicle's deployed driver air bag showing no contact evidence on top/back surface of air bag or to air bag module's top cover flap (case photo #21)

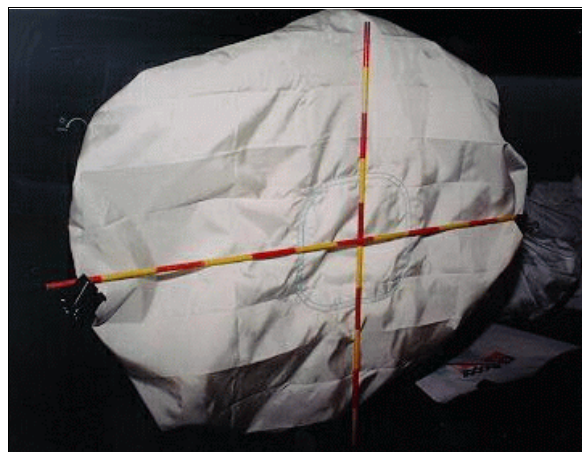
**Figure 9:** Case vehicle's deployed driver air bag showing no contact evidence on air bag's front surface (case photo #22)

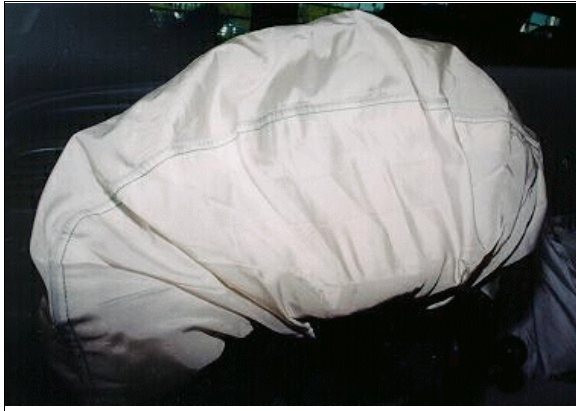
**Figure 10:** Case vehicle's deployed driver air bag showing no contact evidence on bottom/back surface of air bag (case photo #25)

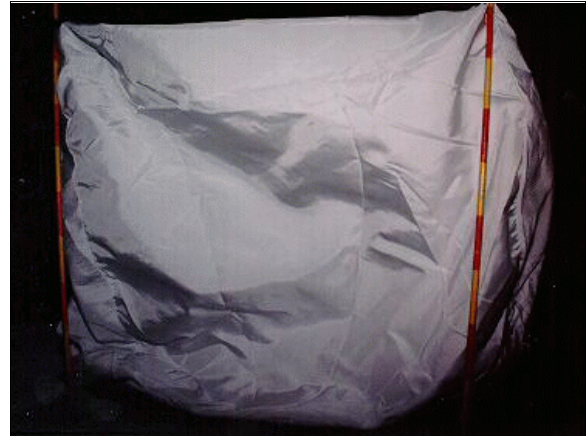
**Figure 11:** Case vehicle's deployed front right passenger air bag showing no contact evidence on air bag's front surface (case photo #30)

The front right passenger's air bag was located in the middle of the instrument panel. There was a single, essentially rectangular, modular cover flap. The cover flap was made of a thick vinyl over a thick cardboard-type frame. The flap's dimensions were 33 centimeters (13.0 inches) at the lower horizontal seam and 22 centimeters (8.7 inches) along both vertical seams. The profile of the case vehicle's instrument panel appears to be flush with the leading edge of the cover flap (i.e., based on the available photographs). An inspection of the front right air bag module's cover flap and air bag revealed that the cover flap opened at the designated tear points, and there was no evidence of damage during the deployment to the air bag or the cover flap. The front right passenger's air bag was designed without any tethers or vent ports. The deployed front right air bag was rectangular with a height of approximately 52 centimeters (20.5 inches) and a width of approximately 58 centimeters (22.8 inches). There was no contact evidence readily apparent on any of the surfaces (i.e., front, top, bottom, right, or left) of the front right air bag (**Figure 11**).

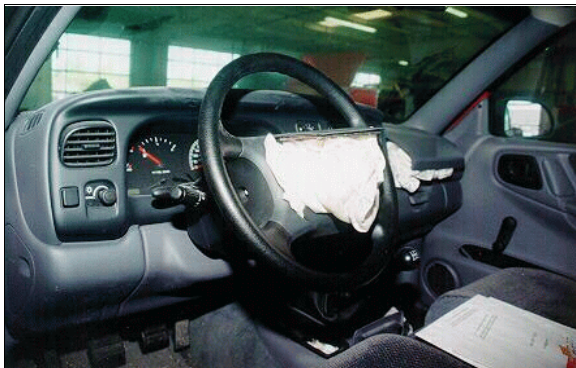
Inspection of the case vehicle's interior revealed that there was no evidence of occupant contact on the interior surfaces of the case vehicle (**Figures 12 and 13**).

**Figure 12:** Case vehicle's front seating area showing deployed driver and front right passenger air bags and no contact evidence on steering wheel, left instrument panel, or driver's knee bolster (case photo #18)

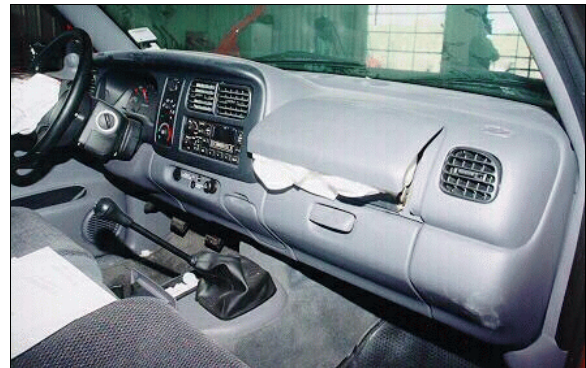
**Figure 13:** Case vehicle's deployed driver and front right passenger air bags and instrument panel areas; Note: no contact evidence on front right air bag module's cover flap or center or right instrument panel areas (case photo #27)
