DEPOWERED AIR BAG REPORT

CASE NUMBER - IN97-062
LOCATION - TEXAS
VEHICLE - 1998 NISSAN ALTIMA
CRASH DATE - December, 1997

1. <i>Report No.</i> IN97-062	2. <i>Government Accession No.</i>	3. <i>Recipient's Catalog No.</i>	
4. <i>Title and Subtitle</i> On-site Depowered/Second Generation Air Bag Investigation Vehicle: 1998 Nissan Altima Location: Texas		5. <i>Report Date:</i> April 29, 1998

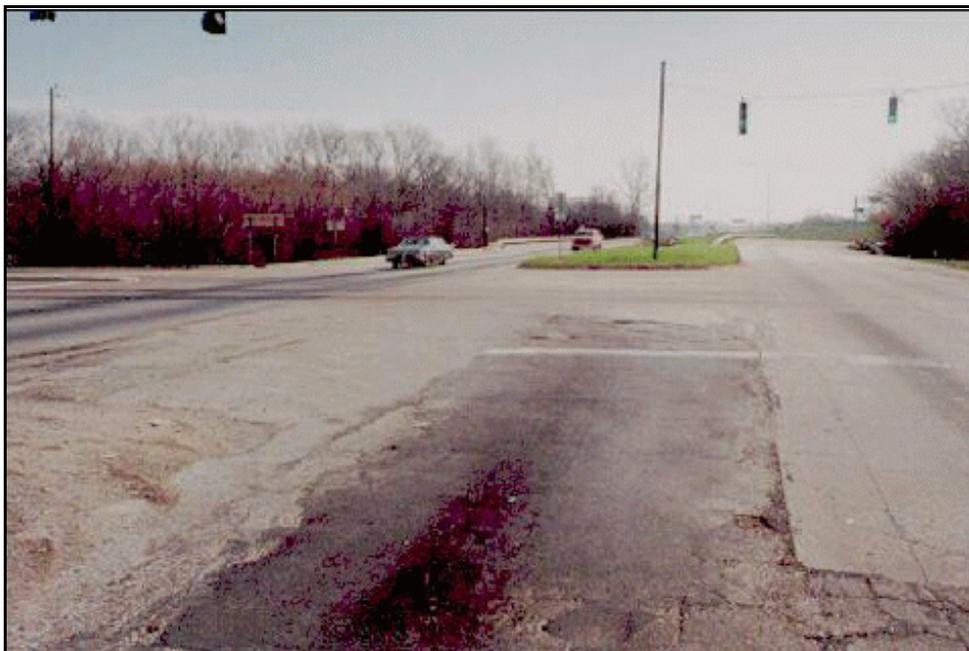
Figure 1: Case vehicle's approach to left turn (case photo #2)

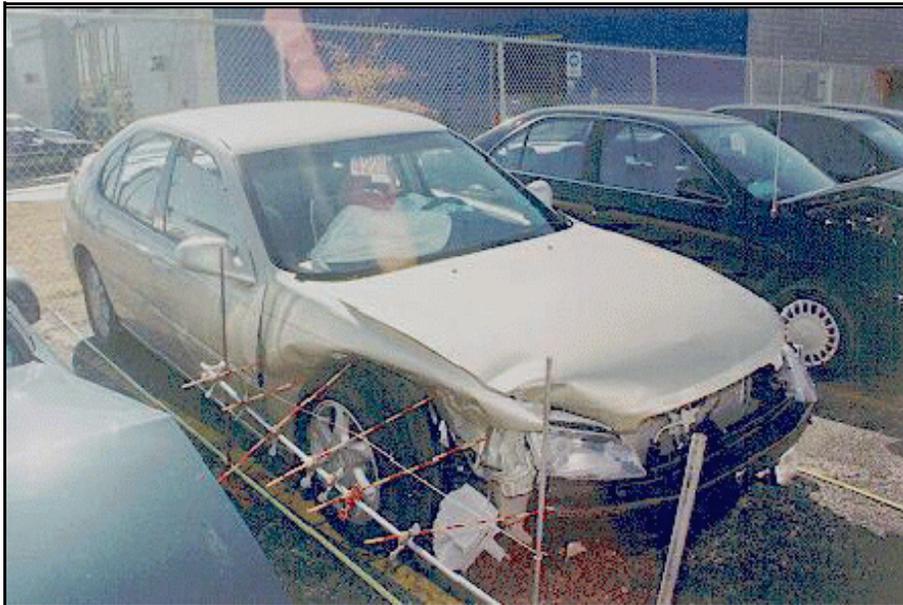
The case vehicle was a front wheel drive 1998 Nissan Altima 4-door sedan (VIN: 1N4DL01D9WC-----) and was not equipped with anti-lock brakes. Direct contact damage was on the right side, primarily forward of the front axle but also including the right front wheel and tire with induced damage causing the entire right front fender to be deformed. In addition, the right front corner of the engine hood and the right front headlight area sustained direct contact,

but the headlight was not broken. There was no glazing damage and all doors remained closed and operational (see Figures 2 and 3). The CDC for the case vehicle is **02-RFEW-3**. The case vehicle was traveling 13 - 16 km.p.h. (8 - 10 m.p.h.) immediately prior to the impact. The SMASH reconstruction program, damage-only algorithm, indicates that the Total, Longitudinal, and Lateral Delta Vs for the case vehicle were, respectively: 28 km.p.h. (17 m.p.h.), -18 km.p.h. (-11 m.p.h.) and -21 km.p.h. (-13 m.p.h.). The Delta V calculations incorporate vehicle #2's final crush profile, which includes the minor impact to vehicle #3 as discussed below.

Figure 2: Case vehicle's front and right side (case photo #22)

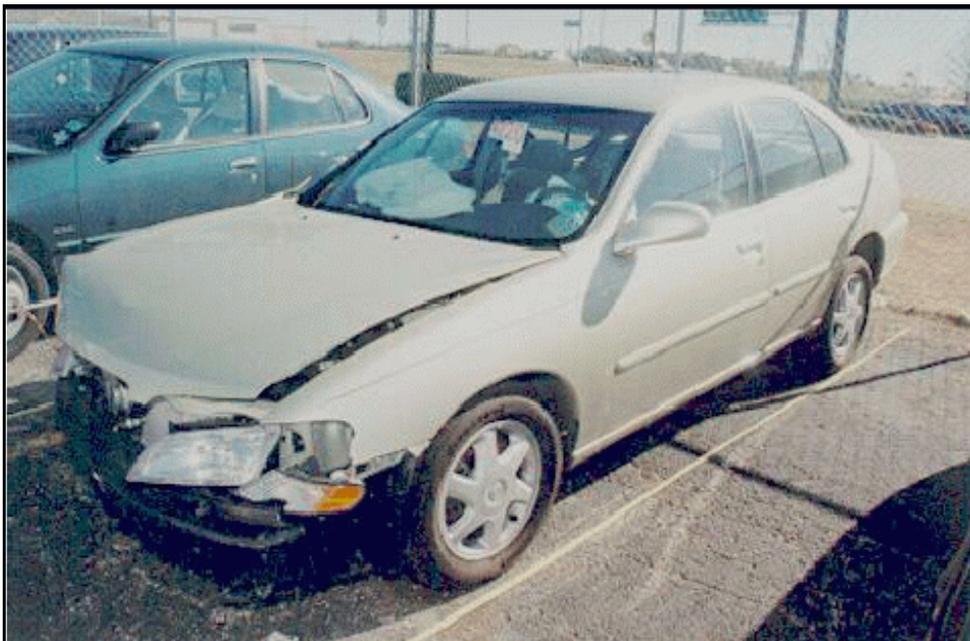
Figure 3: Case vehicle's front and left side (case photo #14)

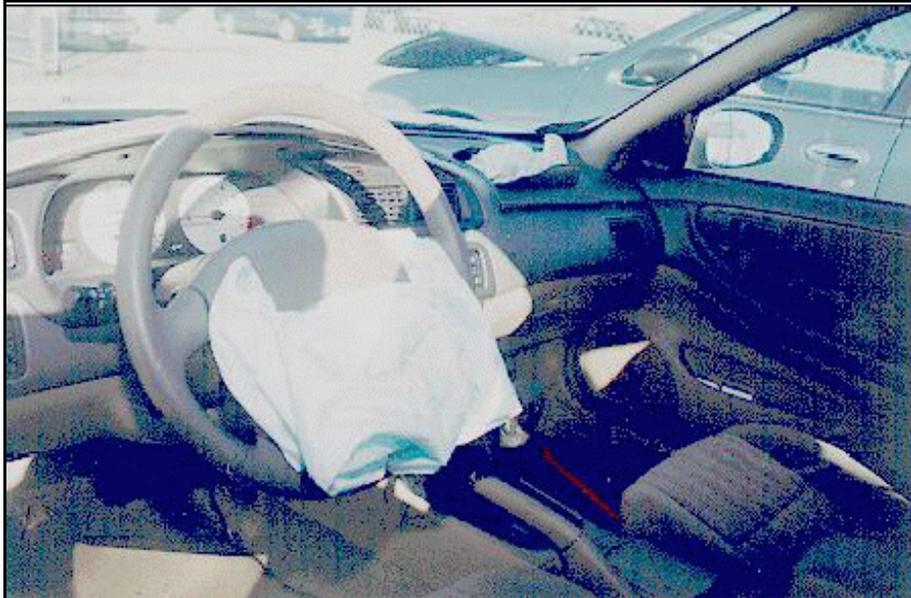
Figure 4: Case vehicle's steering wheel and instrument panel (case photo #26)

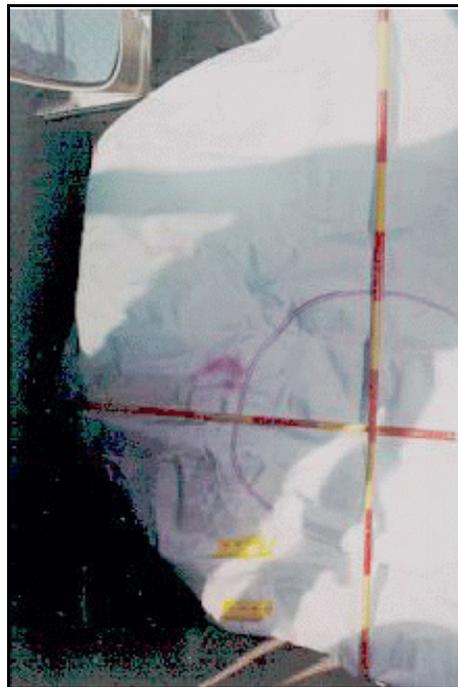
Figure 5: Case vehicle's driver side air bag, with makeup smudges (case photo #26)

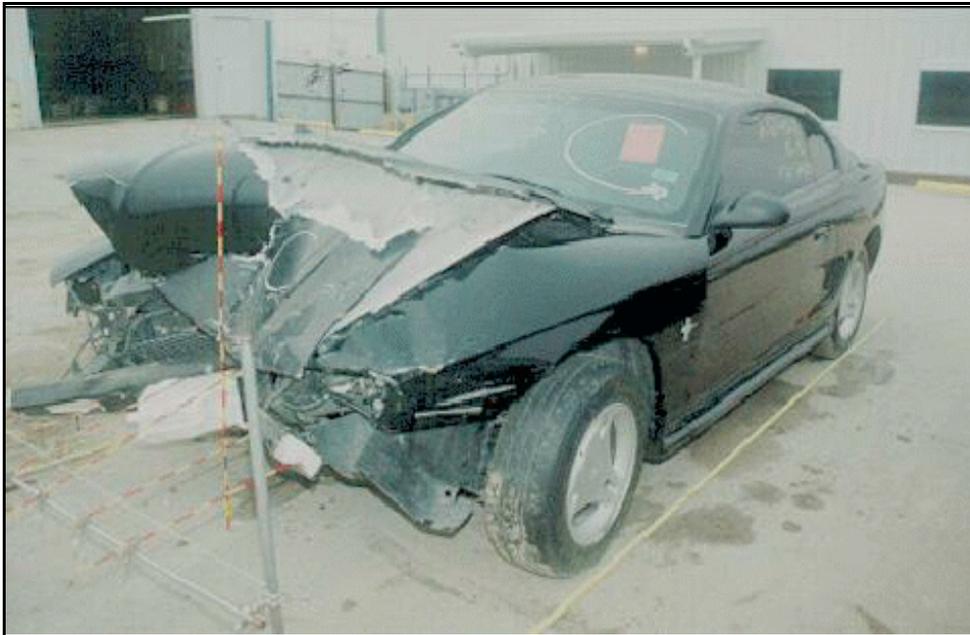
Figure 6: Vehicle #2, front and left side (case photo #38)

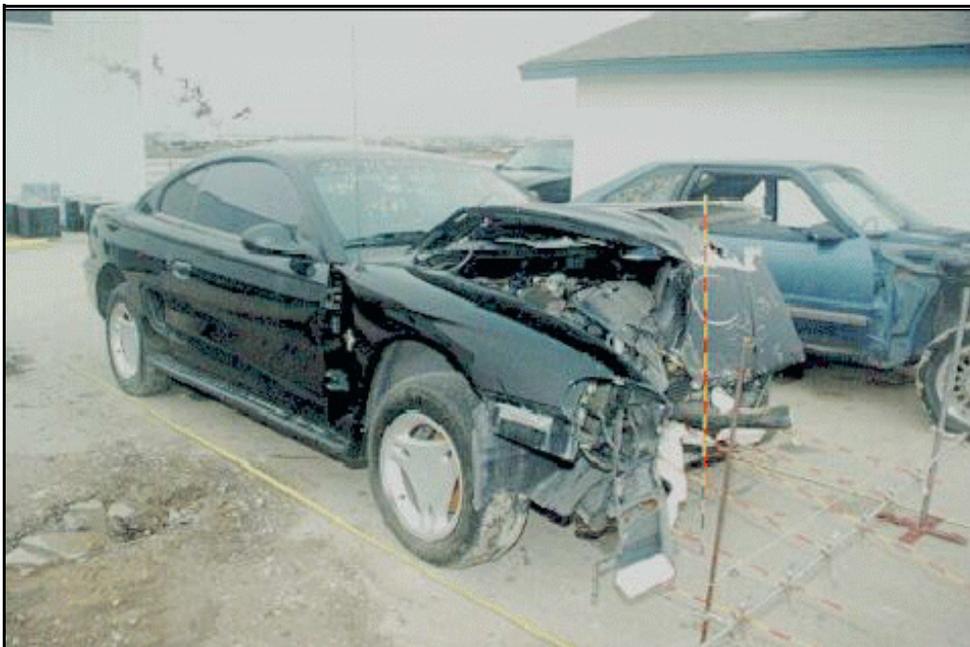
Vehicle #2 was a rear wheel drive 1996 Ford Mustang 2-door coupe (VIN: 1FALP4045TF-----). Vehicle #2 sustained two impacts on its front plane. It is assumed that vehicle #2 was traveling at or near the speed limit, approximately 56 - 64 km.p.h. (35 - 40 m.p.h.), prior to the first impact. It is not known if the driver of vehicle #2 attempted any avoidance actions. In the first event, the center of vehicle #2's front plane impacted the right front corner of the case vehicle. Vehicle #2 rotated approximately 45 degrees clockwise, traveled obliquely across the intersection and struck vehicle #3, which was stopped. In the second event, the center of vehicle #2's front plane impacted the left front corner of vehicle #3. Because vehicle #3 was driven away from the scene, it is assumed that the second impact for vehicle #2 was minor. The final crush profile for vehicle #2 indicates a CDC of **11-FDEW-2** (see Figures 7 and 8). The

Figure 7: Vehicle #2, front and right side (case photo #43)
