DEPOWERED AIR BAG REPORT

CASE NUMBER - IN97-062
LOCATION - TEXAS
VEHICLE - 1998 NISSAN ALTIMA
CRASH DATE - December, 1997

1. <i>Report No.</i> IN97-062	2. <i>Government Accession No.</i>	3. <i>Recipient's Catalog No.</i>	
4. <i>Title and Subtitle</i> On-site Depowered/Second Generation Air Bag Investigation Vehicle: 1998 Nissan Altima Location: Texas		5. <i>Report Date:</i> April 29, 1998

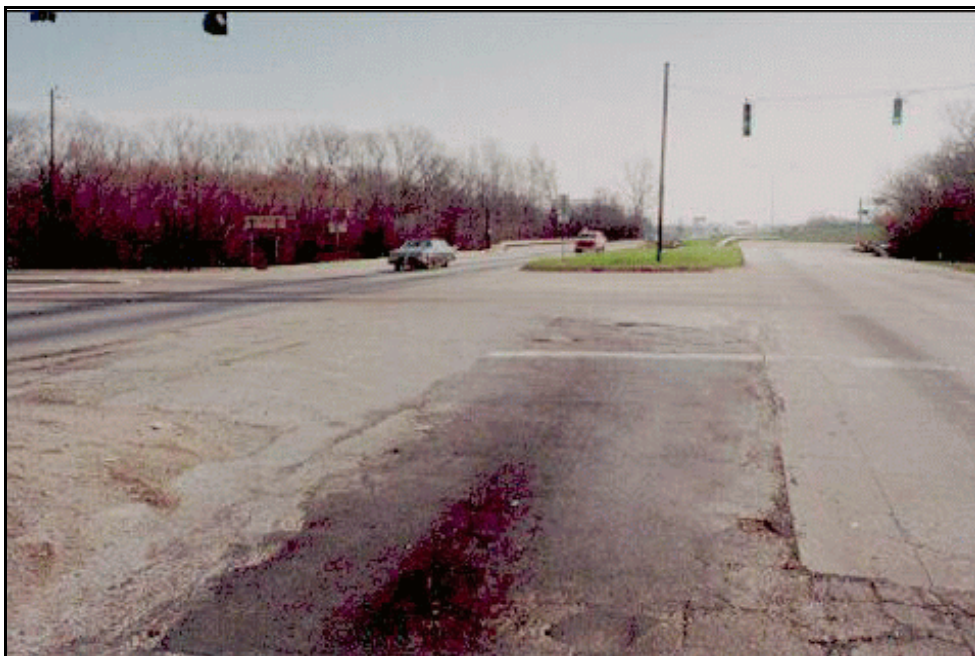
Figure 1: Case vehicle's approach to left turn (case photo #2)

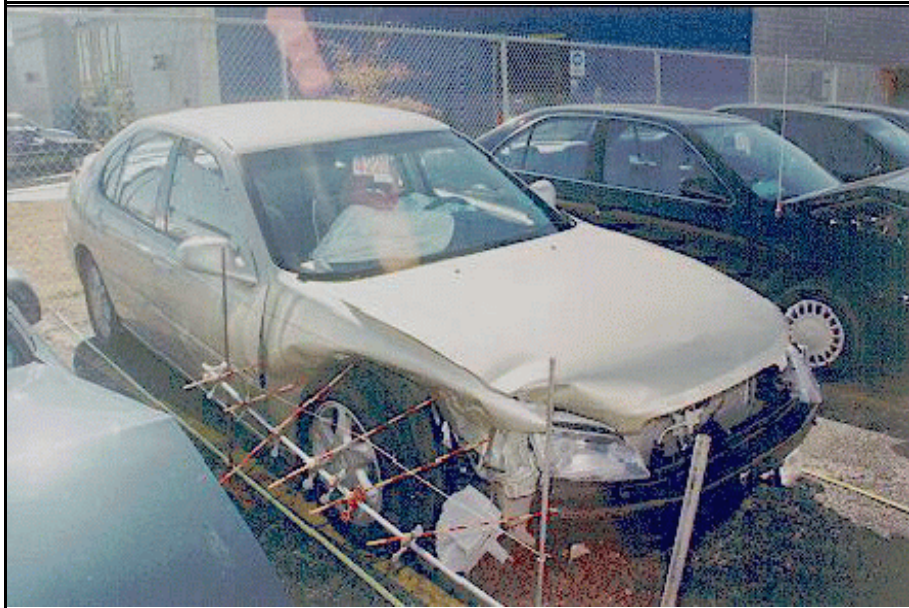
The case vehicle was a front wheel drive 1998 Nissan Altima 4-door sedan (VIN: 1N4DL01D9WC-----) and was not equipped with anti-lock brakes. Direct contact damage was on the right side, primarily forward of the front axle but also including the right front wheel and tire with induced damage causing the entire right front fender to be deformed. In addition, the right front corner of the engine hood and the right front headlight area sustained direct contact,

but the headlight was not broken. There was no glazing damage and all doors remained closed and operational (see Figures 2 and 3). The CDC for the case vehicle is **02-RFEW-3**. The case vehicle was traveling 13 - 16 km.p.h. (8 - 10 m.p.h.) immediately prior to the impact. The SMASH reconstruction program, damage-only algorithm, indicates that the Total, Longitudinal, and Lateral Delta Vs for the case vehicle were, respectively: 28 km.p.h. (17 m.p.h.), -18 km.p.h. (-11 m.p.h.) and -21 km.p.h. (-13 m.p.h.). The Delta V calculations incorporate vehicle #2's final crush profile, which includes the minor impact to vehicle #3 as discussed below.

Figure 2: Case vehicle's front and right side (case photo #22)

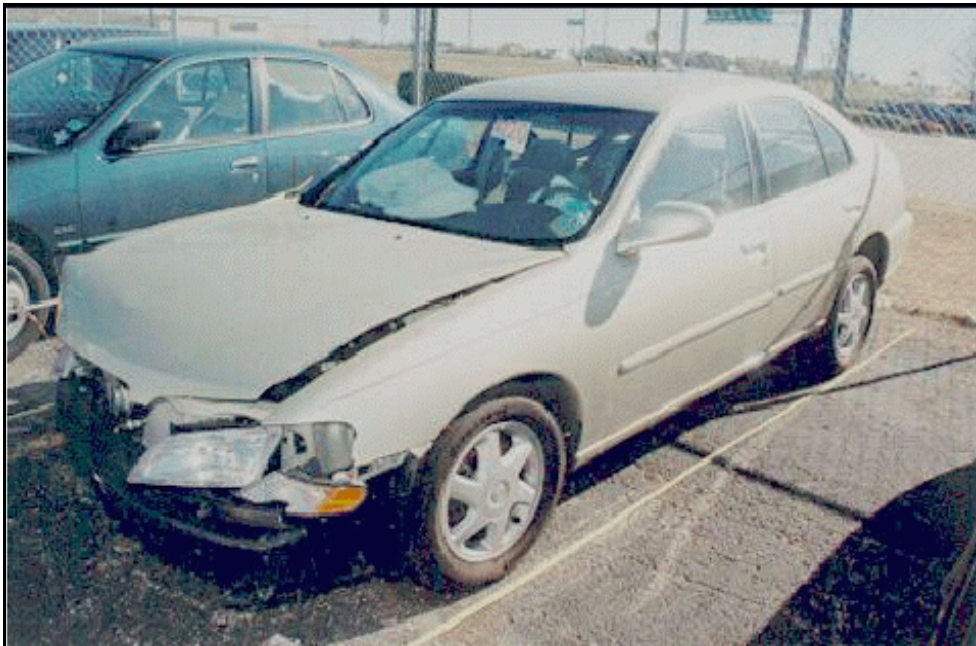
Figure 3: Case vehicle's front and left side (case photo #14)

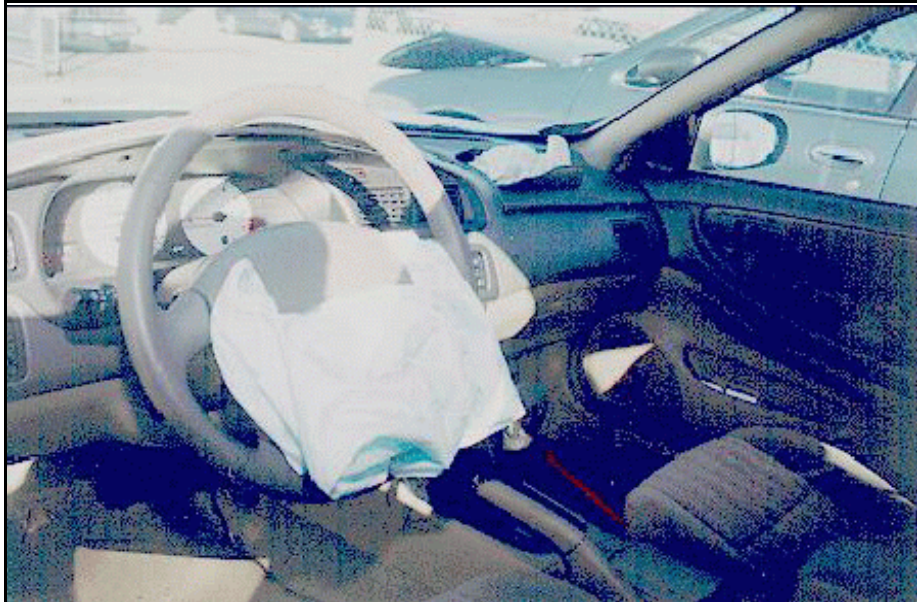
The case vehicle was fitted with bucket seats in the front row. The driver reported that her seat track was adjusted in the forward-most position, but upon inspection it was found at the middle position. It is assumed that the driver's seat track adjustment was changed during post-crash handling of the case vehicle. There was no evidence of seat or track failure. The seat back was slightly reclined and retained its pre-crash adjustment. There were three-point lap-and-shoulder safety belt systems at the four outboard positions, with the front seat positions the only ones showing signs of use. The tilt steering wheel was adjusted in the middle position. The driver's air bag was located in the steering wheel hub with cover flaps in the H-configuration (see Figure 4). The flaps opened along the seams, with no evidence of damage to the flaps or the air bag. The deployed driver's air bag was round with diameter 60 centimeters (24 inches), with two tether straps and two vent ports at the 11 and 1 o'clock positions. The steering wheel rim was not deformed and there was no evidence that the steering column had moved. Inspection of the driver's air bag revealed makeup smudges on the front, near the center (see Figure 5). There were no other points of occupant contact noted anywhere in the vehicle. In addition, there were two areas of dark plastic transfers on the front of the driver's air bag, near the lower-left edge and to the right and above the center. The front right air bag was located in the top of the instrument panel (see Figure 5). The two flaps opened along the seams with no evidence of damage to the flaps or the air bag, except the lower flap was slightly bent from the force of the deployment. There was no damage to the windshield. The deployed front right air bag was a rectangle 40 centimeters (16 inches) wide and 52 centimeters (20 inches) high, with no tether straps and two vent ports in the 10 and 2 o'clock positions. There was a dark plastic transfer mark in the center area of the top of the passenger air bag.

Figure 4: Case vehicle's steering wheel and instrument panel (case photo #26)

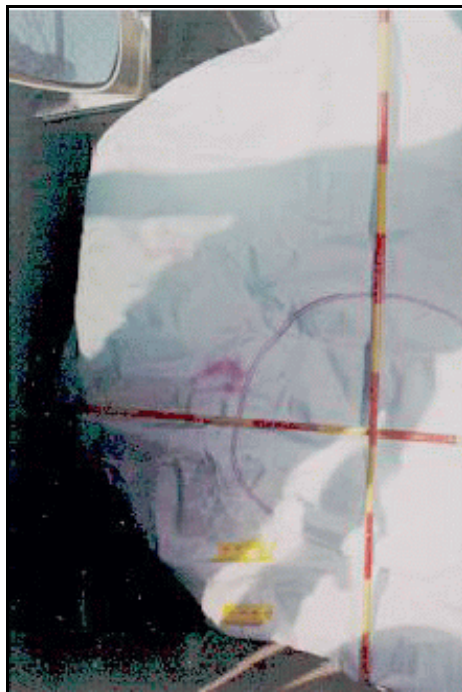
The driver was executing a left turn maneuver, leaning slightly to the left. She did not attempt any avoidance actions. The driver was a heavy, short statured woman seated close to the steering wheel. The impact caused the driver and front right air bags to deploy and caused the driver to be thrust forward and to the right, toward the two o'clock direction of principal force. Her left shoulder loaded the shoulder portion of her safety belt, restricting her forward motion and causing her to rotate slightly counterclockwise and lean forward such that the right side of her torso was leading. The deploying driver's air bag impacted the right side of her chest and right shoulder, causing an area of diffuse, minor bruising on her right shoulder. The air bag billowed up as it encountered her torso, contacting her face such that her make-up smudged the air bag. Her left knee impacted the rigid plastic cover of the knee bolster on the lower edge of the left instrument panel, in the area where the knee bolster is molded to accommodate the steering column, causing a minor contusion. She exited her vehicle with the assistance of the emergency medical technicians and was transported to a hospital via ambulance, where she was treated and released.

Figure 5: Case vehicle's driver side air bag, with makeup smudges (case photo #26)

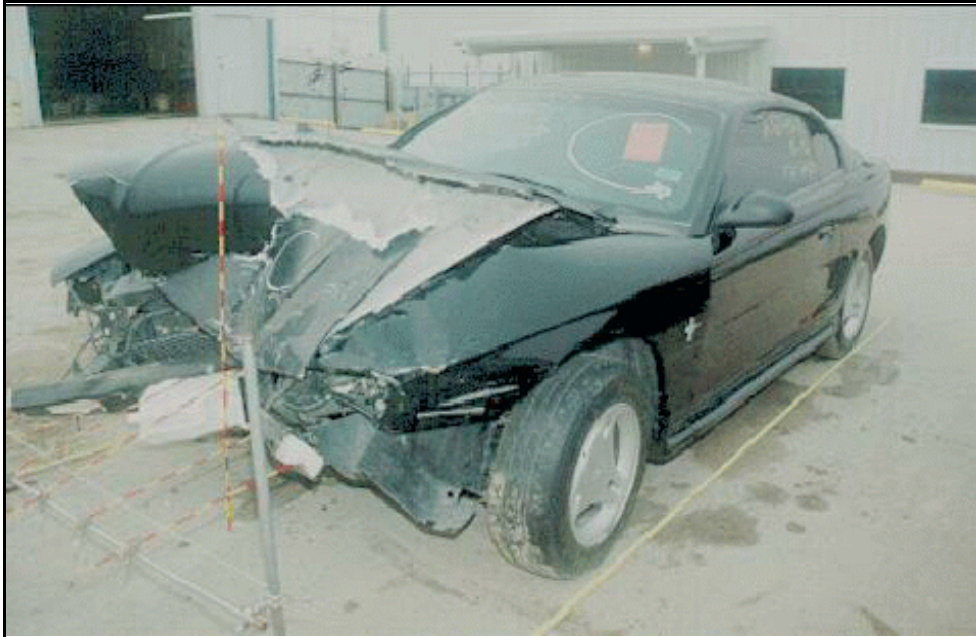
Figure 6: Vehicle #2, front and left side (case photo #38)

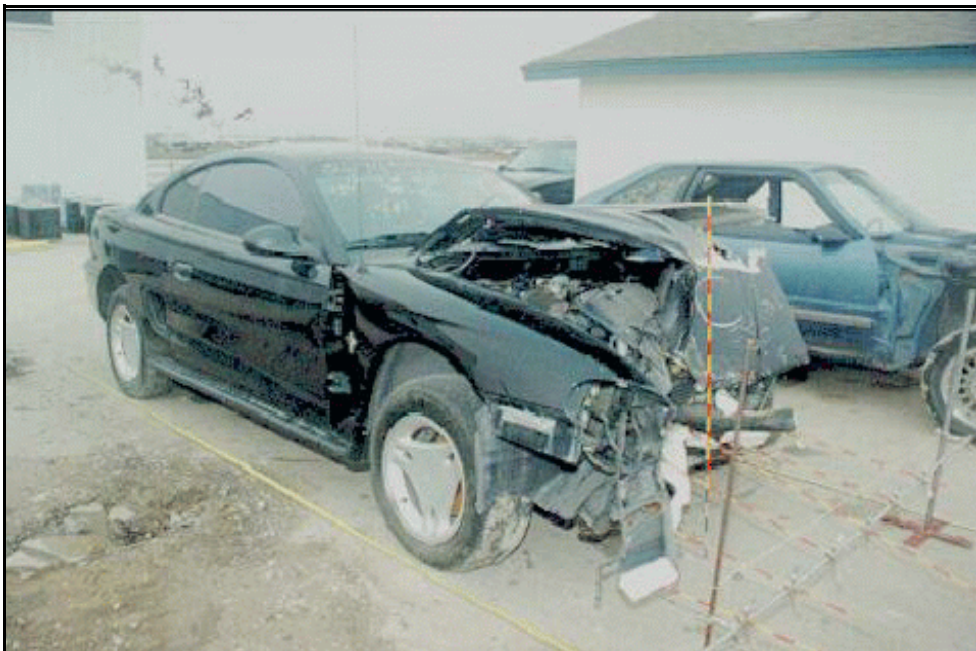
Vehicle #2 was a rear wheel drive 1996 Ford Mustang 2-door coupe (VIN: 1FALP4045TF-----). Vehicle #2 sustained two impacts on its front plane. It is assumed that vehicle #2 was traveling at or near the speed limit, approximately 56 - 64 km.p.h. (35 - 40 m.p.h.), prior to the first impact. It is not known if the driver of vehicle #2 attempted any avoidance actions. In the first event, the center of vehicle #2's front plane impacted the right front corner of the case vehicle. Vehicle #2 rotated approximately 45 degrees clockwise, traveled obliquely across the intersection and struck vehicle #3, which was stopped. In the second event, the center of vehicle #2's front plane impacted the left front corner of vehicle #3. Because vehicle #3 was driven away from the scene, it is assumed that the second impact for vehicle #2 was minor. The final crush profile for vehicle #2 indicates a CDC of **11-FDEW-2** (see Figures 7 and 8). The

Figure 7: Vehicle #2, front and right side (case photo #43)
