**VERIDIAN ON-SITE SIDE IMPACT OCCUPANT PROTECTION INVESTIGATION
SCI TECHNICAL SUMMARY REPORT**

SCI/NASS COMBO CASE NO. - 98-03-063A

SUBJECT VEHICLE - 1998 BMW 528i

CRASH DATE - SEPTEMBER 1998

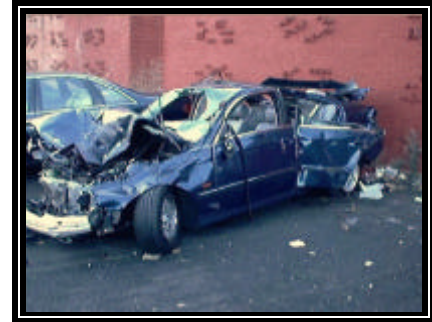
Figure 1. Damaged 1998 BMW 528i

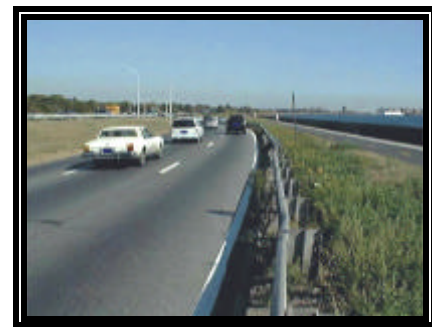
The 26-year-old male driver of the BMW was presumed to have been seated in an upright posture with the seat track adjusted between the mid-track and full-rear positions. The driver was operating the BMW in the outboard eastbound lane of the divided state highway. For unknown reasons, the driver relinquished control of the vehicle and failed to negotiate a left curve. The BMW departed the right side of the roadway in a tracking mode (**Figure 2**).

Figure 2. Eastbound approach for the BMW and area of initial guardrail impact

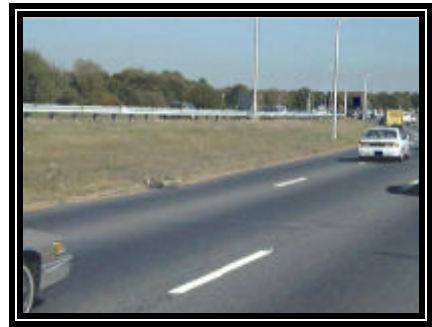
The front right aspect of the BMW impacted the outboard guardrail as the vehicle departed the roadway. Paint transfers were noted on the guardrail from the BMW's contact. The guardrail impact snagged the right front tire/wheel assembly which resulted in complete separation of the suspension components. The BMW was redirected by the guardrail and traveled across the three eastbound travel lanes in a CCW yaw. The BMW initiated a rollover onto the grassy median with the right side leading (**Figure 3**). The damage to the vehicle suggested a longitudinal component in the rollover event. The vehicle appeared to have rolled a total of six quarter-turns. The right front side air bag and right side HPS deployed as a result of the rollover event. It impacted the inboard guardrail for westbound traffic on the opposite side of the median during the fifth quarter turn. The BMW struck the guardrail with the right side area on the fifth quarter turn and with the hood/top aspect on the sixth quarter turn. The unrestrained driver was fully ejected through the windshield and was thrown across the opposing travel lanes and came to rest on a grassy area adjacent to the shoulder. The BMW came to rest on the median adjacent to the opposing guardrail, upside down and facing north.

Figure 3. View of median and rollover trajectory

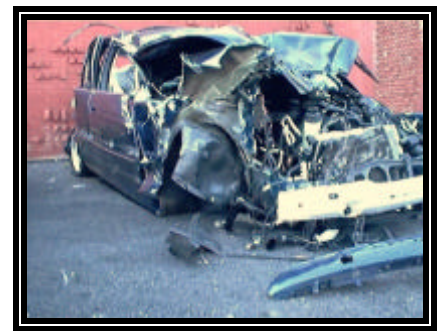
The BMW 528i sustained moderate damage as a result of the initial guardrail impact (**Figure 4**). The bumper fascia was completely separated from the vehicle and the upper radiator support was separated on the right side. The leading edge of the right front fender was crushed rearward and displaced upward. The right front suspension was fractured and the strut, wheel, and control arm were separated. Longitudinal abrasions were present on the rear right aspect of the hood. The right front fender and door sustained longitudinal abrasions with black and yellow transfers which began 74.9 cm (29.5") forward of the rear edge of the right front door and extended 80.0 cm (31.5") rearward. The SCI-revised Collision Deformation Classification for the initial right side guardrail impact was 12-FREE-9.

Figure 4. View of front right damage to the BMW 528i

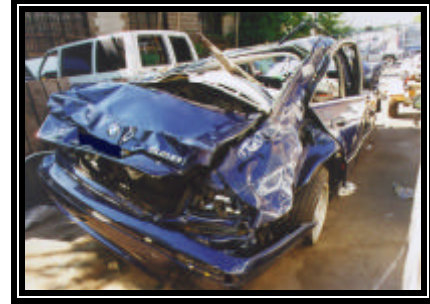
The BMW 528i sustained severe damage as a result of the rollover (**Figure 5**). Laterally oriented abrasions were present on the left half of the hood. The left aspect of the hood was displaced 29.2 cm (11.5") to the right. Longitudinal abrasions were present on the full width of the roof, both side rails, and on the rear aspect of the sun roof. The maximum vertical crush on the left roof side rail measured 12.1 cm (4.8") and the maximum crush on the right roof side rail measured 3.8 cm (1.5"). Grass was embedded into the left side rail. The full width of the trunk lid was abraded fore and aft, crushed forward and shifted laterally to the left. Longitudinal abrasions and lateral crush were also noted on the right rear quarter panel, upper right C-pillar, and right rear door which began 71.1 cm (28.0") forward of the right rear axle. The combined direct and induced damage along the right rear side aspect measured 137.2 cm (54.0") and extended rearward to the right rear corner. Six crush measurements were taken along the right rear quarter panel and were as follows: C1 = 25.4 cm (10.0"), C2 = 25.4 cm (10.0"), C3 = 12.7 cm (5.0"), C4 = 15.2 cm (6.0"), C5 = 5.1 cm (2.0"), C6 = 0.0 cm. Grass was present in the left rear quarter panel and diagonally oriented abrasions were present on the left rear door and left rear quarter panel. The left front fender also sustained diagonally oriented abrasions and was crushed downward approximately 13 cm (5") and laterally to the right approximately 8 cm (3"). The SCI-revised CDC for the rollover event was 00-TDDO-4.

Figure 5. View of right side rollover damage

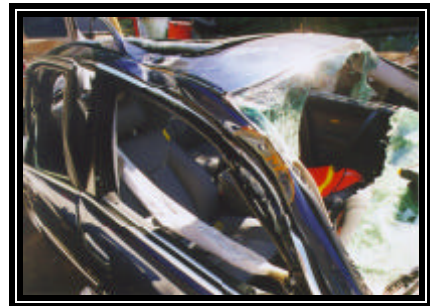
The damage associated with the impact to the median guardrail was moderate. Direct damage was noted on the right upper A-pillar which appeared to be a result of contact with the median guardrail (**Figure 6**). The direct contact damage began 50.8 cm (20") forward of the right B-pillar and measured 23.5 cm (9.3") in length. The maximum crush on the right A-pillar measured 5.1 cm (2.0"). A second impact was located on the roof side rail. The direct damage on the right side rail began 12.7 cm (5.0") forward of the right B-pillar and measured 29.2 cm (11.5") in length. The SCI-revised CDC for the impact to the median guardrail was 00-RDAN-2.

Figure 6. Damage to the right A-pillar and roof side rail

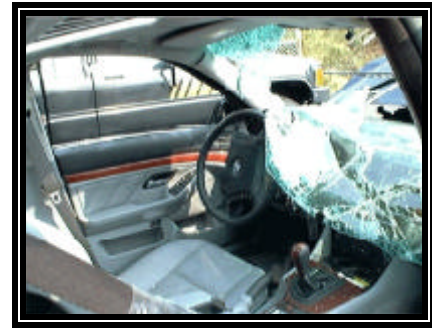
Interior damage to the 1998 BMW 528i was severe and attributed to passenger compartment intrusion and passenger compartment integrity loss (**Figure 7**). Integrity was lost through the windshield, roof glazing, side glazing, backlight, and the left rear door. The windshield laminate was torn along the middle and lower aspects of the right A-pillar. The laminate was split across the windshield header with the bond intact, split along the entire left A-pillar, and split 20.3 cm (8.0") along the base at the left A-pillar. The tempered glazing of the sunroof, backlight, and side doors disintegrated as a result of the crash. The left rear door opened and the trunk latch released during the crash.

Figure 7. Interior view showing windshield integrity loss

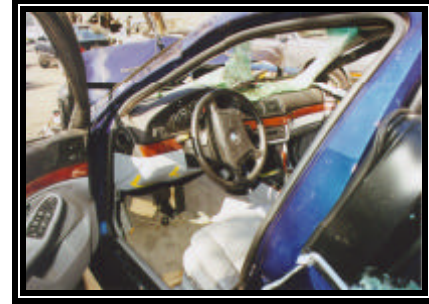
Contact evidence from the driver was present in the BMW (Figure 8). The rear view mirror was separated from the mounting point and exhibited body fluid (blood) on the right aspect and hair at the mirror mount. The probable driver ejection path from the vehicle resulted in the 3 cm (1") forward deformation of the upper half of the steering wheel rim, a fracture of the left turn signal arm from the column, left knee contact evidenced by scuff marks on the left aspect of the knee bolster that were located 51 cm (20") left of center and 28 cm (11") below the top aspect, a body fluid (blood) stain on the left side of the bolster, and a possible contact with the left door side impact air bag cover, which was bowed outward.

Figure 8. View of driver contacts

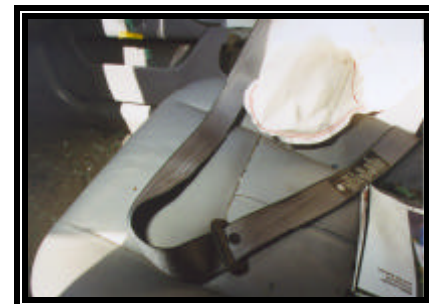
The front right passenger's seat belt exhibited faint routine wear marks on the latch plate suggestive of infrequent usage. Heavy load marks were present on the inside surface of the webbing (Figure 9). The latch plate stop button was located 42.5 cm (16.3") above the seat track mount. Black vinyl transfers from the latch plate were located 35.5 cm (14.0") above the stop button and extended upward 7.6 cm (3.0") along the full width of the belt webbing. The bottom side of the webbing was heavily abraded in a slight diagonal pattern with fragments of vinyl collected on the latch plate. Creases in the webbing were present 22.8 cm (9.0") above the lower anchorage and extended 20.3 cm (8.0") upward. White stress marks from occupant loading were present on the inside aspect of the webbing 20.3 cm (8.0") above the stop button, and white stretch marks were present 43.2 cm (17.0") above the stop button. There were no D-ring loading marks or transfers.

Figure 9. View of front right seat belt showing loading evidence

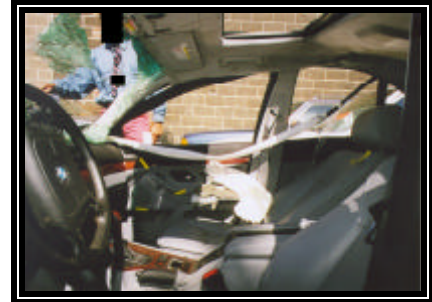
The right front passenger's side air bag deployed from the right front door-mounted module that was located above the right front passenger's arm rest. The leather door panel was hinged at the bottom aspect and measured 29.2 cm (11.5") in length on the top aspect, 19.1 cm (7.5") on the in length along the bottom aspect, and 14.0 cm (5.5") in height. The identification sticker on the inside aspect of the cover flap read: "BMW 8212806, >PUR+PA<2". The front right passenger's side air bag measured 44.5 cm (17.5") in width and 26.7 cm (10.5") in height. Tether stitching was present on the inboard center aspect of the air bag in a longitudinal configuration. The stitching measured 29.1 cm (11.5") long, and curled in a downward 5 cm (2") diameter semi-circle fashion on the rear aspect of the air bag face. There was no contact evidence on the surface of the air bag.

Figure 10. View of deployed front right passenger's side air bag and HPS

The HPS was positioned diagonally across the right front passenger's position at the time of deployment, and extended rearward from the lower right A-pillar at an upward angle to the right roof rails. The nylon tubes were reinforced with Kevlar and were covered with a nylon mesh webbing. A clear plastic membrane cover was present around the HPS which had partially torn due to the deployment. A warning label was affixed to the clear plastic cover regarding the replacement of the deployed HPS. The diameter of the tube measured 12.7 cm (5.0") and the length measured 104.1 cm (41.0"). The tube was tethered by a reinforced rear external strap which measured 33.0 cm (13.0") in length and 2.5 cm (1.0") in width. A lead tube that measured 17.8 cm (7.0") in length was attached to the forward aspect of the HPS and was connected to the inflator that was located in the A-pillar. There were no identifiable contacts to the HPS.

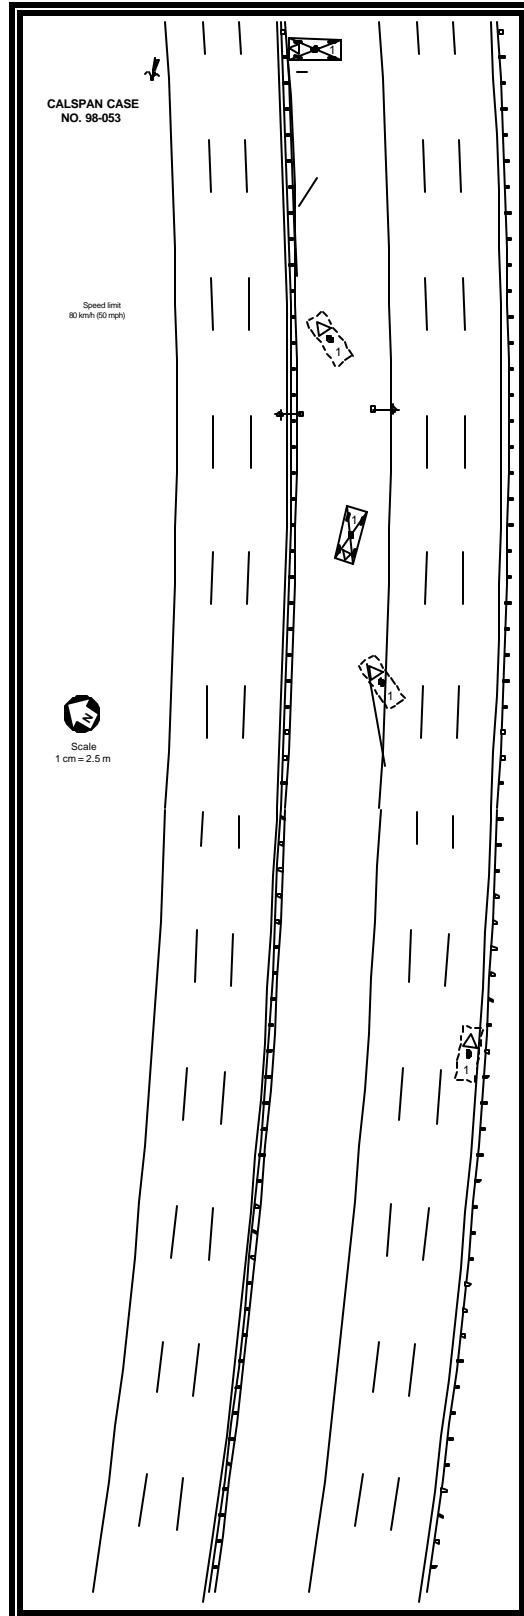
Figure 11. Scene schematic

This single-vehicle crash occurred during the nighttime hours on the eastbound lanes of a divided urban expressway. The roadway was illuminated by luminaires that were positioned in the center median. At the time of the crash the weather was clear and the asphalt roadway was dry. The roadway consisted of three travel lanes in each direction separated by a grassy median barrier which had a 20 degree upward slope toward the westbound lanes. The eastbound lanes were configured with a W-beam guardrail and 10 cm (4") curb on the outboard aspect. The westbound lanes were configured with a double W-beam guardrail on the inboard aspect. The roadway had a slight curve to the left and there were no traffic controls present at the crash site. The posted speed limit for the urban expressway was 80 km/h (50 mph). The scene schematic is included as **Figure 11** of this report.
