NASS/SCI COMBINED DRIVER AIR BAG FATALITY INVESTIGATION

CALSPAN CASE NO. 1998-04-004B

VEHICLE - 1993 BUICK CENTURY CUSTOM WAGON

CRASH DATE - JANUARY, 1998

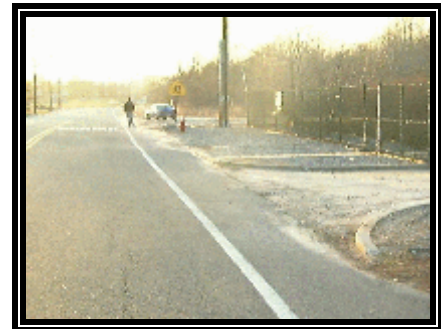
Figure 1: Pre-crash trajectory view.

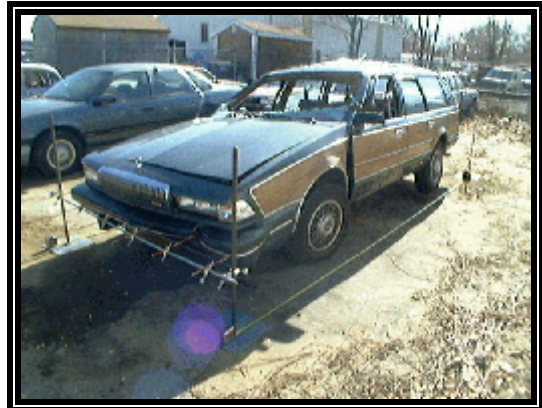
The Collision Deformation Classification(CDC) of the hydrant impact as determined by the NASS inspection was 12-FLEN-01. The direct contact damage began 2.0 cm (0.8 in) inboard of left front bumper corner and extended right 22.0 cm (8.7 in). The maximum engagement of the front bumper with the hydrant occurred at C2, located 31.6 cm (12.4 in) inboard of the left front corner (refer to Figure 2). The crush profile measured during the inspection was: C1=10.0 cm (3.9 in), C2=17.0 cm (6.7 in), C3=7.0 cm (2.8 in), C4=2.0 cm (0.8 in), C5=0, C6=0. The left side wheelbase was foreshortened 7.0 cm (2.8 in) and the left front fender buckled rearward. The A-pillars were cut and the windshield removed during the rescue operations. The total delta V of the Buick computed by the barrier model of the SMASH program was 14.5 km/h (9.0 mph). The delta V was of sufficient magnitude to cause the deployment of the Supplemental Restraint System. Note, the delta V reported was enhanced by the SCI team from the EDCS reported delta V value of 16.9 km/h (10.0 mph)

Figure 2: Left front view of the Buick Century Wagon.

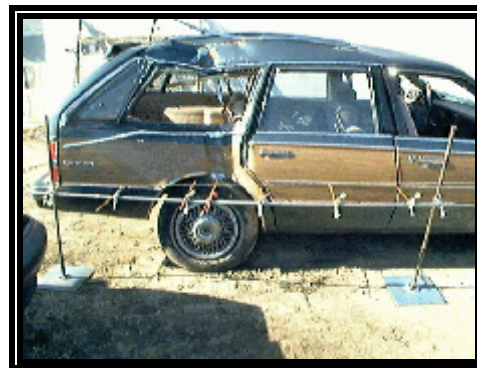
The impact sheared the fire hydrant casing. However, the vehicle's suspension snagged the hydrant's internal piping and the Buick's momentum caused it to rotate counterclockwise about the hydrant. The Buick rotated approximately 45 degrees, disengaged from the hydrant and continued a westbound trajectory and in the process initiated a right side leading roll. The Buick then impacted a utility pole located 5.0 m (16.4 ft) north of the curb edge and 5.6 m (18.4 ft) west of the fire hydrant. The right rear quarterpanel of the vehicle struck the utility pole resulting in a CDC of 00-RBAN-03 (refer to Figure 3). (Note, the SCI team revised the CDC extent zone to 03, from the EDCS

Figure 3: Right side view of the Buick.

reported CDC of 00-RBAN-02.) The nature of the damage indicated the vehicle had rolled approximately 30 degrees at the time of the impact. The vehicle then rebounded and completed the one-quarter turn coming to rest on its right side and in contact with a utility pole, Figure 4.

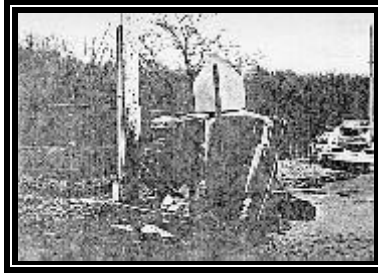
Figure 4: View of final rest.

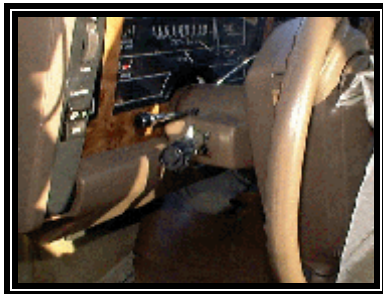
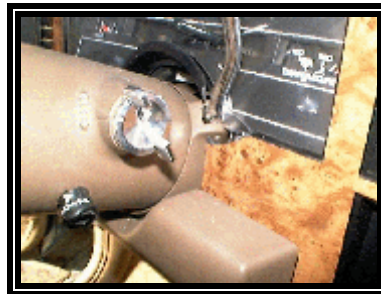
The tilt steering column was adjusted between the center and full down positions. It was a non-telescoping column. There was no steering wheel rim deformation. However, the steering column exhibited signs of significant interaction between the driver and the steering wheel hub. The steering column was compressed completely forward off the shear capsules (approximately 5 to 8 cm (2 to 3 in)), with the tilt and transmission levers in contact with instrument panel (Figures 5 and 6).

Figure 5: Left view of the steering column.

Figure 6: Right view of the steering column.

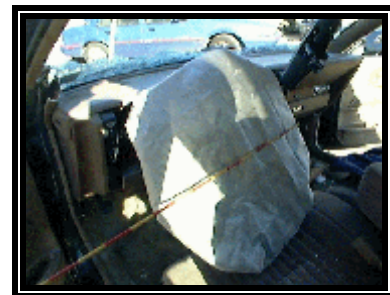
The driver air bag module was designed in the typical manner and housed in the center of the steering wheel and the air bag had deployed as designed from the H-configuration module. The module cover flaps were symmetrical and measured 20.0 cm x 5.0 cm (7.9 in x 2.0 in) width by height. The deflated air bag measured 50 cm (20 in) in diameter. The bag was tethered and had two vent ports on the back side on the bag located in the 3 and 9 o'clock sectors. It should be noted that in Figure 7, the steering wheel was rotated clockwise approximately 90 degrees, such that the 9 o'clock sector of the rim was vertical.

Figure 7: Driver air bag.

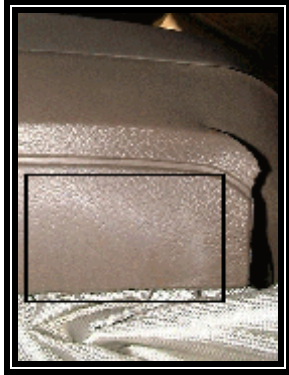
There were two distinct areas of interaction between the occupant and the SRS identified during the NASS inspection. The cover flaps opened at the designated tear seams, however the flaps exhibited heavy blue fabric transfers and were covered with faint blue fibers. The transfers were located on the center and right aspects of both the upper and lower flaps. These fibers transferred from the driver's blue sweater to the cover flaps during the deployment sequence. The interview with the driver's family confirmed that the

Figure 8: Blue fabric transfers on the upper cover flap.

As the deployment initiated, the cover flaps rotated open against the driver's chest evidenced by the blue fabric transfers to the cover flaps from her clothing. The mid aspect of her chest was abraded in the contact. The air bag began to expand and unfold out of the module, however the driver's position over the top of the module impeded its egress. This impedance caused the friction heating between the cover

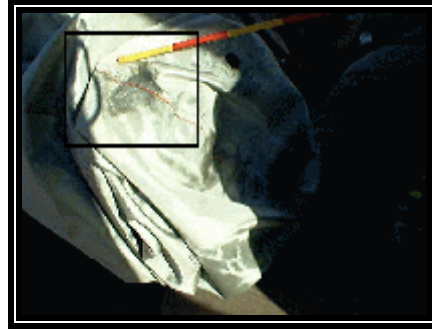
driver was wearing a blue sweater. On the air bag's peripheral seam, in the 3 o'clock sector, a black transfer 25 cm (10 in) in length was identified. This transfer was caused by friction heating between the inside surface of the cover flaps and the membrane of the air bag in the early stages of the deployment. The existence of these interactions indicate the driver's chest was on top of the air bag module at the beginning of the deployment sequence. The driver's forward position and forward trajectory impeded the normal egress of the air bag from the module.

Figure 9: Black transfer in the 3 o'clock sector of the air bag's peripheral seam.

flaps and air bag membrane evidenced by the black transfers on the bag's periphery. The air bag expanded into the driver's chest causing massive chest trauma and the aortic laceration. The air bag's continued expansion abraded the anterior aspect of the driver's neck. The driver then began to accelerate rearward.
