**VERIDIAN ON-SITE REDESIGNED AIR BAG DEPLOYMENT INVESTIGATION  
NASS/SCI COMBO CASE NO. 98-05-008K  
VEHICLE - 1998 CADILLAC DEVILLE CONCOURS  
LOCATION - PENNSYLVANIA  
CRASH DATE- FEBRUARY 1998**

Contract No.  
DTNH22-94-D-07058

**VERIDIAN ON-SITE REDESIGNED AIR BAG DEPLOYMENT INVESTIGATION  
NASS/SCI COMBO CASE NO. 98-05-008K  
VEHICLE - 1998 CADILLAC DEVILLE CONCOURS  
LOCATION - STATE OF PENNSYLVANIA  
CRASH DATE - FEBRUARY, 1998**

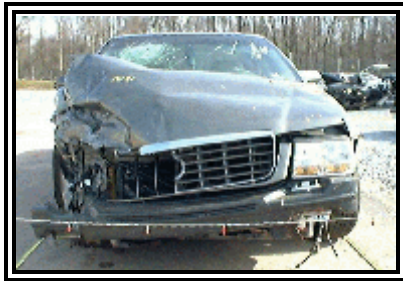
The 1998 Cadillac DeVille Concours was equipped with a redesigned frontal air bag system and front door mounted side air bags. The frontal driver and right passenger air bags deployed as the result of the impact with the Plymouth. Exterior damage to the vehicle (refer to Figures 1-3) involved the front bumper, the grille, the hood, both front fenders, the radiator, and displacement of the right front axle. Direct contact began at the right front bumper corner and extended 73.7 cm (29.0") toward the left. The maximum crush of 36.8 cm (14.5") was located at the right front bumper corner.

**Figure 1**- Frontal view of the 1998 Cadillac DeVille Concours

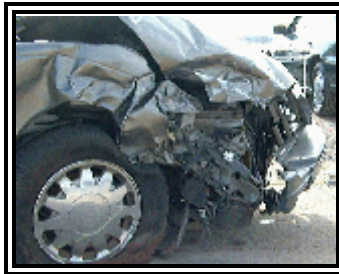
**Figure 2** - View of the right front fender showing extent of frontal crush

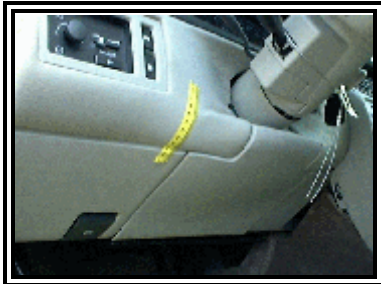
Interior vehicle damage to the 1998 Cadillac DeVille Concours was attributed to occupant contacts and the deployment of the redesigned frontal air bag system. The left side of the driver side knee bolster which was composed of a rigid vinyl material was dislodged from its anchor point from contact by the driver's left knee during the crash sequence. The lower instrument panel adjacent to the dislodged knee bolster panel was also deformed by the driver's left knee contact (**refer to Figure 4**). There was no steering column displacement detected at the left or right shear capsules. The steering wheel was tilted upward in the full up adjusted position at the time of inspection which was 32 degrees above horizontal.

**Figure 4** - View of contact evidence along the lower instrument panel and knee bolster

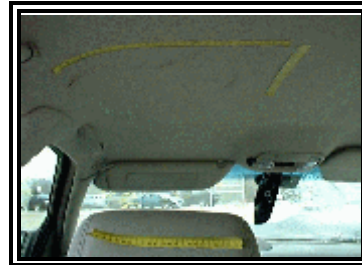
**Figure 5** - View from rear seat looking forward of contact evidence on the roof head liner and rear surface of the driver seat head restraint

The top portion the driver's head restraint exhibited a light black/gray color transfer which was attributed to contact by the driver during his rebound kinematic pattern following the first impact with the Plymouth Reliant (**refer to Figure 5**). The contact began 3.8 cm (1.5") below the top surface of the head restraint and extended laterally 19.1 cm (7.5"). It continued over the top surface and narrowed to 10.2 cm (4.0") on the back surface and ending 2.5 cm (1.0") below the top surface. The vertical and lateral dimension of the head restraint measured 15.2 cm (6.0") and 30.4 cm (12.0"), respectively.

The roof head liner directly above the driver's head restraint exhibited contact evidence by the driver's head. This was apparent from the black and white hair embedded in the fabric of the roof liner. This contact pattern was located 66.0 cm (26.0") rearward from the windshield header and 22.9 cm (9.0") left of the vehicle centerline. The hair artifact pattern was shaped in an "L" configuration with the longitudinal side measuring 8.3 cm (3.25") long and the lateral side, which extended from the end of the

longitudinal segment toward the left roof side rail, measured 21.6 cm (8.5"). Within this evidence pattern were pronounced dark brown transfer marks were attributed to tissue transfers from the driver's scalp and were correlated with the medically reported scalp abrasions.

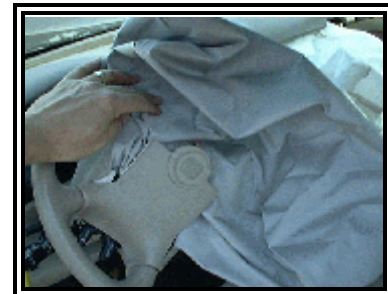
The front left air bag module cover opened in the prescribed "T" pattern where the left flap measured 9.5 cm (3.75") laterally and the right flap measured 12.1 cm (4.75") which included a 2.5 cm (1.0") semi-circle overlap tab that contained the Cadillac insignia (refer to Figure 6). The vertical height of the flaps measured 10.8 cm (4.25") at the common tear seam line. The flaps measured 12.7 mm (0.5") in thickness and were made of a soft vinyl with the underside constructed of several rows of vinyl. There were no apparent occupant contact points on the cover surface.

**Figure 6** - View of the "T" pattern front left air bag module cover flaps

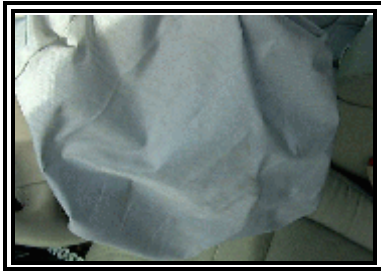
The front left air bag exhibited tan color striated transfer marks in the upper right quadrant and both lower quadrants which were attributed to contact with the underside of the air bag module cover during the deployment sequence (**refer to Figure 7**). The transfer in the upper right quadrant was heavier in color concentration and measured 35.6 cm (14.0") vertically and 25.4 cm (10.0") laterally. There was no visible driver contact evidence on the air bag.

**Figure 7** - View of the front left non-tethered air bag showing the striated transfer pattern from contact with the air bag module cover

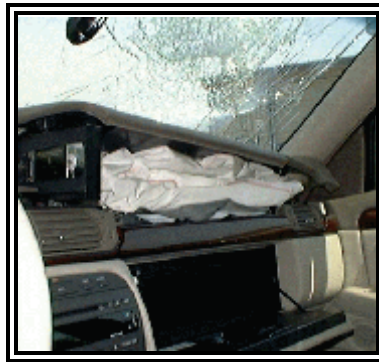
**Figure 8** - View of the front right air bag relocated back under the instrument panel

The front right air bag module was a top mount design which incorporated the top surface of the instrument panel as the air bag module cover (**refer to Figure 8**). The top instrument panel was secured by pressure clips which released as the air bag expanded. There was no damage noted to this panel.
