**REDESIGNED AIR BAG SPECIAL STUDY (RABSS)
SCI TECHNICAL SUMMARY REPORT**

NASS CDS CASE NO. 1998-05-095K

RABSS VEHICLE - 1998 HONDA ACCORD LX

CRASH DATE - JULY, 1998

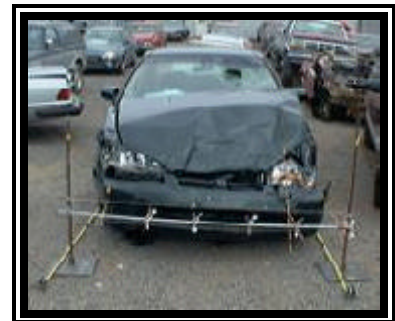
The Honda Accord LX sustained moderate frontal damage as a result of the impact with the Infinity Q45 (**Figure 3**). The direct contact damage encompassed the full frontal width resulting in a combined direct and induced damage length (Field L) of 155.0 cm (61.0 in). Six crush measurements were taken at the level of the bumper: C1= 26.0 cm (10.2 in), C2= 18.0 cm (7.1 in), C3= 10.0 cm (3.9 in), C4= 29.0 cm (11.4 in), C5= 10.0 cm (3.9 in), C6= 15.0 cm (5.9 in). Damage was noted to the hood which was displaced up and rearward from engagement against the side surface of the Infinity. Both fenders were damaged from 11.0 cm (4.3 in) of lateral end structure shifting to the left which restricted the left front wheel/tire. The windshield was fractured from induced impact forces and (interior) driver contact.

Figure 3. Frontal damage to the 1998 Honda Accord LX.

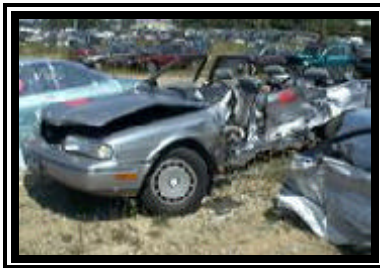
Figure 4. Left side damage to the 1990 Infinity Q45.

The 1990 Infinity Q45 sustained moderate left side damage as a result of the impact with the Honda Accord (**Figure 4**). The direct contact damage began 60.0 cm (23.6 in) aft of the left front axle and extended 220.0 cm (86.6 in) rearward. Induced damage was noted to the left fender and quarter panel. The left front door panel and roof were removed by rescue personnel during the occupants' extrication from the vehicle.

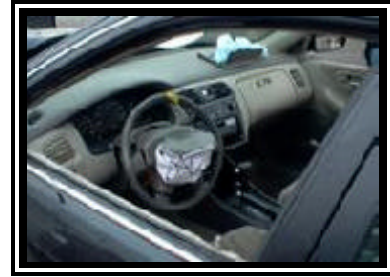
Interior damage to the Honda Accord identified through the NASS vehicle inspection was minimal and was attributed to occupant contact (**Figure 5**). Although routine wear marks were noted to the

latchplate of the 3-point manual lap and shoulder belt system, no loading marks were identified to the belt webbing which would support restraint usage during the crash. No contact evidence was found to the exterior surface of the driver or passenger air bag module cover flap, but blood spattering was noted to the left upper quadrant of the driver air bag. The upper portion of the steering wheel rim was deformed forward 4.0 cm (1.6 in) while the lower portion was deformed forward 2.0 cm (0.8 in) (tilt column set to the full up position). A web type fracture was documented to the left windshield with a skin transfer embedded into the glazing. The knee bolster on both sides of the steering column was fractured and scuffed (rigid plastic type). A scuff mark was documented on the front left door panel. No intrusion of interior components were found in the vehicle.

Figure 5. Interior view of the 1998 Honda Accord LX.

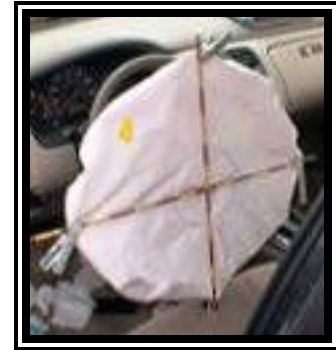
The 1998 Honda Accord LX was equipped with redesigned frontal air bags for the driver and front right passenger positions. The air bags had deployed as a result of the crash. Air bag warning labels were affixed to each sun visor. The driver air bag was housed in the center of the steering wheel with a horizontally oriented flap tear seam (H-configuration). The upper flap measured 18.5 cm (7.3 in) in width and 8.5 cm (3.3 in) in height while the lower flap measured 13.0 cm (5.1 in) in width and 4.0 cm (1.6 in) in height. There was no contact evidence on the air bag or exterior surface of the module cover flaps, but blood spattering was noted to the left upper quadrant of the air bag which was attributed to the driver's left forearm contact to the windshield. The NASS researcher measured the diameter of the driver air bag at 54.0 cm (21.3 in) in its deflated state (**Figure 6**). The bag was tethered by two internal straps and vented by two ports located at the 11 o'clock and 1 o'clock (centered) sectors on the rear aspect of the air bag.

Figure 6. 1998 Honda Accord LX redesigned driver air bag.

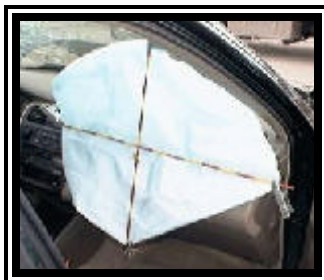
Figure 7. 1998 Honda Accord LX redesigned passenger air bag.

The front right redesigned passenger air bag deployed from a top mount module in the right instrument panel with a single cover flap design hinged at the rear aspect. There was no contact evidence on the module cover flap which was rectangular in shape and measured 26.0 cm (10.2 in) in width and 5.5 cm (2.2 in) in height. There was no contact evidence on the passenger air bag which measured 75.0 cm (29.5 in) in width and 60.0 cm (23.6 in) in height in its deflated state (**Figure 7**). No internal tether straps were present. The bag was vented by two ports located at the 9 o'clock and 3 o'clock sectors on the side aspect of the air bag. No cutoff switch was reported for the front right air bag.

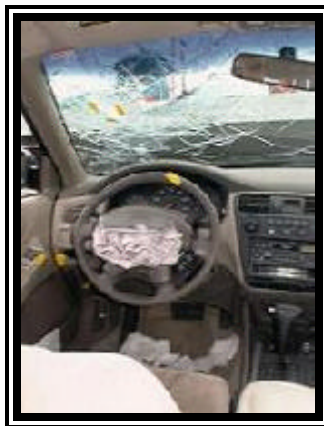
The unrestrained 27 year old male driver of the 1998 Honda Accord LX was seated in an upright posture with the seat back slightly reclined and the seat track adjusted to the rear most position. The police report noted that the driver was not belted, further evidenced by the lack of loading marks to the belt webbing and extent of deformation to the driver space (**Figure 8**). At impact, he initiated a forward trajectory in response to the 1 o'clock impact force and loaded the deployed redesigned driver air bag, evidenced by the kinematic response pattern in relation to the rearward extent of the deployed air bag. The redesigned air bag provided protection to the head/face against further contact to the windshield. The driver subsequently bottomed out the air bag as evidenced by the deformation to the upper and lower sections of the steering wheel rim. His lower extremities loaded the knee bolster as the left forearm contacted the windshield, evidenced by the indentations/scuff marks to the bolster and web type fracture/skin transfer to the windshield. Injury information was limited as the driver refused the NASS interview and the medical records were not obtained. The police reported an (unspecified) bleeding wound to the chest/stomach. The driver was transported to a local hospital for unspecified treatment.

Figure 8. Interior view of the driver space.
