**REDESIGNED AIR BAG SPECIAL STUDY (RABSS)
SCI TECHNICAL SUMMARY REPORT**

NASS RABSS CASE NO. 1998-08-803F

RABSS VEHICLE - 1998 CHEVROLET LUMINA LS

CRASH DATE - SEPTEMBER, 1998

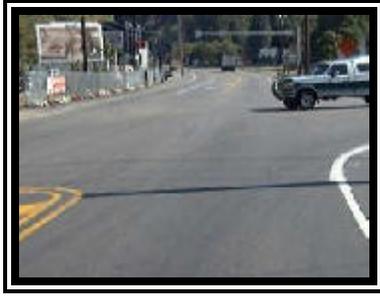
Figure 1. Southbound approach for the 1998 Chevrolet Lumina LS.

The 52 year old male driver of the 1998 Chevrolet Lumina was operating the vehicle southbound (**Figure 1**) and proceeding straight when he observed the Pontiac Sunbird turn left (north) across his lane of travel. Upon recognition of the impending harmful event, the driver braked (13.0 meters (42.7 ft) of pre-impact skid marks documented at the crash site) and steered right in avoidance remaining in the southbound travel lane prior to the collision. The 1993 Pontiac Sunbird was driven by a 76 year old male who was operating the vehicle eastbound (**Figure 2**) when he stopped at the stop sign and proceeded to turn left (north).

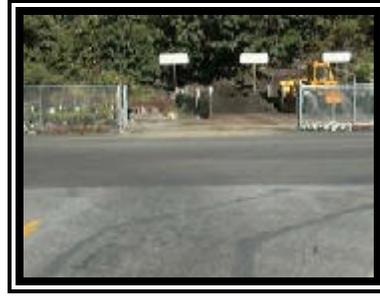
Figure 2. Eastbound approach for the 1993 Pontiac Sunbird.

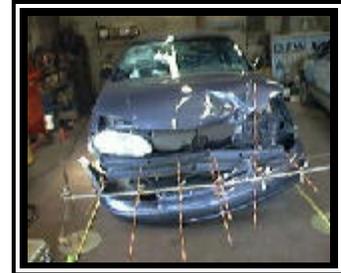
The Chevrolet Lumina sustained moderate frontal damage as a result of the impact with the Pontiac Sunbird (Figure 3 & 4). The direct contact damage began at the front right bumper corner and extended 95.0 cm (37.4 in) inboard. The impact deformed the full frontal width resulting in a combined direct and induced damage length (Field L) of 129.0 cm (50.8 in). Six (revised) crush measurements were documented at the level of the reinforcement bar: C1= 0 cm, C2= 10.0 cm (3.9 in), C3= 20.0 cm (7.9 in), C4= 18.0 cm (7.1 in), C5= 8.0 cm (3.1 in), C6= 1.0 cm (0.4 in). Damage was noted to the hood which was displaced rearward from the impact force. The bumper fascia separated from the reinforcement bar. The windshield was fractured from exterior forces and the (interior) front right passenger air bag module cover flap. No wheels were restricted or flat. The location of the sideslap damage to the right side was not obtained by the NASS researcher.

Figure 3. Frontal damage to the 1998 Chevrolet Lumina LS.

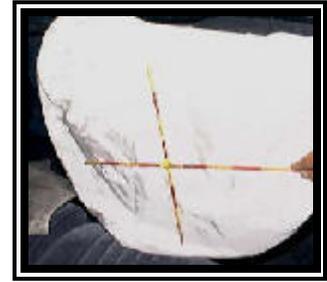
in) in width and 26.0 cm (10.2 in) in height along the left edge of the flap and 23.0 cm (9.1 in) along the right edge. The NASS researcher measured the passenger air bag at 64.0 cm (25.2 in) in width and 56.0 cm (22.0 in) in height in its deflated state (**Figure 10**). The bag was tethered by two internal straps and vented by two ports located at the 10 o'clock and 2 o'clock sectors on the side aspect of the air bag. No cutoff switch was reported for the front right air bag.

Figure 10. 1998 Chevrolet Lumina redesigned passenger air bag.

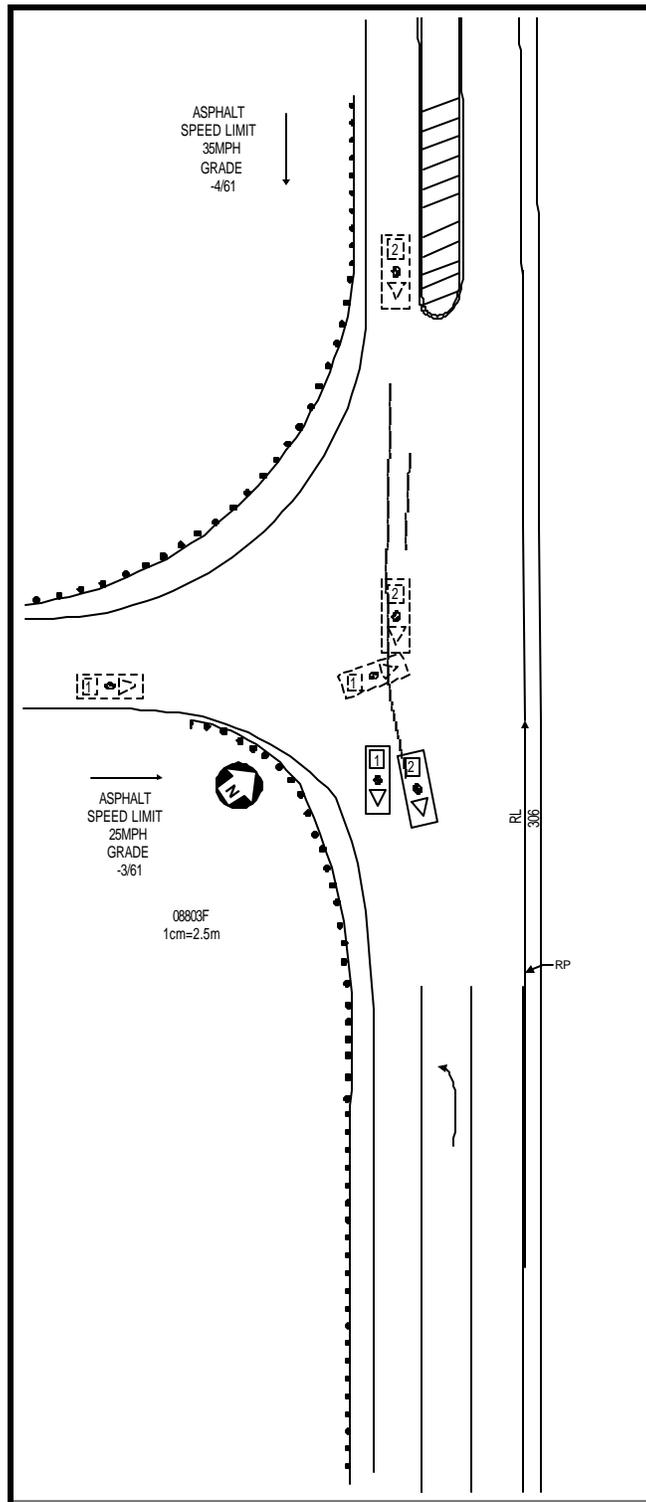
Figure 11. NASS Scene Diagram

This two-vehicle crash occurred during the afternoon hours of September, 1998. At the time of the crash, it was daylight with no adverse conditions as the roads were dry. The crash occurred in the southbound lane of an north/south two lane asphalt roadway (see **Figure 11 - page 7**). Traffic control at the scene included stop signs for eastbound traffic. The speed limit at the crash scene was 56 km/h (35 mph) for north/southbound traffic and 40 km/h (25 mph) for east/westbound traffic.
