**REDESIGNED AIR BAG SPECIAL STUDY (RABSS)
SCI TECHNICAL SUMMARY REPORT**

NASS RABSS CASE NO. 1998-08-805F

RABSS VEHICLE - 1998 BUICK LeSABRE CUSTOM

CRASH DATE - NOVEMBER, 1998

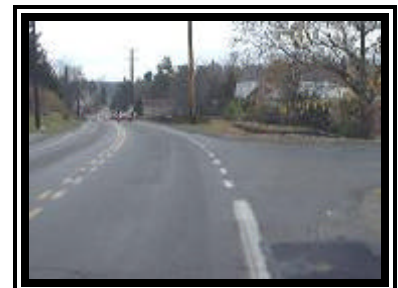
The 79 year old male driver of the 1998 Buick LeSabre was operating the vehicle northbound and negotiating a left curve (**Figure 1**) at a driver reported speed of 72 km/h (45 mph). As the Buick crested the hill the driver apparently fell asleep and allowed

Figure 1. Northbound approach for the 1998 Buick LeSabre (impacted pole in background).

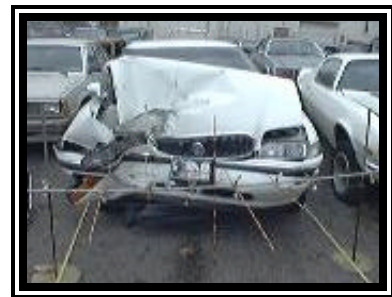
The 1998 Buick LeSabre Custom sustained moderate frontal damage as a result of the impact with the utility pole (**Figure 2**). The direct contact damage began 20.0 cm (7.9 in) to the left of the front right bumper corner and extended 40.0 cm (15.7 in) inboard. The impact deformed the full frontal width resulting in a combined direct and induced damage length (Field L) of 123.0 cm (48.4 in). Six crush measurements were documented at the level of the bumper: C1= 0 cm, C2= 0 cm, C3= 1.0 cm (0.4 in), C4= 14.0 cm (5.5 in), C5= 42.0 cm (16.5 in), C6= 18.0 cm (7.1 in). The hood was displaced up and rearward from engagement against the utility pole.

The right fender was deformed rearward which restricted the right front wheel (not deflated). Reduction in the right side wheelbase measured 10.0 cm (3.9 in). No windshield damage was noted as a result of exterior impact forces, but a spider web fracture pattern was noted from (interior) occupant contact.

Figure 2. Frontal damage to the 1998 Buick LeSabre.

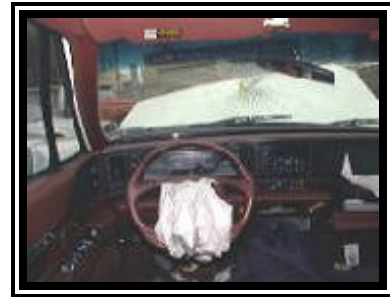
Interior damage to the Buick LeSabre identified through the NASS vehicle inspection was moderate and was attributed to occupant contact (**Figure 3**). The upper portion of the steering wheel rim was deformed forward 4.0 cm (1.6 in) with the turn signal column attachment displaced. Scuff marks were documented to the driver knee bolster (padded type) and center instrument panel area. The ashtray was out-of-place. The rear-view mirror was displaced forward (undamaged) with a small spider web fracture pattern noted to the nearby windshield area. The right portion of the front left seat back was deformed slightly rearward. Intrusions into the front right passenger space included 4.0 cm (1.6 in) of longitudinal toe pan intrusion and 3.0 cm (1.2 in) of vertical floorpan intrusion.

Figure 3. Interior view.

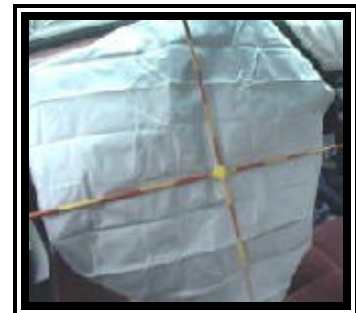
The 1998 Buick LeSabre Custom was equipped with redesigned frontal air bags for the driver and front right passenger positions. The air bags had deployed as a result of the crash. Air bag warning labels were affixed to each sun visor. The driver air bag was housed in the center of the steering wheel with a vertically oriented flap tear seam (I-configuration). The flaps were symmetrical in shape and measured 13.0 cm (5.1 in) in width and 9.0 cm (3.5 in) in height. Although no contact evidence was identified on the exterior surface of the module cover flaps, light red horizontal striations were documented on the upper/lower sections of the air bag. The NASS researcher measured the diameter of the driver air bag at 62.0 cm (24.4 in) in its deflated state (**Figure 4**). No internal tether straps were present. The bag was vented by two ports located at the 3 o'clock and 9 o'clock sectors on the rear aspect of the air bag.

Figure 4. 1998 Buick LeSabre redesigned driver air bag.

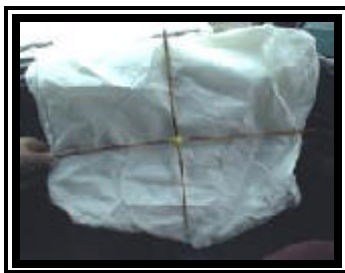
Figure 5. 1998 Buick LeSabre redesigned passenger air bag.

The front right passenger air bag deployed from the right mid-instrument panel area with a single cover flap design hinged at the top aspect. There was no contact evidence identified on the air bag or exterior surface of the module cover flap. The cover flap was rectangular in shape and measured 32.0 cm (12.6 in) in width and 13.0 cm (5.1 in) in height. The NASS researcher measured the passenger air bag at 62.0 cm (24.4 in) square in its deflated state (**Figure 5**). No internal tether straps were present. The bag was vented by two ports located at the 3 o'clock and 9 o'clock sectors on the side aspect of the air bag. No cutoff switch was reported for the front right redesigned passenger air bag.

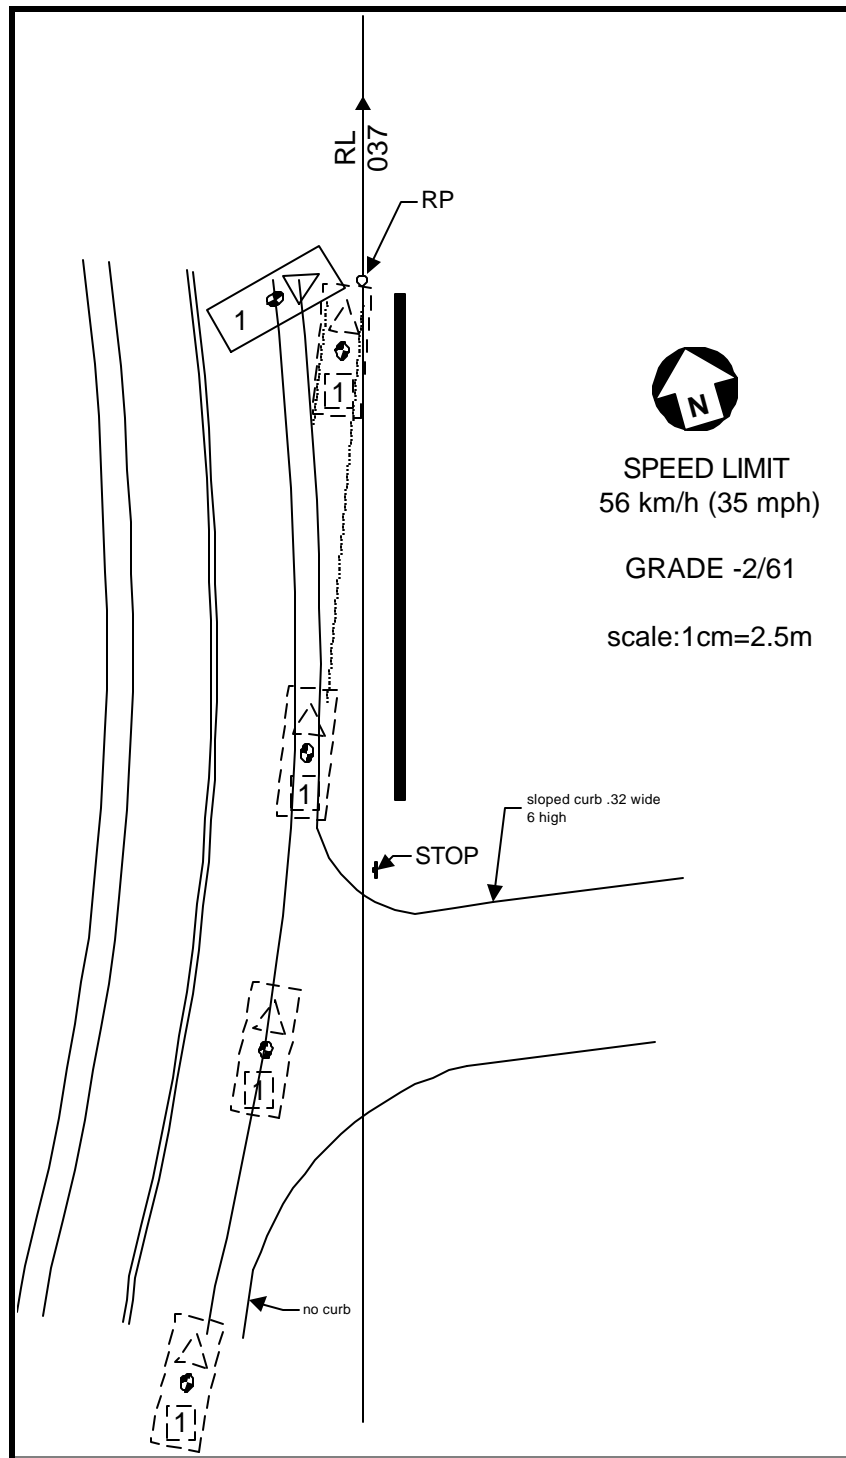
Figure 6. NASS Scene Diagram

This single vehicle crash occurred during the late evening hours of November, 1998. At the time of the crash, it was dark (street lighted) with no adverse conditions as the roads were dry. The crash occurred off the east pavement edge of a rural two lane north/south asphalt roadway (see **Figure 6 - page 5**) which curved left for northbound traffic. A hillcrest was documented just south of the crash site adjacent to an intersecting residential roadway. No traffic control was present at the scene which had a posted speed limit of 56 km/h (35 mph).
