**REDESIGNED AIR BAG SPECIAL STUDY (RABSS)
SCI TECHNICAL SUMMARY REPORT**

NASS RABSS CASE NO. 1998-09-801E

RABSS VEHICLE - 1998 FORD ESCORT LX

CRASH DATE - JULY, 1998

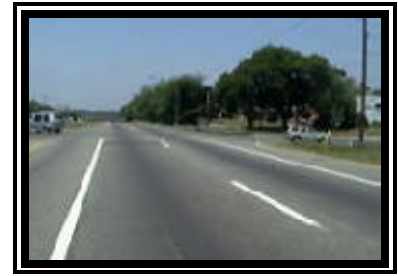
The 19 year old female driver of the 1998 Ford Escort LX was operating the vehicle northbound (**Figure 1**) and proceeding straight when she observed the Cadillac Deville turn left (east) across her lane of travel. Upon recognition of the impending harmful event, the driver steered right and braked {5.0 meters (16.4 ft) of pre-impact skid marks documented at the crash site} in avoidance remaining in the northbound travel lanes prior to the collision. The 1983 Cadillac Deville was driven by a 19 year old male who was operating the vehicle southbound when he approached the intersection and proceeded to turn left (east).

Figure 1. Northbound approach for the 1998 Ford Escort LX.

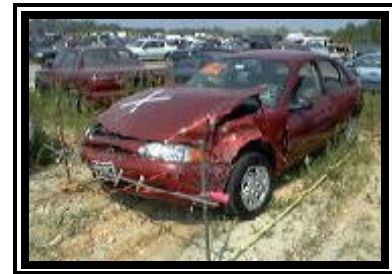
The Ford Escort sustained moderate frontal damage as a result of the impact with the Cadillac Deville (**Figure 3**). The direct contact damage began at the front left bumper corner and extended 12.0 cm (4.7 in) inboard. The impact deformed the full frontal width resulting in a combined direct and induced damage length (Field L) of 132.0 cm (52.0 in). Six (*revised*) crush measurements were documented at the level of the bumper: C1= 23.0 cm (9.1 in), C2= 2.0 cm (0.8 in), C3= 1.0 cm (0.4 in), C4= 0 cm, C5= 0 cm, C6= 0 cm.

Figure 3. Frontal damage to the 1998 Ford Escort LX.

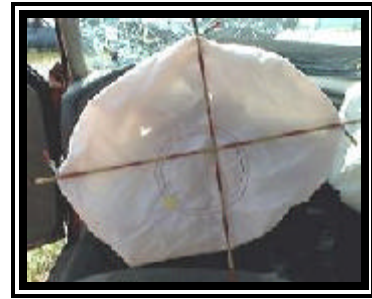
The 1998 Ford Escort LX was equipped with redesigned frontal air bags for the driver and front right passenger positions. The air bags had deployed as a result of the crash. The driver air bag was housed in the center of the steering wheel with a horizontally oriented flap tear seam (H-configuration). The upper flap measured 21.0 cm (8.3 in) in width and 8.0 cm (3.1 in) in height while the lower flap measured 21.0 cm (8.3 in) in width and 10.0 cm (3.9 in) in height. Although no contact evidence was identified on the exterior surface of the module cover flaps, blood spattering was identified at the lower left quadrant of the air bag. The NASS researcher measured the diameter of the driver air bag at 56.0 cm (22.0 in) in its deflated state (**Figure 4**). The bag was tethered by two internal straps and vented by two ports located at the 11 o'clock and 1 o'clock sectors on the rear aspect of the air bag.

Figure 4. 1998 Ford Escort LX redesigned driver air bag.

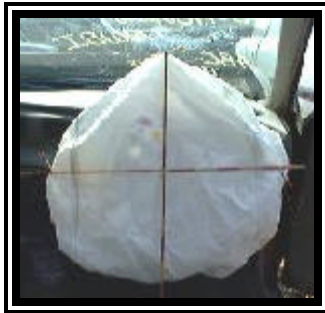
Figure 5. 1998 Ford Escort LX redesigned passenger air bag.

The front right passenger air bag deployed from a mid-mount module in the right instrument panel with a single cover flap design hinged at the top aspect. The cover flap opened in an upward direction toward the windshield (windshield fractured). The cover flap was rectangular in shape and measured 31.0 cm (12.2 in) in width and 19.0 cm (7.5 in) in height. Although no contact evidence was identified on the exterior surface of the module cover flap, a lipstick transfer was documented to the upper left quadrant of the air bag. The NASS researcher measured the passenger air bag at 44.0 cm (17.3 in) in width and 72.0 cm (28.3 in) in height in its deflated state (**Figure 5**). No tether straps were present. The bag was vented by two ports located below the 10 o'clock and 2 o'clock sectors on the side aspect of the air bag. No cutoff switch was reported for the front right air bag.

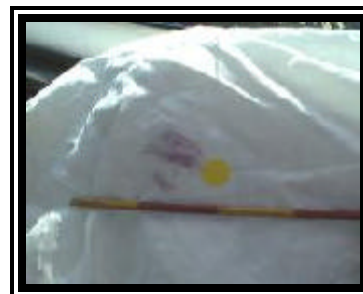
The 45 year old female passenger was seated in the front right position of the Ford Escort. She was properly restrained by the 3-point manual lap and shoulder belt system (anchorage adjustment placed to the full down position), seated in an upright posture with the seat back slightly reclined and the seat track adjusted to the mid-to-forward position. At impact, she initiated a forward trajectory in response to the 11 o'clock impact force and loaded the manual restraint resulting in contusions/abrasions to the right shoulder and left pelvis. Contact to the redesigned passenger air bag resulted in an abrasion to the face as evidenced by the lipstick transfer to the upper left quadrant of the air bag (**Figure 7**). Although no significant trauma

Figure 7. Lipstick transfers to the passenger air bag.

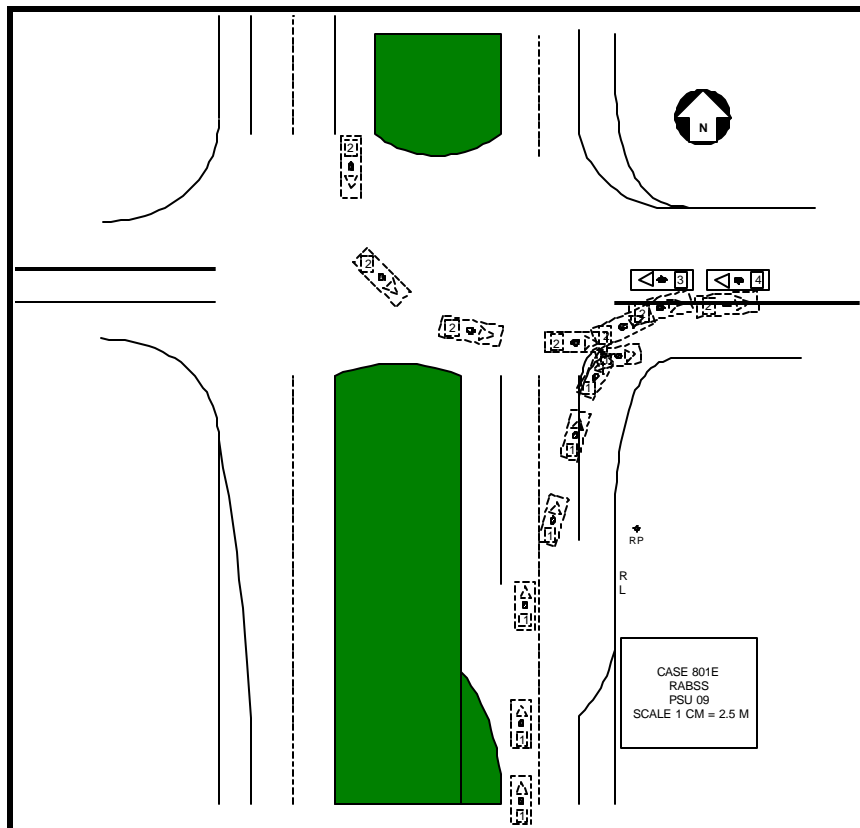
Figure 8. NASS Scene Diagram

This two-vehicle crash occurred during the early evening hours of July, 1998. At the time of the crash, it was daylight with no adverse conditions as the roads were dry. The crash occurred in the northbound lanes of an north/south multi-lane asphalt roadway (see **Figure 8 - page 7**) which is divided by a grass median. Traffic control at the scene included stop signs for east/westbound traffic. The speed limit at the crash scene was 56 km/h (35 mph).
