**REDESIGNED AIR BAG SPECIAL STUDY (RABSS)
SCI TECHNICAL SUMMARY REPORT**

NASS RABSS CASE NO. 1998-09-804E

RABSS VEHICLE - 1998 VOLKSWAGEN BEETLE

CRASH DATE - OCTOBER, 1998

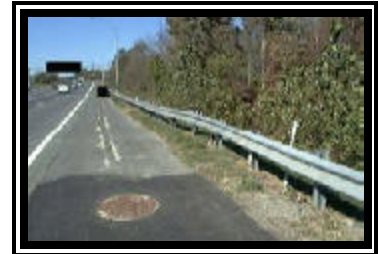
As the Volkswagen Beetle departed the right (east) pavement edge of the multi-lane highway, the front right area struck the guardrail (**Figure 1**) resulting in moderate damage. The impact induced deceleration was sufficient to deploy the Beetle's redesigned frontal air bag system. Although the impact was classified as a yielding object (out of scope), the damage algorithm of the WinSMASH program computed a (barrier equivalent) velocity change of 17.2 km/h (10.7 mph). The specific longitudinal component was -16.2 km/h (-10.1 mph). The Collision Deformation Classification (CDC) for this impact to the Beetle was 01-FREE-9. Engagement continued as the right side impacted the guardrail (with no separation of the contact damage) which resulted in moderate right side damage. The lateral displacement of the right door panel was sufficient to deploy the Beetle's side impact air bag system. The Beetle came to rest in close proximity to the point of impact facing north.

Figure 1. Guardrail impact area.

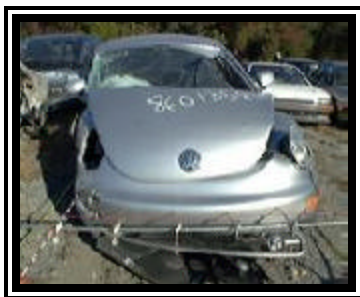
The Volkswagen Beetle sustained moderate frontal damage as a result of the impact with the guardrail (**Figure 2**). The direct contact damage began at the front right bumper corner and extended 15.0 cm (6.0 in) inboard. The impact deformed the full frontal width resulting in a combined direct and induced damage

length (Field L) of 135.0 cm (53.0 in). Six crush measurements were documented at the level of the bumper: C1 = 4.0 cm (1.6 in), C2 = 9.0 cm (3.5 in), C3 = 12.0 cm (4.7 in), C4 = 14.0 cm (5.5 in), C5 = 15.0 cm (5.9 in), C6 = 13.0 cm (5.1 in). Induced damage was noted to the hood which was displaced rearward from the impact force. The right front wheel/tire was deflated and restricted. Direct damage was noted to the right side of the vehicle which extended rearward to the B-pillar and shattered the side glazing (**Figure 3**). The windshield was fractured from exterior forces and the (interior) front right air bag module cover flap.

Figure 2. Frontal damage to the 1998 Volkswagen Beetle.

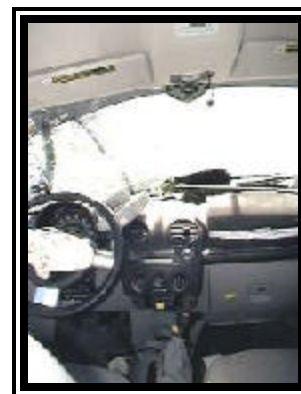
Interior damage to the Volkswagen Beetle identified through the NASS vehicle inspection was moderate and was attributed to occupant contact (**Figure 4**). No transfers or loading marks were noted to the available 3-point manual lap and shoulder belt systems. Blood spattering was documented on the right side of the redesigned driver air bag. No contacts were found on the passenger air bag or exterior surface of the driver or passenger air bag module cover flaps. Scuff marks were noted on the left and right door panels, left knee bolster (rigid plastic type) and glove compartment door. The transmission selector lever was displaced to the right. The radio and climate control components located at the center instrument panel were out of place. The windshield was fractured from the front right air bag module cover flap. The rearview mirror separated from the windshield (undamaged). No deformation was noted to the steering wheel rim which was placed to the full up position. The right instrument panel intruded rearward 5.0 cm (2.0 in) into the front right seating area. The right door panel intruded 3.0 cm (1.2 in) laterally into the front right seating position along with 5.0 cm (2.0 in) of lateral floorpan intrusion which deformed the seat back to a slightly forward position.

Figure 4. Interior view of the 1998 Volkswagen Beetle.

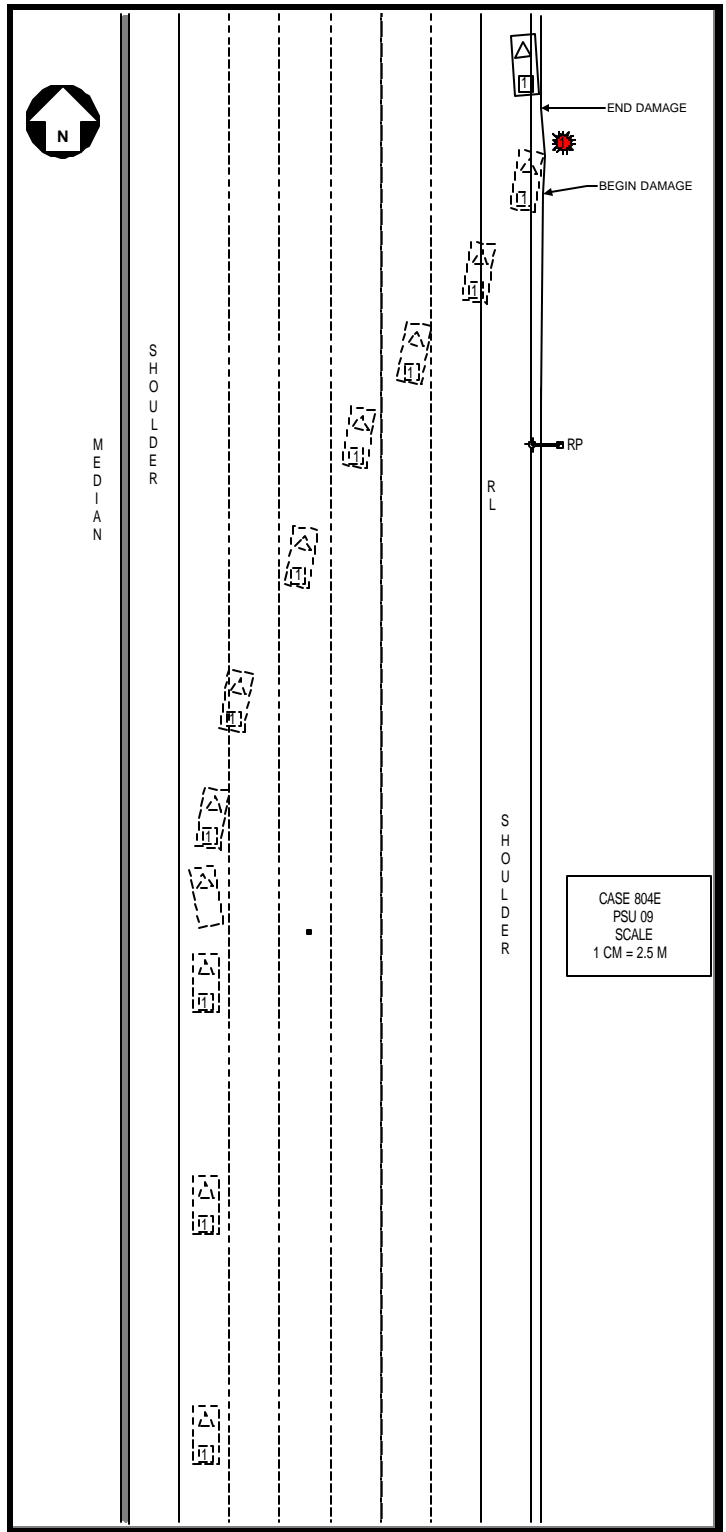
Figure 11. NASS Scene Diagram

This single vehicle crash occurred during the early morning hours of October, 1998. At the time of the crash, it was dark (street lighted) with rain conditions as the roads were wet. The crash occurred off the east pavement edge of the northbound six lane (asphalt) highway (see **Figure 11 - page 8**). The speed limit at the crash scene was 89 km/h (55 mph).
