**TRANSPORTATION SCIENCES
CRASH RESEARCH SECTION**

**REDESIGNED AIR BAG SPECIAL STUDY (RABSS)
SCI TECHNICAL SUMMARY REPORT**

NASS CDS CASE NO. 1998-11-197K

RABSS VEHICLE - 1998 DODGE STRATUS

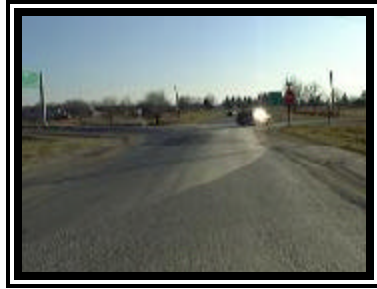
The 77 year old female driver of the 1994 Ford Tempo was operating the vehicle southbound (**Figure 1**) when she stopped at the stop sign and attempted to proceed straight through the 4-leg intersection. The 33 year old female driver of the 1998 Dodge Stratus was operating the vehicle westbound (**Figure 2**) at a

Figure 1. Southbound approach for the 1994 Ford Tempo GL.

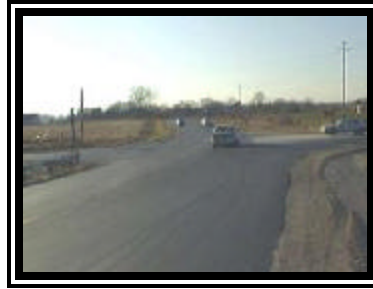
(driver reported) speed of 80 km/h (50 mph) when she observed the Ford cross her path of travel. The driver of the Dodge reported no avoidance maneuvers in anticipation of the impending crash.

Figure 2. Westbound approach for the 1998 Dodge Stratus.

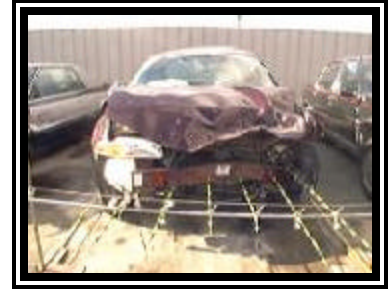
The 1998 Dodge Stratus sustained moderate frontal damage as a result of the impact with the Ford Tempo (**Figure 3**). The direct contact damage encompassed the entire frontal width resulting in a combined direct and induced damage length (Field L) of 108.0 cm (42.5 in). Six crush measurements were documented at the level of the reinforcement bar (*bumper fascia separation*): C1= 50.0 cm (19.7 in), C2= 48.0 cm (18.9 in), C3= 49.0 cm (19.3 in), C4= 33.0 cm (13.0 in), C5= 12.0 cm (4.7 in), C6= 0 cm. The Collision Deformation Classification (CDC) for this impact to the Dodge was 01-FDEW-3 with a principal direction of force of (+)20 degrees. The bumper assembly shifted approximately 12.0 cm (4.7 in) to the left (*entire end structure must shift to increment the principal direction of force*). White paint transfers were documented along the bumper fascia and hood. An indentation was noted to the center area of the bumper fascia attributed to the B-pillar on the Ford. The left fender was displaced rearward which restricted the left front wheel/tire (not deflated). The hood was displaced up and rearward from engagement against the side surface of the Ford. Reduction in the left side wheelbase measured 17.0 cm (6.7 in). A tear of the lamination which measured 48cm x 5cm was identified at the left windshield area.

Figure 3. Frontal damage to the 1998 Dodge Stratus .

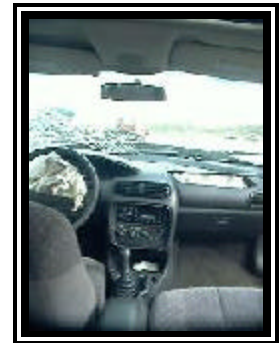
Damage to the interior surfaces of the Dodge Stratus were minimal and attributed to occupant contact (**Figure 4**). A spider-web fracture pattern was documented to the left mid-windshield area. Scuff marks were identified on the left A-pillar and knee bolster (rigid plastic type). No intrusions were found in the vehicle.

Figure 4. Interior view of the 1998 Dodge Stratus.

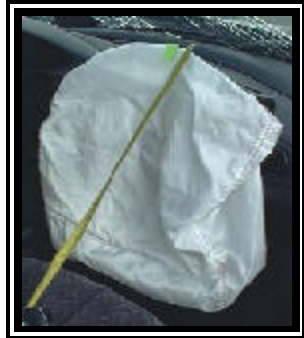
The 1998 Dodge Stratus was equipped with redesigned frontal air bags for the driver and front right passenger positions. The air bags had deployed as a result of the crash. The driver air bag was housed in the center of the steering wheel with a horizontally oriented flap tear seam (H-configuration). The flaps were nearly symmetrical in shape as the upper flap measured 21.0 cm (8.3 in) in width and 10.0 cm (3.9 in) in height while the lower flap measured 21.0 cm (8.3 in) in width and 7.0 cm (2.8 in) in height. Although no contact evidence was identified on the exterior surface of the module cover flaps, blue fabric transfers were documented on the lower left quadrant of the air bag face which measured 5.0 cm x 4.0 cm (2.0 in x 1.6 in). Multiple black vinyl transfers were also noted to the upper left quadrant of the air bag from expansion within the module. The NASS researcher measured the diameter of the driver air bag at 52.0 cm (20.5 in) in its deflated state (**Figure 5**). The bag was tethered by two internal straps and reportedly vented by one port located at the 12 o'clock sector on the rear aspect of the air bag.

Figure 5. 1998 Dodge Stratus redesigned driver air bag.

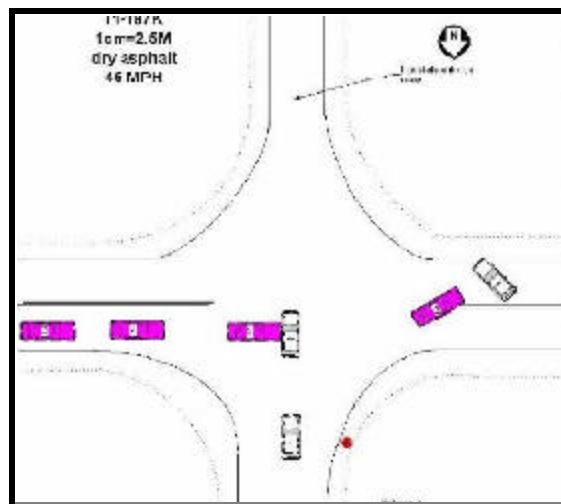
Figure 7. NASS Scene Diagram.

This two vehicle crash occurred during the morning hours of October, 1998. At the time of the crash, it was daylight with no adverse conditions as the roads were dry. The crash occurred in the westbound lane of a level/asphalt 4-leg intersection (see **Figure 7 - page 6**) which curved left for westbound traffic. The southern leg of the intersection was designated as an interstate entrance ramp with southbound traffic controlled by a stop sign. The posted speed limit at the crash site was 72 km/h (45 mph).
