**REDESIGNED AIR BAG SPECIAL STUDY (RABSS)
SCI TECHNICAL SUMMARY REPORT**

NASS RABSS CASE NO. 1998-11-812E

RABSS VEHICLE - 1998 SATURN SC1

CRASH DATE - OCTOBER, 1998

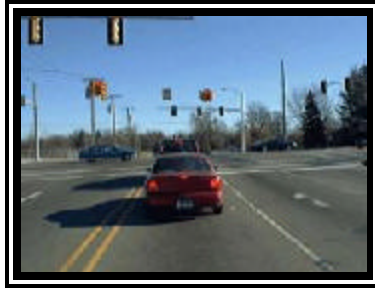
Figure 1. Eastbound approach for the 1995 Oldsmobile Achieva.

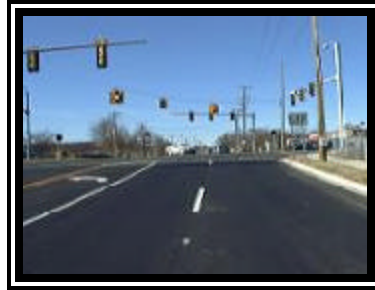
Figure 2. Westbound approach for the 1998 Saturn SC1.

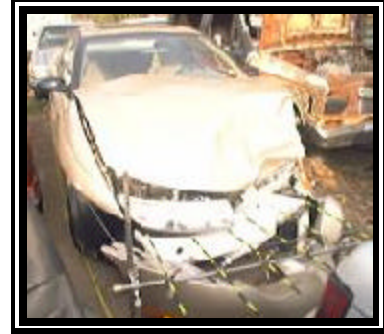
The 1998 Saturn SC1 2-door coupe sustained moderate frontal damage as a result of the impact with the Oldsmobile Achieva (**Figure 3**). The direct contact damage began at the front left bumper corner and extended 63.0 cm (24.8 in) inboard. The impact deformed the full frontal width resulting in a combined direct and induced damage length (Field L) of 101.0 cm (39.8 in). Six crush measurements were documented at the level of the reinforcement bar (*bumper fascia separation*): C1= 16.0 cm (6.3 in), C2= 37.0 cm (14.6 in), C3= 28.0 cm (11.0 in), C4= 19.0 cm (7.5 in), C5= 8.0 cm (3.1 in), C6= 0 cm. The (*revised*) Collision Deformation Classification (CDC) for this impact to the Saturn was 12-FYEW-2 with a principal direction of force of (-)10 degrees. The left fender/hood area was displaced rearward from the impact force. Reduction in the left side wheelbase measured 8.0 cm (3.1 in). All glazing remained intact.

Figure 3. Frontal damage to the 1998 Saturn SC1 2-door coupe.

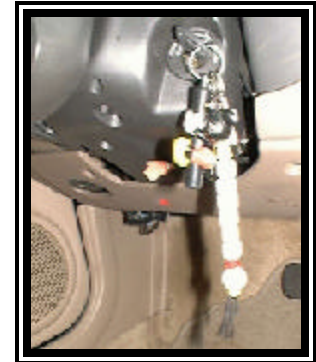
Damage to the interior surfaces of the Saturn SC1 were minimal and attributed to occupant contact (**Figure 4**). Scuff marks were identified on the left side of the knee bolster (rigid plastic type) and right side of the steering column. No intrusions were found in the vehicle.

Figure 4. Scuff marks to the knee bolster and steering column.

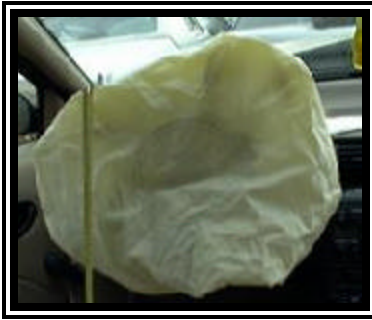
The 1998 Saturn SC1 was equipped with redesigned frontal air bags for the driver and front right passenger positions. The air bags deployed as a result of the crash. The driver air bag was housed in the center of the steering wheel with a vertically oriented flap tear seam (I-configuration). The flaps were symmetrical in shape and measured 13.5 cm (5.3 in) in width and 12.0 cm (4.7 in) in height. Although no contact evidence was identified on the exterior surface of the module cover flaps, small puncture holes measuring approximately 0.5 cm (0.2 in) in diameter were documented to the upper left quadrant of the air bag attributed to the driver's braces. Black vinyl transfers were noted to the right upper quadrant from expansion within the module. The NASS researcher measured the diameter of the driver air bag at 43.0 cm (16.9 in) in its deflated state (**Figure 5**). The bag was tethered by two internal straps and vented by two ports located at the 11 o'clock and 1 o'clock sectors on the rear aspect of the air bag.

Figure 5. 1998 Saturn SC1 redesigned driver air bag.

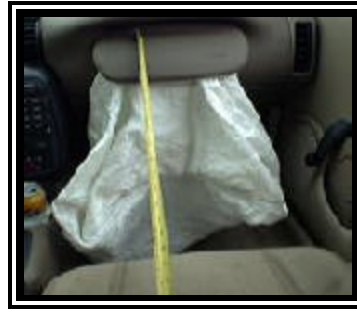
The front right passenger air bag deployed from the right mid-instrument panel area with a single cover flap design hinged at the top aspect. No contact evidence was identified on the air bag or exterior surface of the module cover flap. The cover flap was oval shaped and measured 30.5 cm (12.0 in) in width and 12.0 cm (4.7 in) in height. The NASS researcher measured the passenger air bag at 66.0 cm (26.0 in) in width and 47.0 cm (18.5 in) in height in its deflated state (**Figure 6**). The bag was tethered by two internal straps. No vent ports or cutoff switch were reported for the front right passenger air bag.

Figure 6. 1998 Saturn SC1 redesigned passenger air bag.

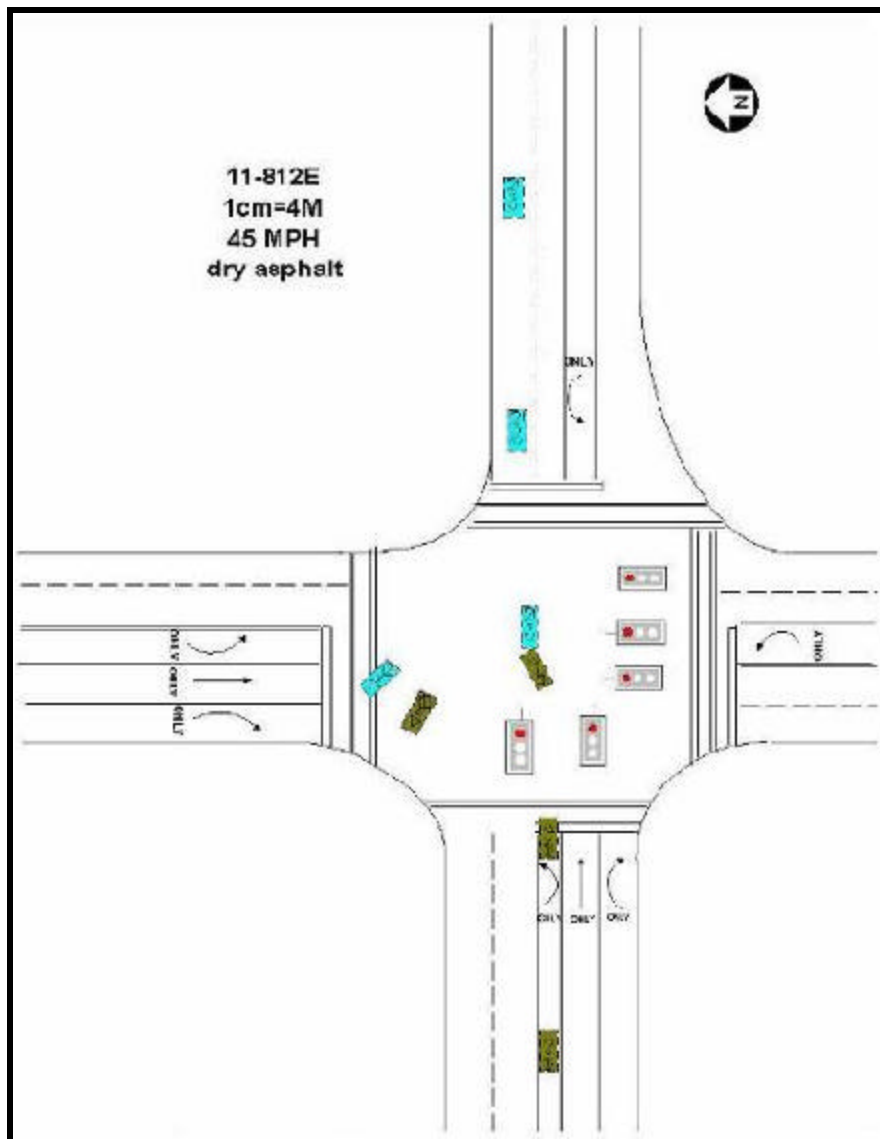
This two vehicle crash occurred during the evening hours of October, 1998. At the time of the crash, it was dark (street lighted) with no adverse conditions as the roads were dry. The crash occurred in a multi-lane straight (asphalt) 4-leg intersection which was controlled by an overhead signal system (see **Figure 7 - page 5**). The posted speed limit at the crash site was 72 km/h (45 mph).

Figure 7. NASS Scene Diagram (physical plant and vehicle numbering incorrectly plotted by researcher).
