**REDESIGNED AIR BAG SPECIAL STUDY (RABSS)  
SCI TECHNICAL SUMMARY REPORT**

**NASS RABSS CASE NO. 1998-12-802E**

**RABSS VEHICLE - 1998 DODGE RAM PICKUP TRUCK**

**CRASH DATE - AUGUST, 1998**

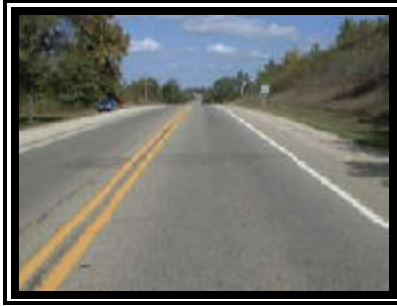
The 21 year old male driver of the 1996 Chevrolet S-10 was en route home and operating the vehicle northbound (**Figure 1**) when he reportedly "became lost" and allowed the vehicle to cross the centerline into the southbound lane. Upon recognition of the southbound Dodge, the driver steered right (back) towards the northbound lane. The 23 year old male driver of the 1998 Dodge Ram was operating the vehicle southbound (**Figure 2**) when he crested the hill and observed "headlights" (northbound Chevrolet) in his lane of travel. The driver steered left towards the northbound lane in anticipation of the impending crash.

**Figure 1. Northbound approach for the 1996 Chevrolet S-10 pickup truck.**

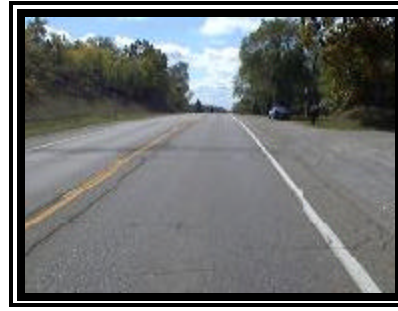
**Figure 2. Southbound approach for the 1998 Dodge Ram pickup truck.**

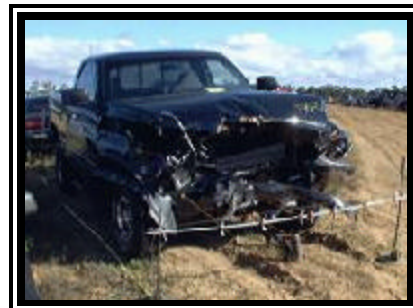
The 1998 Dodge Ram pickup truck sustained severe frontal damage as a result of the impact with the Chevrolet pickup (**Figure 3**). The direct contact damage encompassed the full frontal width resulting in a combined direct and induced damage length (Field L) of 159.0 cm (62.6 in). Six crush measurements were

documented at the level of the bumper: C1= 47.0 cm (18.5 in), C2= 60.0 cm (23.6 in), C3= 66.0 cm (26.0 in), C4= 70.0 cm (27.6 in), C5= 48.0 cm (18.9 in), C6= 36.0 cm (14.2 in). The Collision Deformation Classification (CDC) for this impact to the Dodge was 01-FDEW-3 with a principal direction of force of (+)20 degrees. The grille and headlight assemblies fractured and separated from the vehicle during the collision sequence. The hood was displaced up and rearward from the impact force. Both fenders were deformed rearward which restricted the front wheels/tires (not deflated). Induced left side bed/cab contact was noted along with buckling to the roof area at the left B-pillar. Reduction in the left side wheelbase measured 23.0 cm (9.1 in) while the right wheelbase was elongated 5.0 cm (2.0 in). All glazing remained undamaged.

**Figure 3. Frontal damage to the 1998 Dodge Ram pickup truck.**

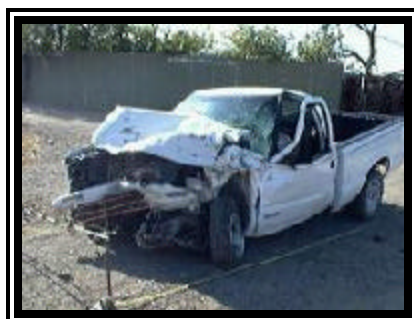
**Figure 4. Frontal damage to the 1996 Chevrolet S-10 pickup truck.**

The 1996 Chevrolet S-10 pickup truck sustained severe frontal damage as a result of the impact with the Dodge Ram (**Figure 4**). The direct contact damage encompassed the full frontal width resulting in a combined direct and induced damage length (Field L) of 104.0 cm (40.9 in). A maximum crush value of 90.0 cm (35.4 in) was documented at the front left bumper corner area. The CDC for this impact to the Chevrolet was 11-FDEW-4 with a principal direction of force of (-)20 degrees. The hood was displaced up and rearward from the impact force. The left fender was deformed rearward which restricted/deflated the left front wheel/tire. Induced left side bed/cab contact was noted along with buckling to the roof area

at the left A and B-pillars. Reduction in the left side wheelbase measured 28.0 cm (11.0 in) while the right wheelbase was elongated 11.0 cm (4.3 in). The windshield was fractured from (exterior) impact forces and (interior) occupant contact.

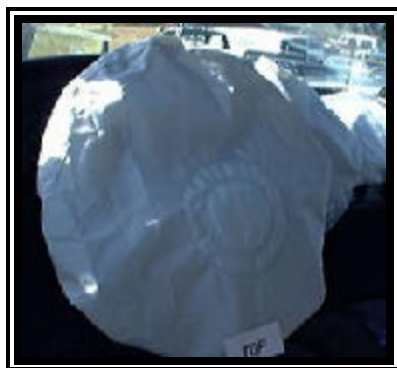
The 1998 Dodge Ram was equipped with redesigned frontal air bags for the driver and front right passenger positions. The air bags had deployed as a result of the crash. The driver air bag was housed in the center of the steering wheel with a horizontally oriented flap tear seam (H-configuration). No contact evidence was identified on the air bag or exterior surface of the module cover flaps. The flaps were asymmetrical in shape as the upper flap measured 14.0 cm (5.5 in) in width and 10.0 cm (3.9 in) in height while the lower flap

measured 14.0 cm (5.5 in) in width and 3.0 cm (1.2 in) in height. The NASS researcher measured the diameter of the driver air bag at 62.0 cm (24.4 in) in its deflated state (**Figure 5**). The bag was tethered by four internal straps and vented by one port located at the 12 o'clock sector on the rear aspect of the air bag.

**Figure 5. 1998 Dodge Ram redesigned driver air bag.**

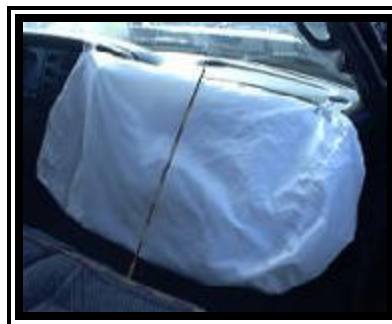
The front right passenger air bag deployed from the right mid-instrument panel area with a single cover flap design hinged at the forward aspect. No contact evidence was identified on the air bag or exterior surface of the module cover flap. The cover flap was rectangular in shape and measured 29.0 cm (11.4 in) in width and 20.0 cm (7.9 in) in height. The NASS researcher measured the passenger air bag at 92.0 cm (36.2 in) in width and 61.0 cm (24.0 in) in height in its deflated state (**Figure 6**). No vent ports or internal tether straps were present. A cutoff switch was found on the center mid-instrument panel area and was set to the “on” position.

**Figure 6. 1998 Dodge Ram redesigned passenger air bag.**

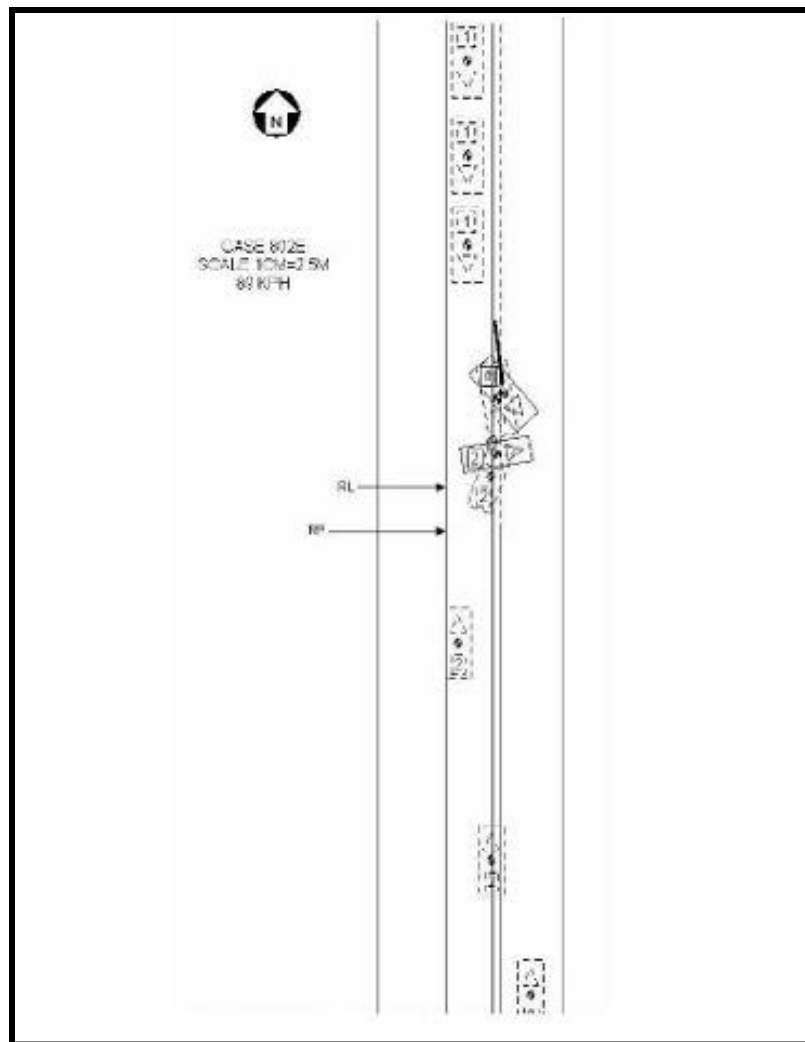
Figure 7. NASS Scene Diagram.

This two vehicle crash occurred during the early morning hours of August, 1998. At the time of the crash, it was dark (street not lighted) with no adverse conditions as the roads were dry. The crash occurred along the centerline of a straight two lane north/south asphalt roadway (see **Figure 7 - page 5**) with a hillcrest just north of the crash site. No traffic control was present at the scene which had a posted speed limit of 89 km/h (55 mph).
