SCI/NASS COMBINATION CASE REPORT

CASE NUMBER - NASS-98-41-099A

LOCATION - Florida

VEHICLE - 1998 DODGE STRATUS ES

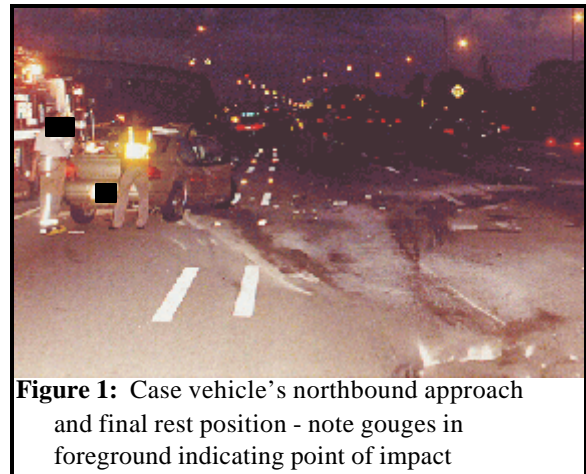
The case vehicle (vehicle #2) was traveling north in the fourth northbound lane of a five-lane roadway that was part of a divided urban interstate highway. Vehicle #3 was also traveling north, in the third northbound lane of the same roadway. Vehicle #1 was traveling south in the fourth northbound lane. It was dark with no street lights, the weather was clear and there were no roadway defects. The speed limit was 105 km.p.h. [65 m.p.h.]. The crash occurred in the fourth northbound lane. It is not known if the case vehicle driver attempted any avoidance actions, but there are no brake skids cited in the police report and none are visible in the police on-scene photographs. Gouge marks at the initial point of impact are parallel to the lane lines, indicating no steering maneuvers (**Figure 1**). The front right area of the case vehicle impacted the front right of vehicle #1, causing the case vehicle's driver and front right passenger air bags to deploy. Vehicle #1 was also equipped with front air bags and the driver and front right passenger air bags deployed. The case vehicle rotated a few degrees clockwise and slid to rest heading north-northeast, straddling the fourth and fifth lanes. Vehicle #1 was pushed backwards and sideways into the third lane and the front right area of vehicle #3 impacted the right front of vehicle #1. Vehicle #1 rotated approximately 90 degrees counterclockwise and came to rest headed east, straddling the first and second lanes. Vehicle #3 rotated a few degrees counterclockwise and slid to rest heading north-northwest, straddling the fourth and fifth lanes (**Figure 2**). The crash severity for the case vehicle was high (greater than 40 km.p.h [25 m.p.h.]).

Figure 1: Case vehicle's northbound approach and final rest position - note gouges in foreground indicating point of impact

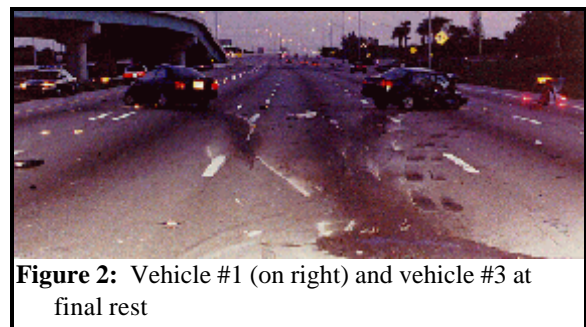
Figure 2: Vehicle #1 (on right) and vehicle #3 at final rest

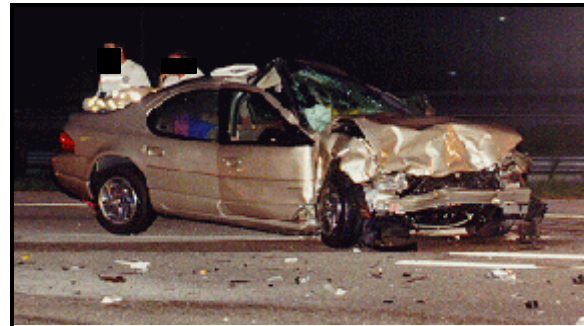
The case vehicle sustained direct contact damage across the right half of the front (**Figure 3**). The bumper cover was torn off, the grille and headlights were shattered, the hood was folded and crushed down along the front edge and the windshield was fractured across the entire width. The right front wheel was forced rearward against the right A-pillar, resulting in the right A-pillar being displaced rearward, causing the right side of the roof to buckle upward and the right front door to buckle outward. The left side profile of the passenger area was essentially unchanged, with no movement of the left A-pillar, roof rail or door sill. The left front door remained closed and operational. The CDC for the case vehicle, estimated from police photographs, is **12-FZEW-5**. Delta V was estimated using the case vehicle's CDC with the other vehicle treated as missing (because vehicle #1 sustained two impacts in the same area and a CDC could not be estimated; see discussion of vehicle #1, below). These ROLDMIS CDC-only results provide a borderline reconstruction, but the results appear reasonable. The estimated total, longitudinal and lateral delta Vs are, respectively, 63.0 km.p.h. [39.1 m.p.h.], -63.0 km.p.h. [-39.1 m.p.h.] and 0.0 km.p.h.

Figure 3: Case vehicle's front contact damage and induced damage on right side

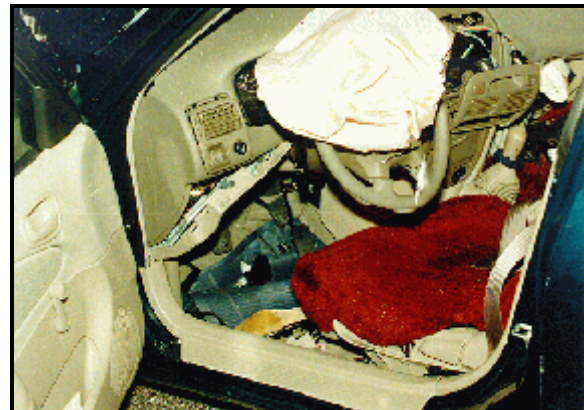
There was heavy intrusion into the front right area, extending into the center. The driver's seat area sustained only modest intrusion, primarily as a result of the movement by the instrument panel on the right side but also including intrusion on the right side of the toe pan in the driver's foot well and displacement of the clutch, brake and accelerator pedals (**Figure 4**). The steering wheel is not fully visible in the available photographs, but the rim sustained major deformation and was jammed against the intruded instrument panel to the right of the driver's seat area.

Figure 4: Case vehicle's driver seat area - note undeformed door opening and minor intrusion in foot well

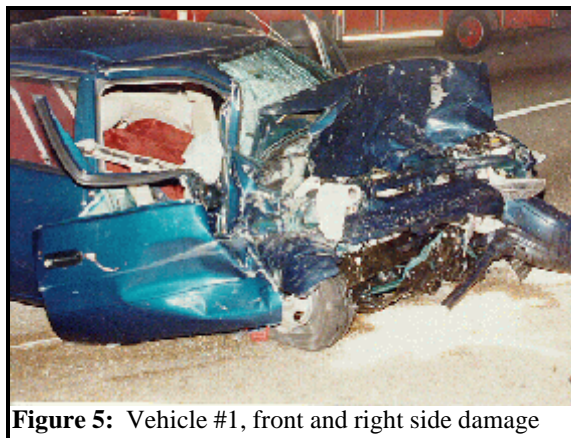
Figure 5: Vehicle #1, front and right side damage

Vehicle #1 sustained direct contact damage across the right two-thirds of the front, with the right front wheel pushed rearward into the right A-pillar, causing the A-pillar to be displaced rearward resulting in extensive intrusion into the right side of the front seat row (**Figure 5**). The left side of the passenger cabin was essentially undamaged, with no disturbance of the left A-pillar, roof rail or door sill (**Figure 6**). Vehicle #1's driver (34-year-old female, height and weight unknown) sustained police-reported incapacitating injuries. There was no other occupant in vehicle #1.

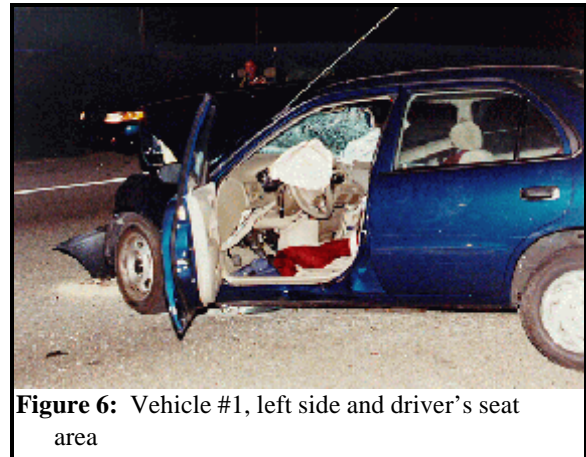
Figure 6: Vehicle #1, left side and driver's seat area
