**REDESIGNED AIR BAG SPECIAL STUDY (RABSS)
SCI TECHNICAL SUMMARY REPORT**

NASS CDS CASE NO. 1998-43-184E

RABSS VEHICLE - 1998 FORD EXPLORER XL

CRASH DATE - JULY, 1998

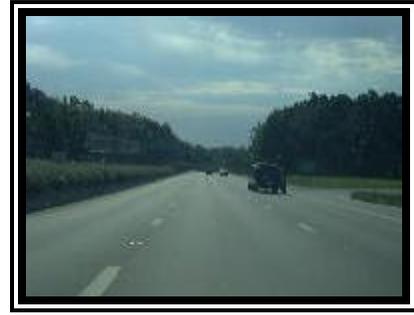
Figure 1. Westbound approach view of the crash site.

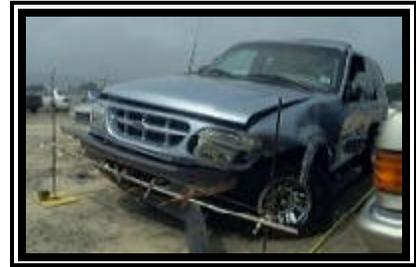
The 1998 Ford Explorer XL sustained minor left side surface damage as a result of the initial impact with the Lincoln (**Figure 2**). The direct contact damage began 90.0 cm (35.4 in) aft of the left rear axle and extended 309.0 cm (121.7 in) forward. Six crush measurements were documented at the level of the mid-door: C1= 2.0 cm (1.6 in), C2= 1.0 cm (4.7 in), C3= 4.0 cm (7.1 in), C4= 8.0 cm (8.7 in), C5= 3.0 cm (9.4 in), C6= 0 cm.

The (*SCI revised*) Collision Deformation Classification (CDC) for this initial impact to the Ford was 09-LDEW-1 with a principal direction of force of (-)90 degrees.

Direct contact damage was also identified at the front left area attributed to the secondary (concrete barrier) impact. The direct contact damage began at the front left bumper corner and extended 45.0 cm (17.7 in) inboard. The impact deformed the full frontal width resulting in a combined direct and induced damage length (Field L) of 128.0 cm (50.4 in). Six crush measurements were documented at the level of the bumper: C1= 28.0 cm (11.0 in), C2= 6.0 cm (2.4 in), C3= 3.0 cm (1.2 in), C4= 1.0 cm (0.4 in), C5= 0 cm, C6= 0 cm. The Collision Deformation Classification (CDC) for this second and final impact to the Ford was 12-FLEW-2 with a principal direction of force of (-)10 degrees. The left headlight assembly fractured and partially separated from the vehicle during the collision sequence. The left fender was displaced rearward and to the right which restricted/deflated the left front wheel/tire and jammed the left door. All glazing remained intact.

Figure 2. Frontal and left side surface damage to the 1998 Ford Explorer XL.

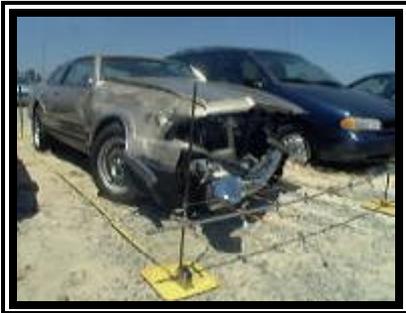
Figure 3. Frontal and right side surface damage to the 1989 Lincoln Mark VII.

The 1989 Lincoln Mark VII 2-door coupe sustained minor right side surface damage as a result of the initial impact with the Ford Explorer (**Figure 3**). The direct contact damage began 25.0 cm (9.8 in) forward of the right rear axle and extended 342.0 cm (134.6 in) forward. A maximum crush value of 4.0 cm (1.6 in) was identified just forward of the right front axle. The CDC for this initial impact to the Lincoln was 03-RYEW-1 with a principal direction of force of (+)90 degrees. Direct contact damage was also documented to the front left area attributed to the secondary (concrete barrier) impact. The direct contact damage began at the front left bumper corner and extended 75.0 cm (29.5 in) inboard.

The impact deformed the full frontal width resulting in a combined direct and induced damage length (Field L) of 121.0 cm (47.6 in). A maximum crush value of 44.0 cm (17.3 in) was identified at the front left bumper corner area. The (*SCI revised*) CDC for this second and final impact to the Lincoln was 11-FYEW-2 with a principal direction of force of (-)20 degrees. The grille and headlight assemblies fractured and separated from the vehicle during the collision sequence. The left fender was deformed rearward which deflated the left front wheel/tire (not restricted).

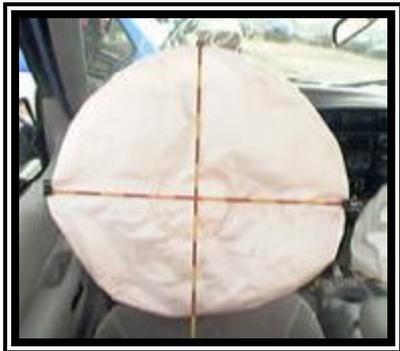
The 1998 Ford Explorer XL was equipped with redesigned frontal air bags for the driver and front right passenger positions. The air bags had deployed as a result of the concrete barrier impact. The driver air bag was housed in the center of the steering wheel with a horizontally oriented flap tear seam (H-configuration). The flaps were asymmetrical in shape as the upper flap measured 25.0 cm (9.8 in) in width along the top portion, 17.0 cm (6.7 in) in width along the lower portion and 10.0 cm (3.9 in) in height while the lower flap measured 17.0 cm (6.7 in) in width and 5.0 cm (2.0 in) in height. Although no contact evidence was identified on the exterior surface of the module cover flaps, makeup transfers were documented along the center of the air bag face. The NASS researcher measured the diameter of the driver air bag at 60.0 cm (23.6 in) in its deflated state (**Figure 4**). The bag was tethered by two internal straps and vented by two ports located at the 11 o'clock and 1 o'clock sectors on the rear aspect of the air bag.

Figure 4. 1998 Ford Explorer XL redesigned driver air bag.

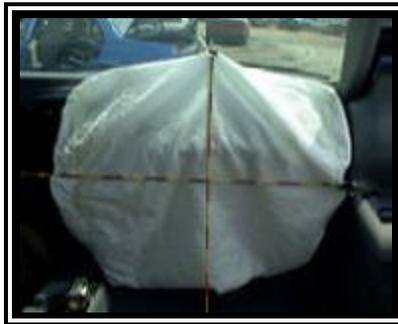
The front right passenger air bag deployed from the right mid-instrument panel area with a single cover flap design hinged at the top aspect. No contact evidence was identified on the air bag or exterior surface of the module cover flap. The cover flap was rectangular in shape and measured 37.0 cm (14.6 in) in width and 17.0 cm (6.7 in) in height. The NASS researcher measured the passenger air bag at 66.0 cm (26.0 in) in width and 50.0 cm (19.7 in) in height in its deflated state (**Figure 5**). No internal tether straps were present. The bag was vented by two ports located at the 9 o'clock and 3 o'clock sectors on the side aspect of the air bag. No cutoff switch was found for the front right air bag.

Figure 5. 1998 Ford Explorer redesigned passenger air bag.

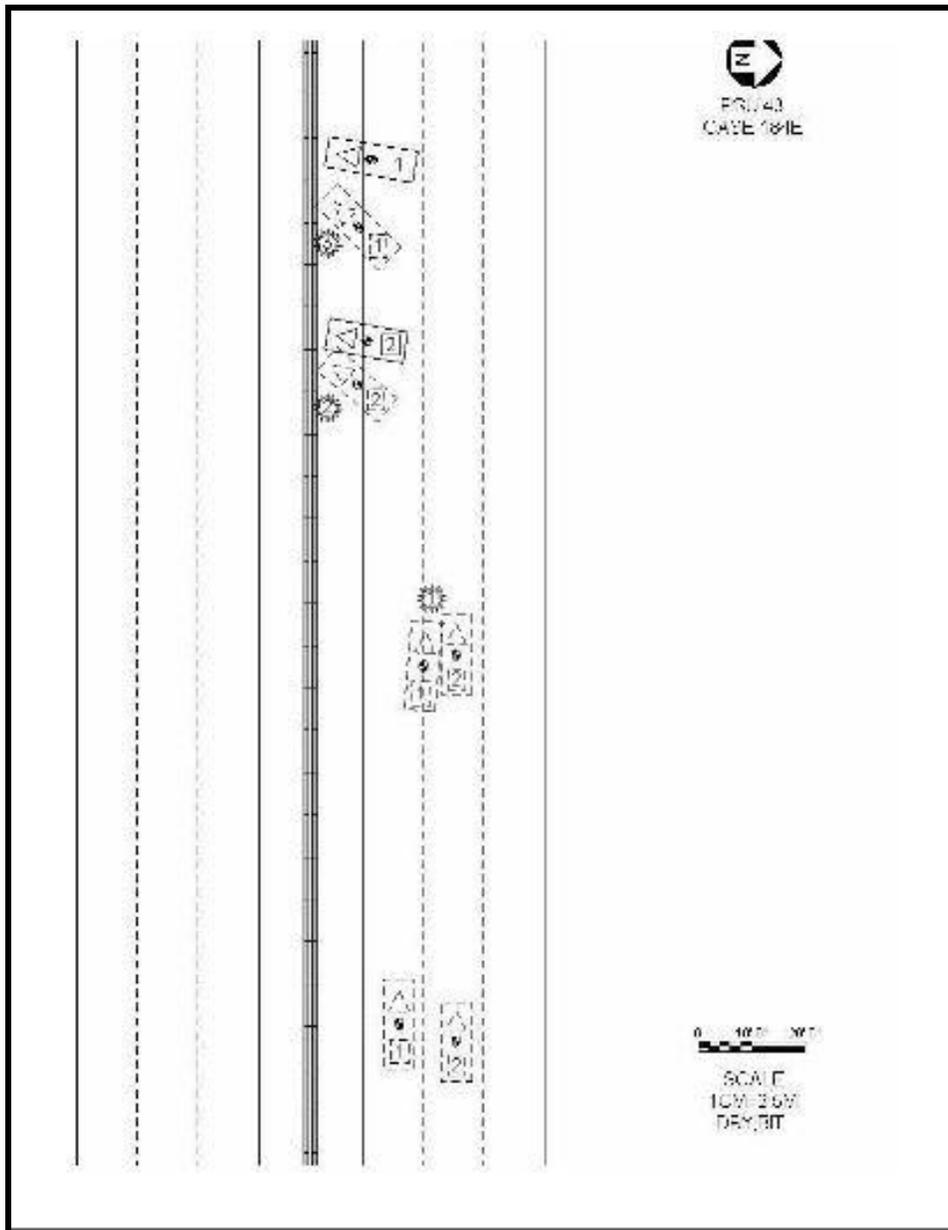
Figure 6. NASS Scene Diagram.

This two vehicle crash occurred during the evening hours of July, 1998. At the time of the crash, it was dark (street not lighted) with no adverse conditions as the roads were dry. The crash occurred in the westbound lanes of a straight and level 6-lane highway (see **Figure 6 - page 6**) which was divided by a raised concrete (jersey) barrier. The asphalt roadway was bordered by wide paved shoulders with on/off-ramp junctions just east of the crash site. No traffic control was present at the scene which had a posted speed limit of 97 km/h (60 mph).
