**REDESIGNED AIR BAG SPECIAL STUDY (RABSS)
SCI TECHNICAL SUMMARY REPORT**

NASS RABSS CASE NO. 1998-43-803E

RABSS VEHICLE - 1998 CHEVROLET SUBURBAN

CRASH DATE - JULY, 1998

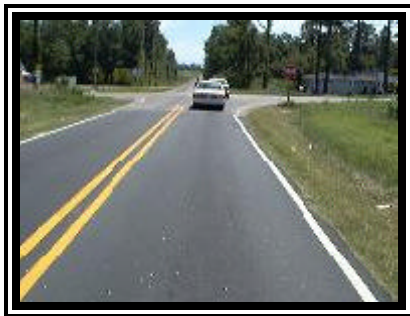
The 21 year old female driver of the 1998 Chevrolet Suburban was operating the vehicle southbound (**Figure 1**) on an approach to the 4-leg intersection when she stopped at the stop sign and proceeded straight at a (driver reported) speed of 8 km/h (5 mph). The driver reported no avoidance maneuvers in anticipation of the impending crash. The 41 year old male driver of the 1997 Dodge Ram pickup was operating the vehicle eastbound (**Figure 2**) at a (police reported) speed of 64 km/h (40 mph) when he entered the intersection and observed the southbound Chevrolet cross his path of travel. The NASS researcher reported no skid marks at the scene indicative of driver avoidance maneuvers.

Figure 1. Southbound approach for the 1998 Chevrolet Suburban.

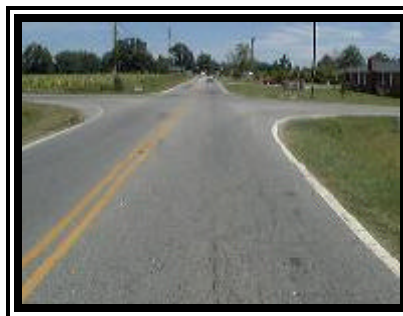
Figure 2. Eastbound approach for the 1997 Dodge Ram pickup truck.

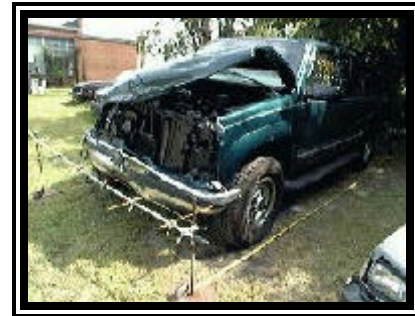
The 1998 Chevrolet Suburban sustained moderate frontal damage as a result of the impact with the Dodge Ram pickup (**Figure 3**). The direct contact damage began at the front right bumper corner and extended 144.0 cm (56.7 in) inboard. The impact deformed the full frontal width resulting in a combined direct and induced damage length (Field L) of 176.0 cm (69.3 in). Six crush measurements were documented at the level of the bumper: C1= 20.0 cm (7.9 in), C2= 16.0 cm (6.3 in), C3= 19.0 cm (7.5 in), C4= 21.0 cm (8.3 in), C5= 21.0 cm (8.3 in), C6= 30.0 cm (11.8 in). The Collision Deformation Classification (CDC) for this impact to the Chevrolet was 81-FDEW-2 with a principal direction of force of (+)30 degrees (principal direction of force incremented to reflect shifting of end structure to the left). The grille and headlight assemblies fractured and separated from the vehicle during the collision sequence. The hood was deformed up and rearward from engagement against the side surface of the Dodge. No reduction in the vehicle's wheelbase was sustained. The windshield was fractured by exterior impact forces while all tempered glazing remained undamaged.

Figure 3. Frontal damage to the 1998 Chevrolet Suburban.

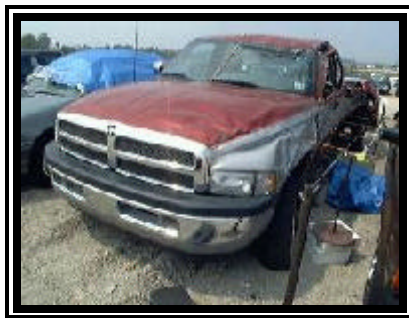
Figure 4. Top and left side surface damage to the 1997 Dodge Ram pickup truck.

The 1997 Dodge Ram pickup sustained moderate left side surface damage as a result of the impact with the Chevrolet Suburban (**Figure 4**). The direct contact damage began 42.0 cm (16.5 in) forward of the left rear axle and extended 356.0 cm (140.2 in) forward. A maximum crush value of 23.0 cm (9.1 in) was identified just forward of the B-pillar. The CDC for this initial impact to the Dodge was 10-LDEW-2 with a principal direction of force of (-)60 degrees. Additional contact damage was documented to the top surface attributed to the rollover impact. The CDC for this second and final impact to the Dodge was 00-TDDO-2. A maximum crush value of 5.0 cm (2.0 in) was identified along the left windshield header area. Mud deposits were noted in the right side wheels as all four tires were deflated (not restricted). The windshield was fractured as the left door window glazing was disintegrated by exterior impact forces (only).

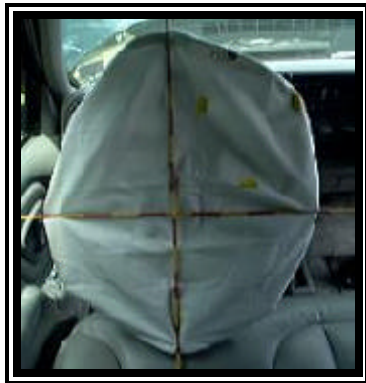
The 1998 Chevrolet Suburban was equipped with redesigned frontal air bags for the driver and front right passenger positions. The air bags had deployed as a result of the crash. The driver air bag was housed in the center of the steering wheel with a vertically oriented flap tear seam (I-configuration). The flaps were symmetrical in shape and measured 7.0 cm (2.8 in) in width and 11.0 cm (4.3 in) in height. Although no contact evidence was identified on the exterior surface of the module cover flaps, skin oil and makeup transfers were documented to the upper right quadrant of the air bag face (**Figure 6**). Multiple black vinyl transfers were also found on the rear aspect of the air bag from expansion within the module. The NASS researcher measured the diameter of the driver air bag at 58.0 cm (22.8 in) in its deflated state (**Figure 5**). The bag was tethered by two internal straps and vented by two ports located at the 11 o'clock and 1 o'clock sectors on the rear aspect of the air bag.

Figure 5. 1998 Chevrolet Suburban redesigned driver air bag.

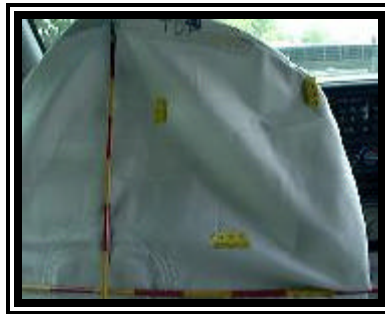
Figure 6. Skin oil and makeup transfers to the driver air bag.

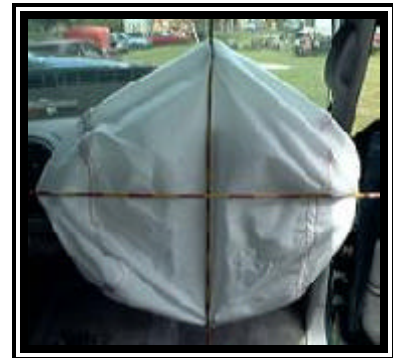
The front right passenger air bag deployed from the right mid-instrument panel area with a horizontally oriented flap tear seam (H-configuration). No contact evidence was identified on the air bag or exterior surface of the module cover flap. The cover flaps were nearly symmetrical in shape as the upper flap measured 32.5 cm (12.8 in) in width and 7.0 cm (2.8 in) in height while the lower flap measured 32.5 cm (12.8 in) in width and 6.0 cm (2.4 in) in height. The NASS researcher measured the passenger air bag at 54.0 cm (21.3 in) in width and 65.0 cm (25.6 in) in height in its deflated state (**Figure 7**). The bag was tethered by two internal straps and vented by two ports located at the 10 o'clock and 2 o'clock sectors on the rear aspect of the air bag. No cutoff switch was found for the front right air bag.

Figure 7. 1998 Chevrolet Suburban redesigned passenger air bag.

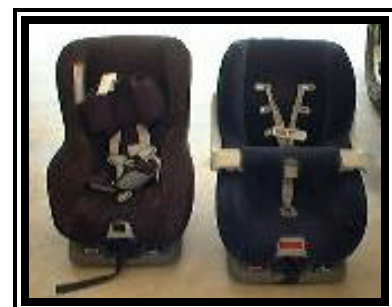
The rear center seating position was occupied by a 5 month old male. He was restrained by the available 2-point manual lap belt system used in conjunction with a Century Smart Move XT child safety seat (**Figure 8**) equipped with a 5-point restraint harness. Although uninjured in the collision, the infant passenger was taken later to a private physician for evaluation.

Figure 8. Century Smart Move XT child safety seats.

The rear right seating position was occupied by an 18 month old female. She was restrained by the available 3-point manual lap and shoulder belt system used in conjunction with a Century Smart Move XT child safety seat (**Figure 8**)
