**REDESIGNED AIR BAG SPECIAL STUDY (RABSS)  
SCI TECHNICAL SUMMARY REPORT**

**NASS RABSS CASE NO. 1998-43-806E**

**RABSS VEHICLE - 1998 FORD TAURUS SE**

**CRASH DATE - SEPTEMBER, 1998**

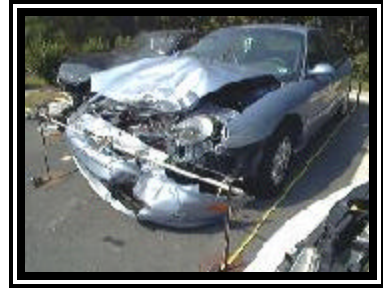
The 1998 Ford Taurus SE sustained moderate frontal damage as a result of the impact with the motorcycle (**Figures 3 & 4**). The direct contact damage began at the front left bumper corner and extended 78.6 cm (30.9 in) inboard. The impact deformed the full frontal width resulting in a combined direct and induced damage length (Field L) of 131.0 cm (51.6 in). Six crush measurements were documented at the level of the reinforcement bar (bumper cover protrusion): C1= 4.0 cm (1.6 in), C2= 30.0 cm (11.8 in), C3= 29.0 cm (11.4 in), C4= 18.0 cm (7.1 in), C5= 7.0 cm (2.8 in), C6= 3.0 cm (1.2 in). An indentation was noted to the front left area from the front wheel/tire of the motorcycle. The hood was displaced up and rearward from the impact force. No reduction in the vehicle's wheelbase was identified. The right mid-windshield area fractured from the interior passenger air bag module cover flap (only).

**Figure 3. Frontal damage to the 1998 Ford Taurus SE.**

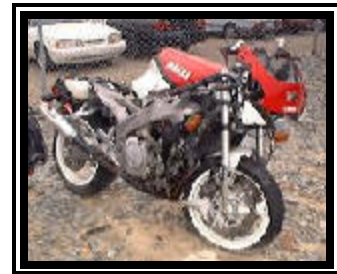
**Figure 4. Frontal damage to the 1992 Yamaha FZR1000 motorcycle.**

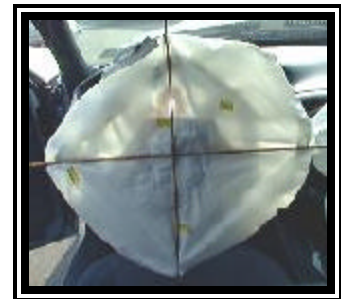
The 1998 Ford Taurus SE was equipped with redesigned frontal air bags for the driver and front right passenger positions. The air bags had deployed as a result of the crash. The driver air bag was housed in the center of the steering wheel with a single cover flap design hinged at the top aspect. The flap measured 12.5 cm (4.9 in) in width along the top portion, 9.5 cm (3.7 in) along the lower portion and 5.0 cm (2.0 in) height. Although no contact evidence was identified on the exterior surface of the module cover flap, brown spots were documented to the upper and lower portions of the air bag along with black vinyl transfers from expansion within the module. The NASS researcher measured the diameter of the driver air bag at 62.0 cm (24.4 in) in its deflated state (**Figure 5**). The bag was tethered by two internal straps and vented by two ports located at the 11 o'clock and 1 o'clock sectors on the rear aspect of the air bag.

**Figure 5. 1998 Ford Taurus SE redesigned driver air bag.**

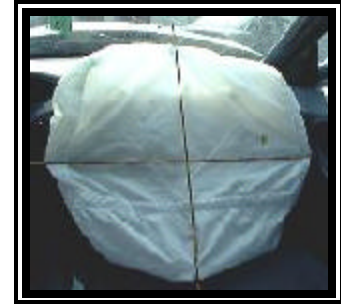
The front right passenger air bag deployed from the right top instrument panel area with a single cover flap design hinged at the top aspect. The cover flap was asymmetrical in shape and measured 40.0 cm (15.7 in) in width and 23.0 cm (9.1 in) in height along the left edge and 21.0 cm (8.3 in) in height along the right edge. The windshield was fractured by the module cover flap. Although no contact evidence was identified on the exterior surface of the module cover flap, gray powder marks were documented to the upper right quadrant of the air bag. The NASS researcher measured the passenger air bag at 60.0 cm (23.6 in) in width and 52.0 cm (20.5 in) in height in its deflated state (**Figure 6**). The bag was tethered by two internal straps. No vent ports were present. No cutoff switch was reported for the front right redesigned passenger air bag.

**Figure 6. 1998 Ford Taurus SE redesigned passenger air bag.**
