**REDESIGNED AIR BAG SPECIAL STUDY (RABSS)
SCI TECHNICAL SUMMARY REPORT**

NASS RABSS CASE NO. 1998-43-808E

RABSS VEHICLE - 1998 FORD ESCORT LX

CRASH DATE - SEPTEMBER, 1998

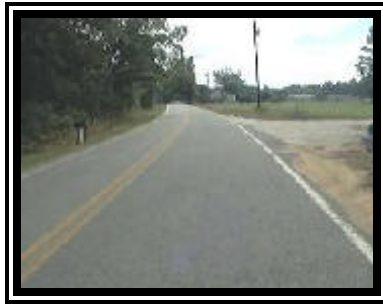
The 31 year old male driver of the 1998 Ford Escort LX was operating the vehicle southbound and negotiating a left curve (**Figure 1**) at a police reported speed of 105 km/h (65 mph). As the vehicle rounded the curve it partially exited the right (west) pavement edge. The driver overcorrected with a left steer and braking which redirected the vehicle towards the left (east) pavement edge. The investigating officer noted 60.9 meters (200.0 feet) of pre-impact tire marks, however, the NASS researcher failed to identify the marks at the scene.

Figure 1. Southbound approach for the 1998 Ford Escort LX.

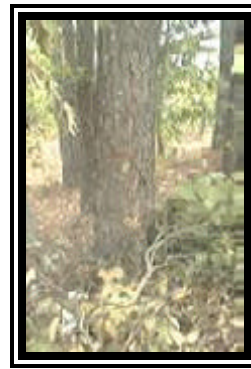
Figure 2. Struck tree.

As the Ford Escort exited the east pavement edge of the two lane rural roadway, the frontal area struck a small cluster of brush resulting in superficial damage (overlooked in the NASS case file). The Collision Deformation Classification (CDC) for this impact to the Ford Escort was 12-FDEW-1. As the vehicle continued forward, the front left area impacted a large diameter tree (**Figure 2**) resulting in moderate damage. The impact induced deceleration was sufficient to deploy the Ford's redesigned frontal air bag system. The damage algorithm of the WinSMASH program computed a (barrier equivalent) velocity change of 41.5 km/h (25.8 mph) which appears to be high. The specific longitudinal component was -41.5 km/h (-25.8 mph). The CDC for this second impact to the Ford was 12-FYEW-3. The vehicle rotated counterclockwise approximately 20 degrees and came to rest in close proximity to the tree facing southeast.

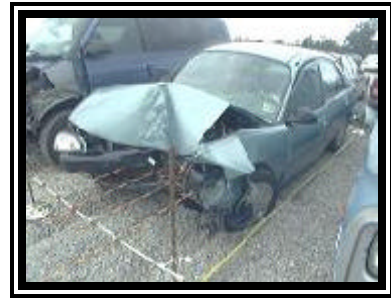
The 1998 Ford Escort LX sustained moderate frontal damage as a result of the impact with the tree (**Figure 3**). The direct contact damage began 21.0 cm (8.3 in) to the right of the front left bumper corner and extended 41.0 cm (16.1 in) inboard. The impact deformed the full frontal width resulting in a

combined direct and induced damage length (Field L) of 107.0 cm (42.1 in). Six crush measurements were documented at the level of the reinforcement bar (bumper cover separation): C1= 28.0 cm (11.0 in), C2= 50.0 cm (19.7), C3= 61.0 cm (24.0 in), C4= 36.0 cm (14.2 in), C5= 8.0 cm (3.1 in), C6= 0 cm. The hood was displaced up and rearward from engagement against the tree. The left fender was deformed rearward which restricted/deflated the left front wheel/tire. Reduction in the left side wheelbase measured 12.0 cm (4.7 in). The left lower windshield was fractured from exterior impact forces as the right mid-windshield fractured from the (interior) passenger air bag module cover flap.

Figure 3. Frontal damage to the 1998 Ford Escort LX.

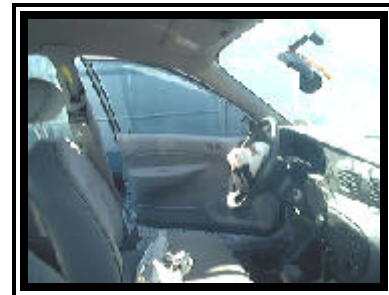
Interior damage to the Ford Escort identified through the NASS vehicle inspection was minimal and was attributed to occupant contact (**Figure 4**). The left B-pillar panel was fractured. The brake pedal was deformed against the longitudinally intruded [20.0 cm (7.9 in)] toepan. No deformation was identified on the knee bolster (padded type) or steering wheel hub/rim.

Figure 4. Interior view.

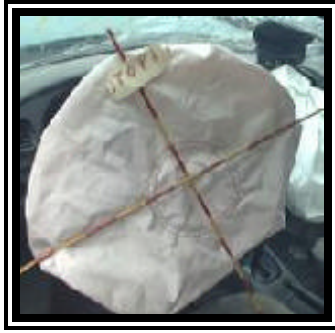
The 1998 Ford Escort LX was equipped with redesigned frontal air bags for the driver and front right passenger positions. The air bags had deployed as a result of the crash. Air bag warning labels were affixed to each sun visor. The driver air bag was housed in the center of the steering wheel with a horizontally oriented flap tear seam (H-configuration). The flaps were asymmetrical in shape as the upper flap measured 20.0 cm (7.9 in) in width and 8.0 cm (3.1 in) in height while the lower flap measured 20.0 cm (7.9 in) in width and 9.0 cm (3.5 in) in height. Although no contact evidence was identified on the exterior surface of the module cover flaps, vinyl transfers were documented on the upper/lower sections of the air bag from expansion within the module. The NASS researcher measured the diameter of the driver air bag at 48.0 cm (18.9 in) in its deflated state (**Figure 5**). The bag was tethered by two internal straps and vented by two ports located at the 11 o'clock and 1 o'clock sectors on the rear aspect of the air bag.

Figure 5. 1998 Ford Escort LX redesigned driver air bag.

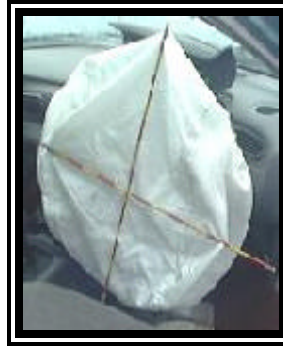
The front right passenger air bag deployed from the right mid-instrument panel area with a single cover flap design hinged at the top aspect. The cover flap was rectangular in shape and measured 34.0 cm (13.4 in) in width and 18.0 cm (7.1 in) in height. Although no contact evidence was identified on the exterior surface of the module cover flap, a vinyl transfer was documented on the left lower quadrant of the air bag from expansion within the module. The NASS researcher measured the passenger air bag at 42.0 cm (16.5 in) in width and 68.0 cm (26.8 in) in height in its deflated state (**Figure 6**). No internal tether straps were present. The bag was vented by two ports located at the 10 o'clock and 2 o'clock sectors on the side aspect of the air bag. No cutoff switch was reported for the front right redesigned passenger air bag.

Figure 6. 1998 Ford Escort LX redesigned passenger air bag.

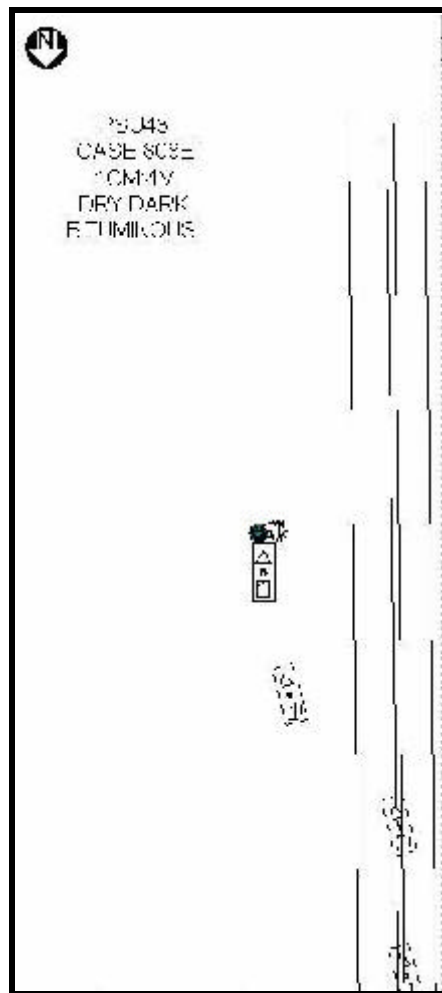
Figure 7. NASS Scene Diagram.

This single vehicle crash occurred during the late evening hours of September, 1998. At the time of the crash, it was dark (street not lighted) with no adverse conditions as the roads were dry. The crash occurred off the east pavement edge of a rural (level) two lane north/south asphalt roadway (**see Figure 7 - page 5**) which curved left for southbound traffic. The roadside environment included soft shoulders and a wooded area to the east. No traffic control was present at the scene which had a posted speed limit of 89 km/h (55 mph).
