REDESIGNED AIR BAG SPECIAL STUDY (RABSS) SCI TECHNICAL SUMMARY REPORT

NASS RABSS CASE NO. 1998-43-810G

RABSS VEHICLE - 1998 CHEVROLET CAVALIER

CRASH DATE - NOVEMBER, 1998

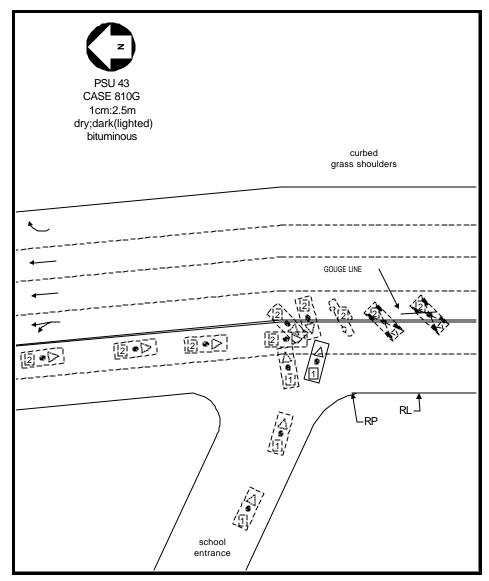
Figure 7. NASS Scene Diagram

This two-vehicle crash occurred during the evening hours of November, 1998. At the time of the crash, it was dark (street lighted) with no adverse conditions as the roads were dry. The crash occurred in the southbound lanes of an 6-lane north/south undivided asphalt roadway (**see Figure 7 - page 5**) which curved to the right for southbound traffic. Traffic control at the scene included a stop sign for eastbound traffic. The speed limit at the crash scene was 56 km/h (35 mph).
