**VERIDIAN REMOTE KNEE BOLSTER AIR BAG INJURY
INVESTIGATION
SCI TECHNICAL SUMMARY REPORT**

NASS CDS CASE NO. 1998-45-046C

VEHICLE - 1997 KIA SPORTAGE SPORT UTILITY VEHICLE

CRASH DATE - APRIL, 1998

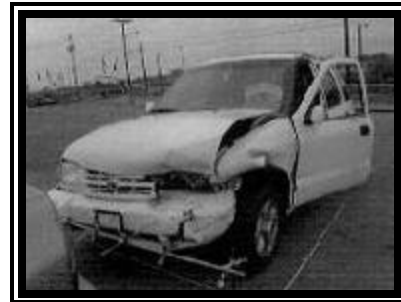
The 1997 Kia Sportage sustained moderate frontal damage as a result of the impact with the Honda Civic (**Figure 3**). The direct contact damage began at the front left bumper corner and extended 48.0 cm (18.9 in) inboard. The impact deformed the full frontal width resulting in a combined direct and induced damage length (Field L) of 130.0 cm (51.2 in). Six crush measurements were documented at the level of the bumper: C1= 41.0 cm (16.1 in), C2= 16.0 cm (6.3 in), C3= 9.0 cm (3.5 in), C4= 6.0 cm (2.4 in), C5= 2.0 cm (0.8 in), C6= 0 cm. The Collision Deformation Classification (CDC) for this impact to the Kia was 11-FYEW-2 with a principal direction of force of (-)30 degrees. The left fender was displaced rearward which restricted/deflated the left front wheel/tire. The hood was deformed up and rearward from the impact force. Reduction in the left side wheelbase measured 16.0 cm (6.3 in). The windshield was fractured from exterior impact forces (only).

Figure 3. Front left damage to the 1997 Kia Sportage.

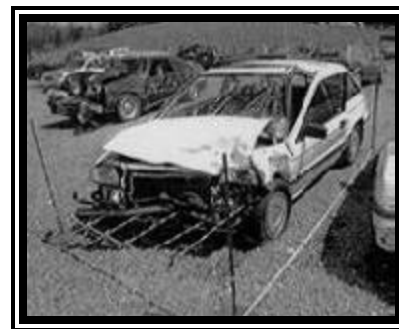
The 1986 Honda Civic sustained moderate frontal damage as a result of the impact with the Kia Sportage (**Figure 4**). The direct contact damage began at the front left bumper corner and extended 63.0 cm (24.8 in) inboard. The impact deformed the full end width resulting in a combined direct and induced damage length (Field L) of 108.0 cm (42.5 in). The CDC for this impact to the Honda was 01-FYEW-4 with a principal direction of force of (+)30 degrees. The hood was deformed up and rearward from the impact force. The left fender was displaced rearward which restricted/deflated the left front wheel/tire and jammed the left door. Induced buckling was noted to the roof at the left B-pillar area along with outward bowing of the upper left door frame. Reduction in the left side wheelbase measured 24.0 cm (9.4 in). The windshield was fractured from (exterior) impact forces and (interior) occupant contact. The left front glazing was disintegrated by the impact force.

Figure 4. Front left damage to the 1986 Honda Civic.

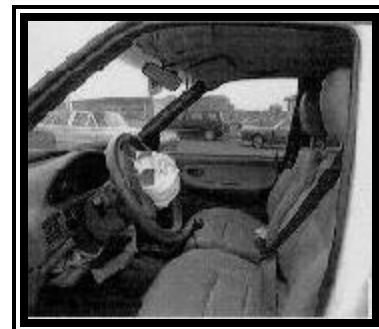
Damage to the interior surfaces of the Kia Sportage were minimal and attributed to occupant contact (**Figure 5**). Scuff marks were documented on the left portion of the driver air bag, knee bolster air bag, and lower right portion of the steering wheel rim. The left front glazing was disintegrated. No intrusions were found in the vehicle.

Figure 5. Interior view.

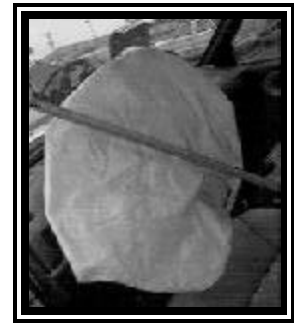
The 1997 Kia Sportage was equipped with a driver knee bolster and frontal air bag which deployed as a result of the crash. The driver air bag was housed in the center of the steering wheel (**Figure 6**) with a horizontally oriented flap tear seam (H-configuration). Although no contact evidence was identified on the exterior surface of the module cover flaps, scuff marks were documented on the left portion of the bag face. The flaps were asymmetrical in shape. The bag was tethered by four internal straps and vented by two ports located at the 11 o'clock and 1 o'clock sectors on the rear aspect of the air bag.

Figure 6. 1997 Kia Sportage driver frontal air bag.

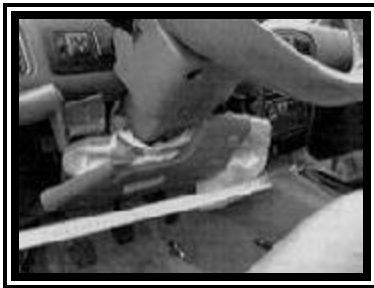
The Kia was also equipped with a driver knee bolster air bag that deployed from the left lower instrument panel area (**Figure 7**). The module cover flap was rectangular in shape. This design provides protection to the driver's lower extremities by allowing the bag to expand against the module cover panel. A tear was identified on the right side of the bag from snagging against the lower steering column/instrument panel (**Figures 8 & 9**).

Figure 7. 1997 Kia Sportage driver knee bolster air bag.

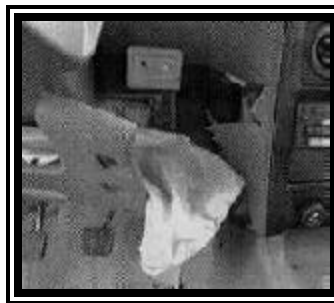
Figure 8. Damage to the driver knee bolster air bag.

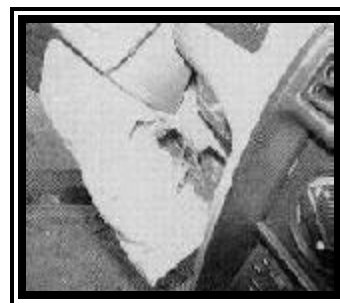
Figure 9. Tear to the driver knee bolster air bag.
