**REDESIGNED AIR BAG SPECIAL STUDY (RABSS)
SCI TECHNICAL SUMMARY REPORT**

NASS CDS CASE NO. 1998-45-121B

RABSS VEHICLE - 1998 CHEVROLET K-1500 PICKUP TRUCK

CRASH DATE - SEPTEMBER, 1998

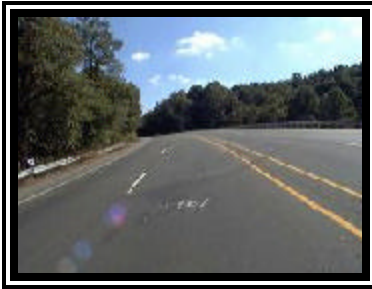
The 17 year old female driver of the 1986 Ford Escort was operating the vehicle southbound and negotiating a left curve in the inboard lane when she apparently had fallen asleep and allowed the vehicle to enter the

Figure 1. Southbound approach for the 1986 Ford Escort Pony.

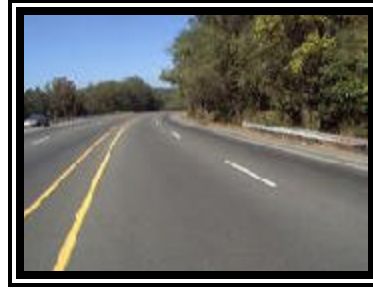
northbound lanes (**Figure 1**). The 23 year old male driver of the 1998 Chevrolet pickup was operating the vehicle northbound (**Figure 2**) and negotiating a right curve in the inboard lane at a driver reported speed of 89 km/h (55 mph). There were no brake marks within either vehicle's trajectory indicative of driver avoidance maneuvers.

Figure 2. Northbound approach for the 1998 Chevrolet K-1500 pickup truck.

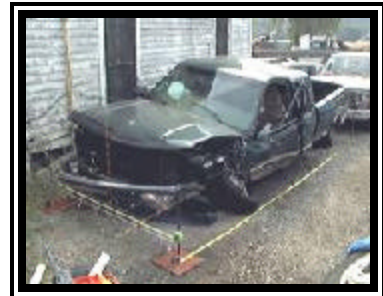
The 1998 Chevrolet K-1500 pickup sustained moderate frontal damage as a result of the impact with the Ford Escort (**Figure 3**). The direct contact damage began at the front left bumper corner and extended 27.0 cm (10.6 in) inboard (incorrectly identified as 48.0 cm in the NASS case file). The impact deformed the full frontal width resulting in a combined direct and induced damage length (Field L) of 135.0 cm (53.1 in). Six crush measurements were documented at the level of the bumper: C1= 88.0 cm (34.6 in), C2= 30.0 cm (11.8 in), C3= 15.0 cm (5.9 in), C4= 10.0 cm (3.9 in), C5= 4.0 cm (1.6 in), C6= 0 cm. The contact damage extended rearward along the left side surface which deformed the fender, deflated/restricted the left front wheel/tire, jammed the left door and shattered the left side glazings. The left rear wheel was also restricted/deflated from rearward displacement against the frame (snagging effect prior to vehicle separation). Induced buckling was noted to the roof area with bed/cab contact noted to the left side. Extension of the left side wheelbase measured 2.0 cm (0.8 in). The windshield fractured from exterior impact forces (only).

Figure 3. Frontal damage to the 1998 Chevrolet K-1500 pickup truck.

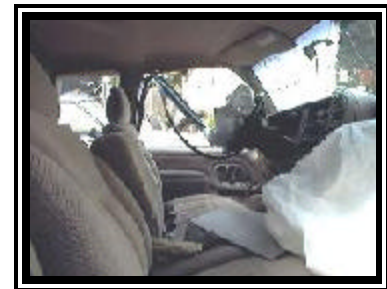
Interior damage to the Chevrolet identified through the NASS vehicle inspection was minimal and was attributed to occupant contact (**Figure 4**). A scuff mark was documented to the left knee bolster (rigid plastic type). Although the NASS researcher documented 5.0 cm (2.0 in) of upper steering wheel rim deformation, it was not evident in the images (tilt column set to the center position). The glove compartment door was loaded by the unrestrained front right passenger. The knee contacts deformed the door and opened the latch. Intrusions into the driver space included 25.0 cm (9.8 in) of lateral door panel intrusion, 9.0 cm (3.5 in) of lateral sill intrusion, 9.0 cm (3.5 in) of longitudinal toepan intrusion and 9.0 cm (3.5 in) of longitudinal instrument panel intrusion.

Figure 4. Interior view.

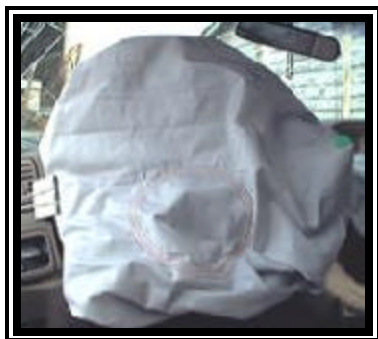
The 1998 Chevrolet K-1500 pickup truck was equipped with redesigned frontal air bags for the driver and front right passenger positions. The air bags had deployed as a result of the crash. The driver air bag was housed in the center of the steering wheel with a vertically oriented flap tear seam (I-configuration). The flaps were symmetrical in shape and measured 8.0 cm (3.1 in) in width and 11.0 cm (4.3 in) in height. Although no contact evidence was identified on the exterior surface of the module cover flaps, a scuff mark was documented to the lower portion of the air bag. The NASS researcher measured the diameter of the driver air bag at 68.0 cm (26.8 in) in its deflated state (**Figure 5**). The bag was tethered by two internal straps and vented by two ports located at the 10 o'clock and 2 o'clock sectors on the rear aspect of the air bag.

Figure 5. 1998 Chevrolet K-1500 pickup redesigned driver air bag.

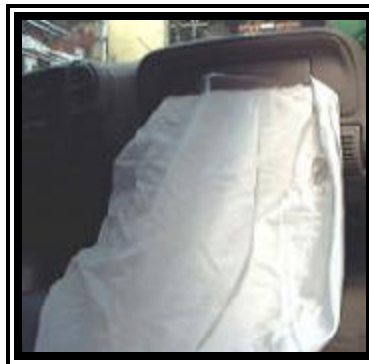
The front right passenger air bag deployed from the right mid-instrument panel area with a horizontally oriented flap tear seam (H-configuration). No contact evidence was identified on the air bag or exterior surface of the module cover flaps. The cover flaps were symmetrical and rectangular in shape which measured 33.0 cm (13.0 in) in width and 6.0 cm (2.4 in) in height. The NASS researcher measured the passenger air bag at 70.0 cm (27.6 in) square in its deflated state (**Figure 6**). No internal tether straps were present. The bag was vented by two ports located at the 10 o'clock and 2 o'clock sectors on the side aspect of the air bag. A cutoff switch was noted to the center mid-instrument panel area and was set to the "on" position.

Figure 6. 1998 Chevrolet K-1500 pickup redesigned passenger air bag.

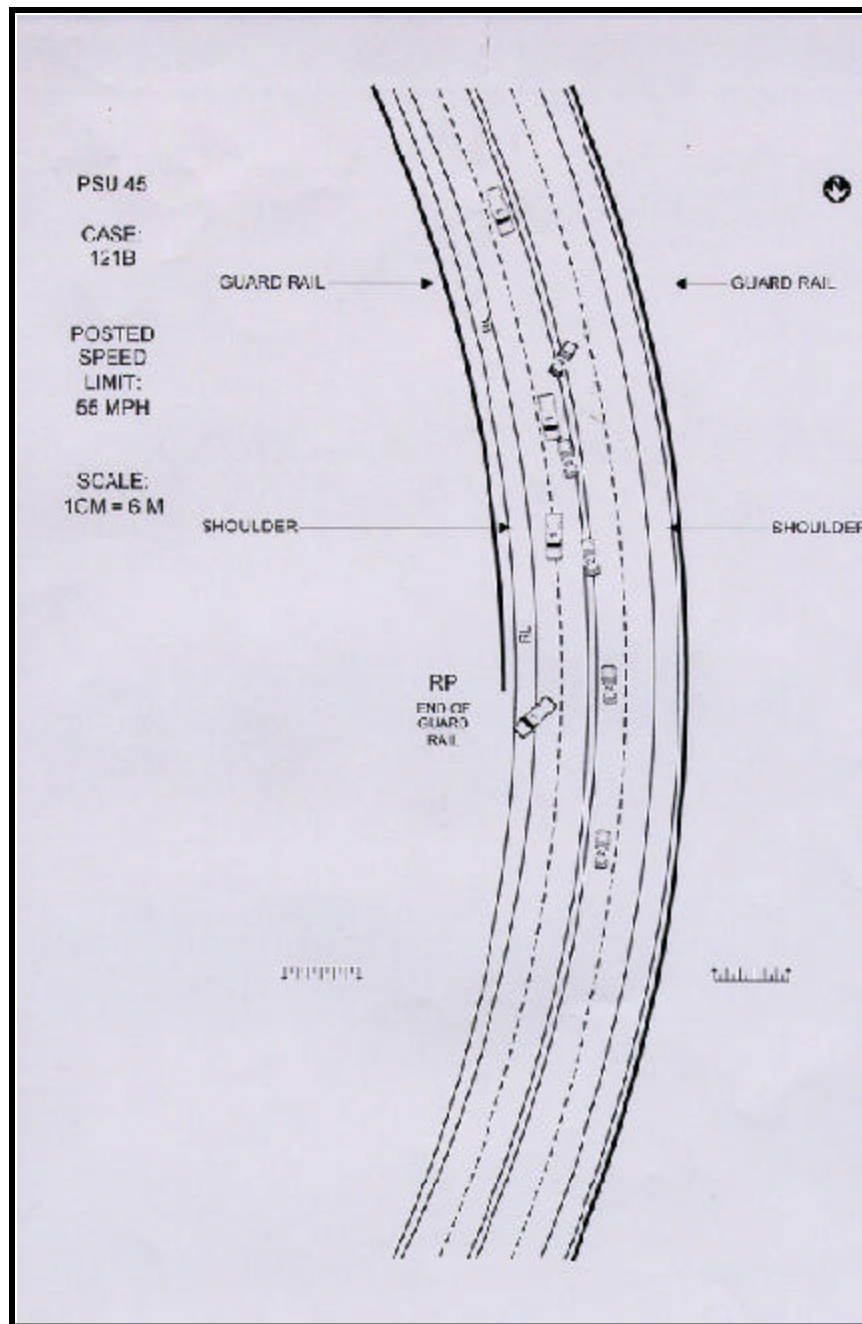
Figure 7. NASS Scene Diagram.

This two vehicle crash occurred during the early evening hours of July, 1998. At the time of the crash, it was daylight with no adverse conditions as the roads were dry. The crash occurred in the northbound lanes of an asphalt 4-lane state roadway (see **Figure 7 - page 6**) which curved right for northbound traffic with a negative grade to the north. No traffic control was present at the scene which had a posted speed limit of 89 km/h (55 mph). The roadside environment featured paved shoulders and W-beam guardrails.
