Remote, Redesigned Air Bag Special Study
FOR NHTSA'S INTERNAL USE ONLY
Dynamic Science, Inc., Case Number (1998-048-803G)
1998 Chevrolet 1500 pickup truck
Alabama
October/1998

1. Report No. 1998-048-803G	2. Government Accession No.	3. Recipient Catalog No.	
4. Title and Subtitle		5. Report Date May 18, 1999	6. Performing Organization Report No.

Summary

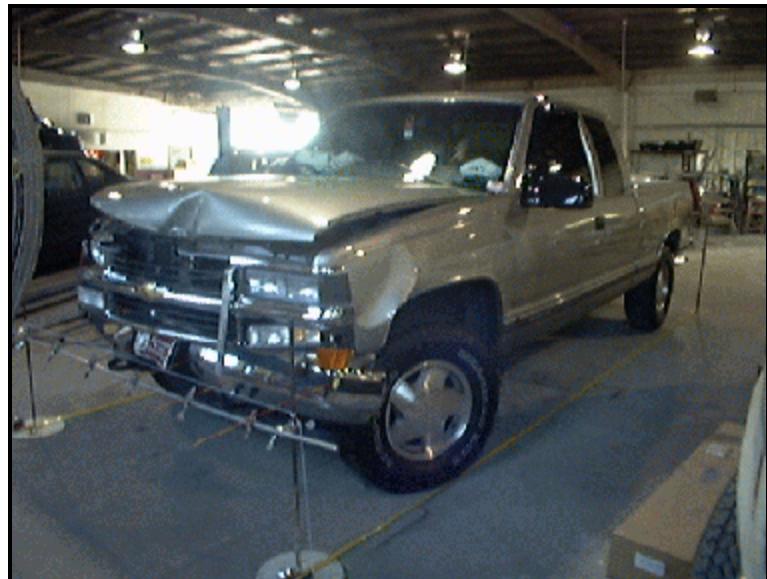
Figure 1. Exterior, Vehicle 2 (Chevrolet 1500 case vehicle)

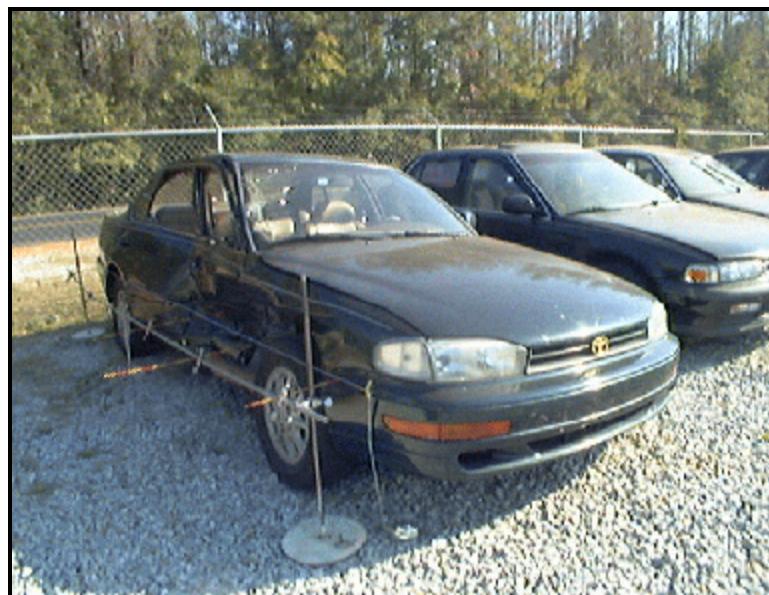
Figure 2. Exterior, Vehicle 1 (Toyota Camry)

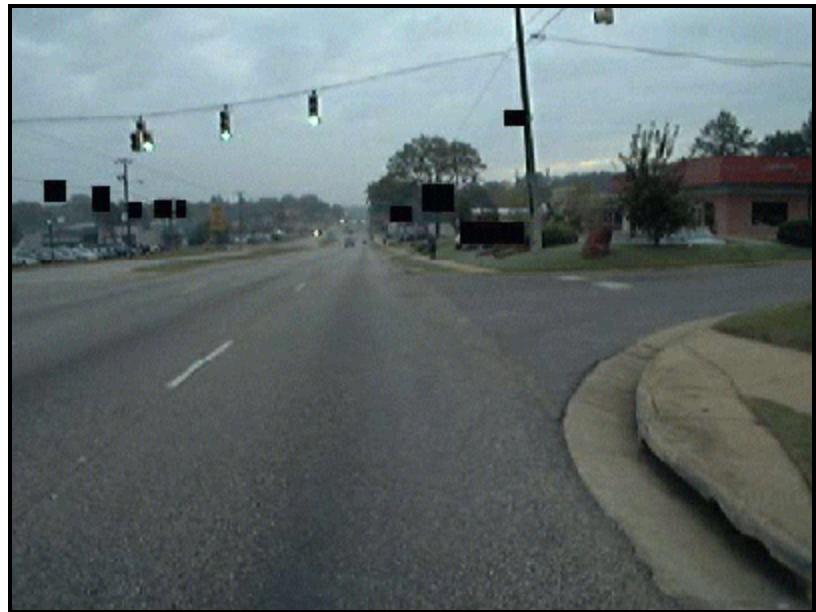
Figure 3. Crash scene, area of impact

Vehicle 1 came to rest with it's left wheels against the east curb of the intersecting road facing south. Vehicle 2 came to rest in the middle of the intersecting road facing southeast.

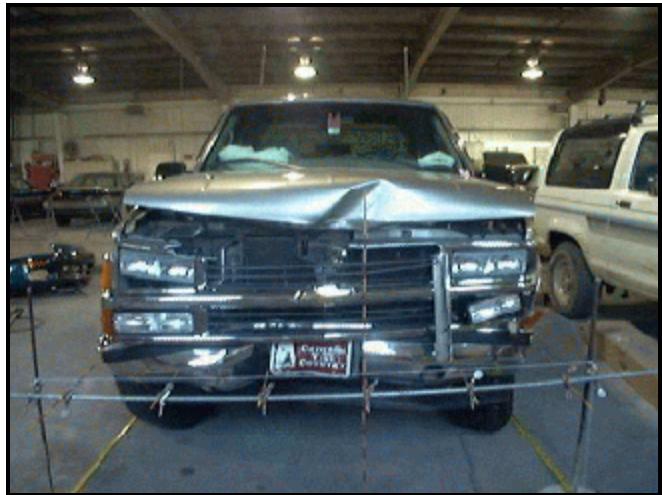
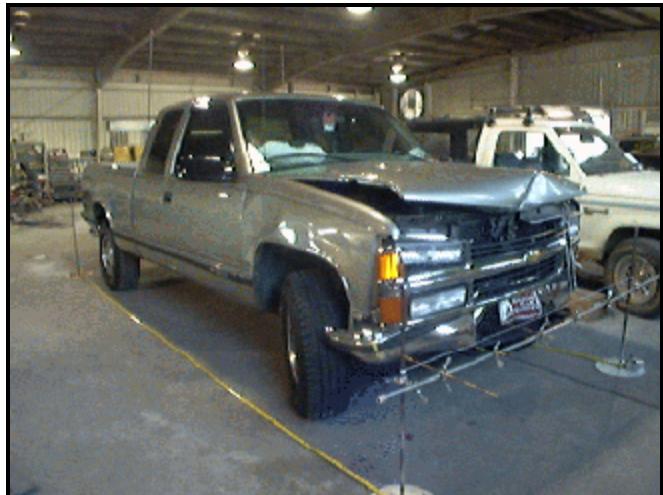
Figure 4. Exterior, Vehicle 2 (1998 Chevrolet 1500)

Figure 5. Exterior, Vehicle 2 (1998 Chevrolet 1500)

Plane of Impact	Field L cm/in.	C1 cm/in.	C2 cm/in.	C3 cm/in.	C4 cm/in.	C5 cm/in.	C6 cm/in.
Bumper	174	25	18	17	16	15	22
	68.5	9.8	7.1	6.7	6.3	5.9	8.7

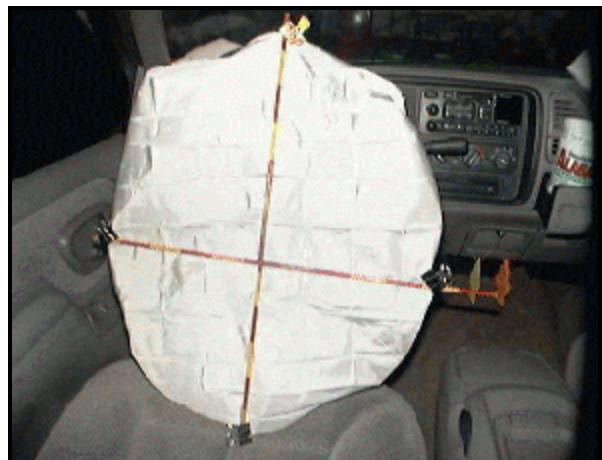
The front left air bag was housed in the steering wheel hub and was concealed by symmetrical I-configuration cover flaps. The circular air bag was equipped with two tethers and two vent ports. No contact evidence was found on the bag and the bag and cover flaps were not damaged.

Figure 6. Driver's side air bag, case vehicle

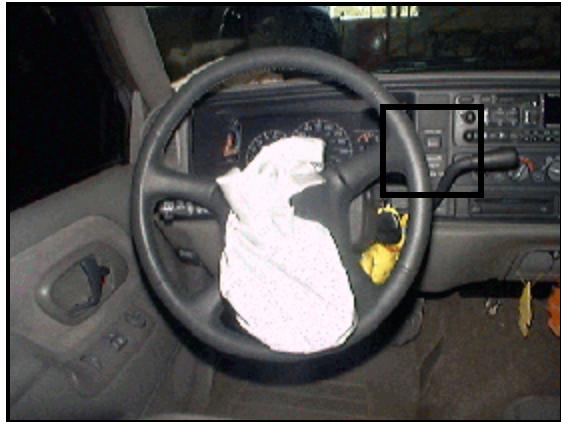
Figure 7. Interior, case vehicle. Box indicates location of air bag shut off switch.

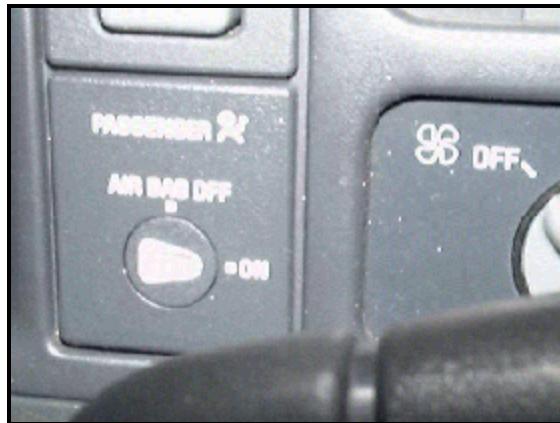
The front right air bag shut off switch was located on the center-instrument panel area. The switch is key activated and was turned to the right “on” position at the time of the crash. There was no evidence of any failures related to the air bag switch and the front right air bag deployed upon impact.

Figure 8. Passenger air bag shut off switch.

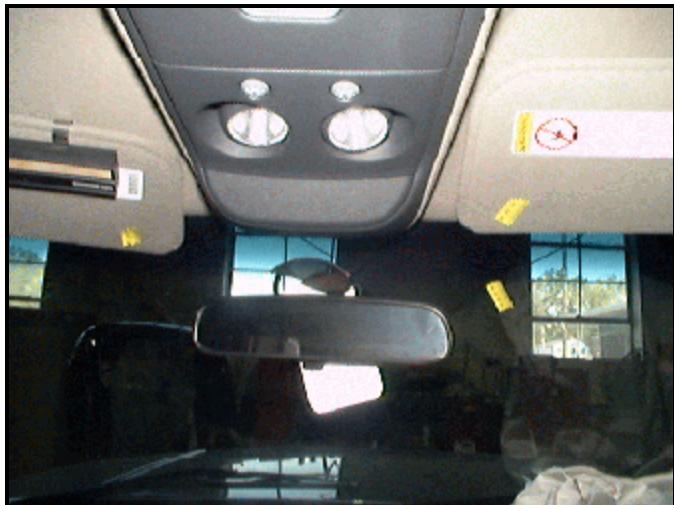
The interior of the Chevrolet 1500 sustained minor damage from occupant contact. There were no areas of intrusion into the passenger compartment. There was occupant contact evidence to windshield, sunvisors, and center armrest.

Figure 9. Interior, case vehicle. Possible contact points.

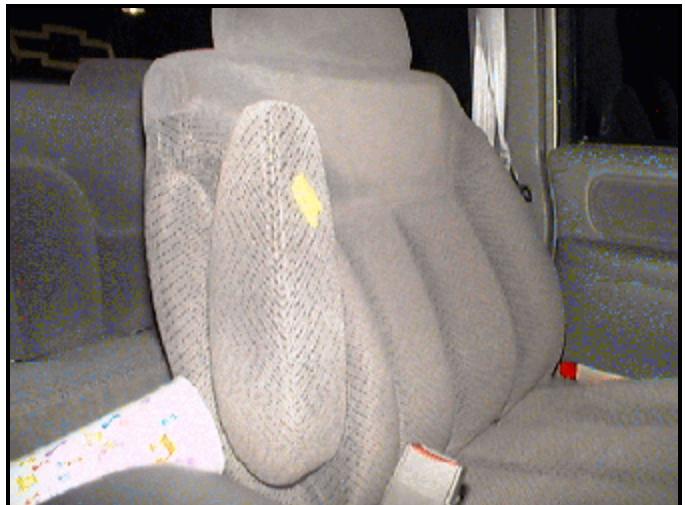
Figure 10. Interior, case vehicle. Possible contact point.
