Remote, Redesigned Air Bag Special Study  
Dynamic Science, Inc., Case Number ( 1998-49-136C)  
1998 Nissan Altima  
Texas  
August/1998

**Summary**

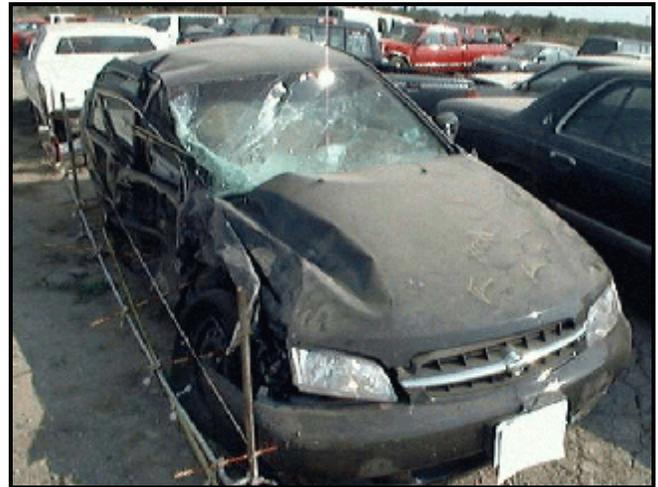
**Figure 1.** Exterior, Vehicle 1

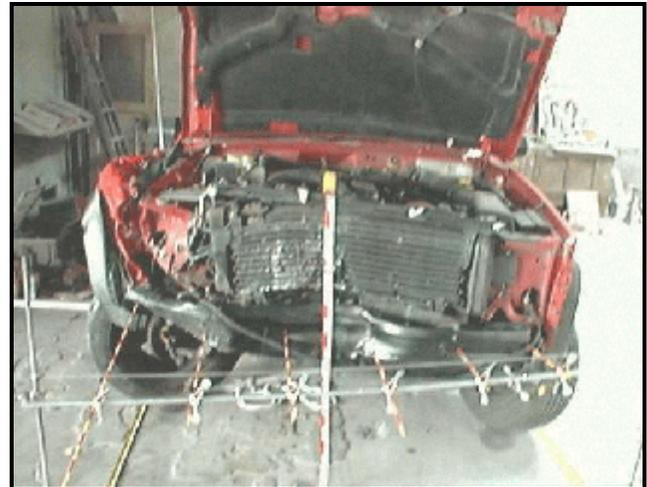
**Figure 2.** Exterior, Vehicle 2 (front)

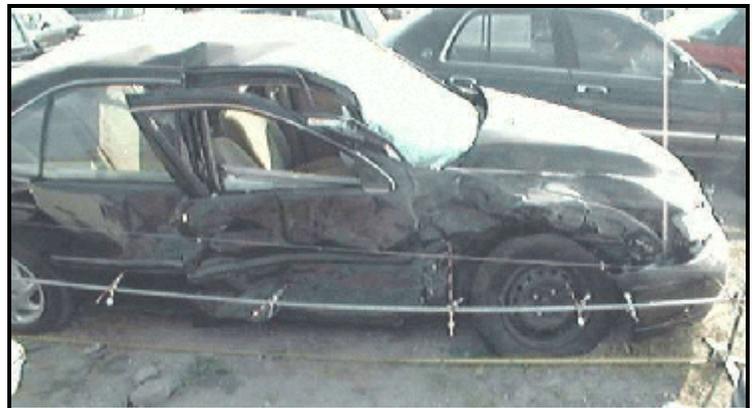
Plane of Impact	Field L cm/in.	C1 cm/in.	C2 cm/in.	C3 cm/in.	C4 cm/in.	C5 cm/in.	C6 cm/in.
Mid-door	322	0	4	23	33	24	0
	126.8	0	1.6	9.1	13	9.4	0

**Figure 4.** Exterior, Vehicle 1 (right side)

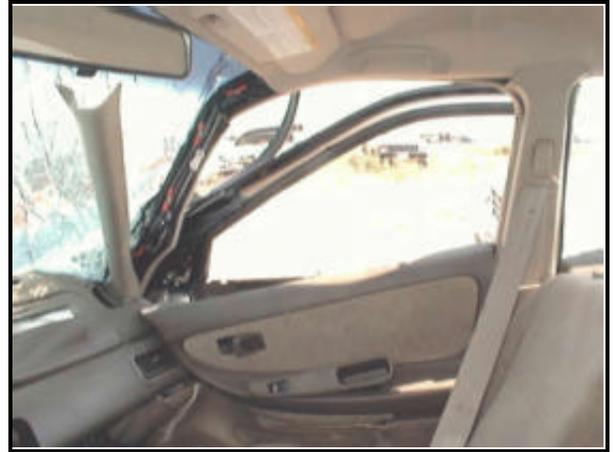
**Figure 5.** Right side intrusion

Intruded Component	Location of Intrusion	Intruded Value cm/in.		Dominant Crush Direction
		cm	in.	
Side panel	Front right	34	13.4	Lateral
A pillar	Front right	28	11	Lateral
IP right	Front right	17	6.7	Lateral
B pillar	Front right	14	5.5	Lateral
Door panel	Rear right	14	5.5	Lateral
Windshield	Front right	6	2.4	Vertical
Floor pan	Rear right	4	1.6	Lateral
Side panel	Front right	4	1.6	Lateral
Roof side rail	Front right	3	1.1	Vertical

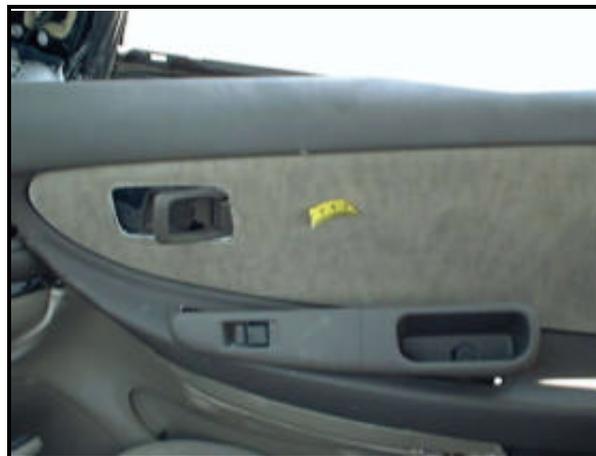
**Figure 6.** Contact to door panel

Vehicle 1 was in a left-hand turn at the time of impact. Both front occupants were wearing the available lap and shoulder belts. During the turn, this vehicle was struck in the right side. The occupants of Vehicle 1 responded to the 030 degree principal direction of force by moving forward and to the right. Both occupants loaded the seat belts. The front right occupant contacted the center console with his right hip. The front left occupant contacted the right side door panel both as a result of the impact and the subsequent intrusion.

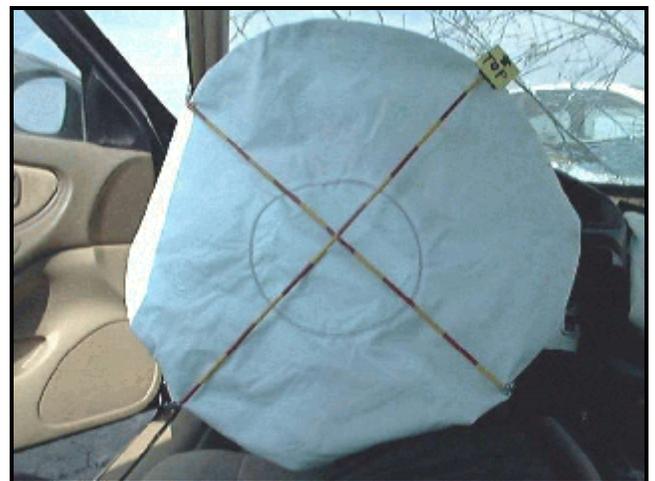
The Nissan Altima was equipped with Nissan redesigned “Second Generation” air bags which consisted of front-left and front-right air bag modules which housed air bags and depowered inflator units. The front-left air bag was housed in the steering wheel hub and was concealed by asymmetrical H-configuration cover flaps. The circular air bag was equipped with two tethers and two vent ports. The front-right air bag was located in the top-instrument panel position and was concealed by symmetrical H-configuration flaps. The rectangular air bag was not equipped with tethers but contained one vent port. There were no indications of damage or contact to either the air bag or the module cover.

**Figure 9.** Driver's side air bag
