Remote, Redesigned Air Bag Special Study

Dynamic Science, Inc., Case Number (1998-49-165G)

1998 Ford Escort/EXP

October/1998

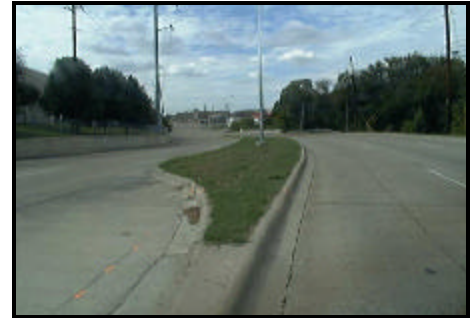
Figure 1. Vehicle 1 impacts curb (Events 1 & 2) with right side tires

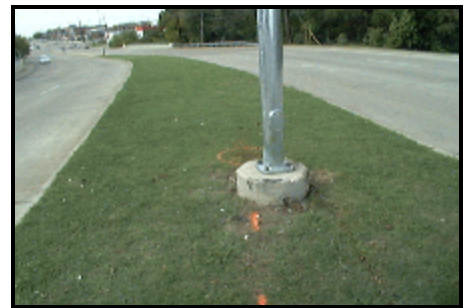
Figure 2. Pole impact (Event #3) and final rest location

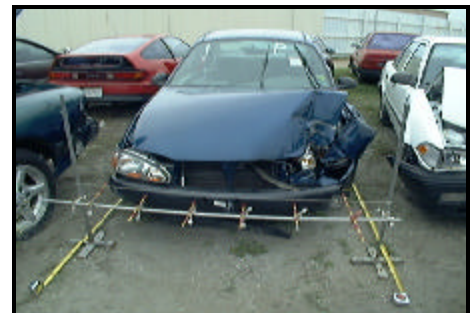
The pole impact was of sufficient force to deploy the driver and passenger air bags. The corner impact nearly bypassed the stiff front bumper structure and settled into the softer upper left corner structure (i.e., hood, left fender and upper radiator support). In addition, the impacted pole was either totally separated or yielded which further complicated the proper application of energy deceleration calculations. The 12 o'clock left corner impact initiated a rapid counterclockwise rotation of the case vehicle. The case vehicle came to rest facing in an easterly direction reportedly in full contact with the damaged pole. The driver of Vehicle 1 sustained an abrasion (AIS-1) to the left side of his neck due to shoulder belt contact. The driver also reported that he sustained a right shoulder dislocation/glenohumeral joint (AIS-2) which was attributed to the deploying driver's air bag.

Figure 3. Vehicle 1/Frontal damage

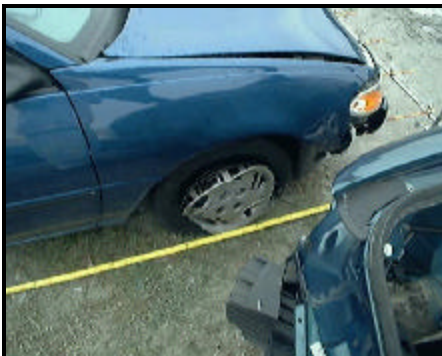
Figure 6. Front, right tire damage (curb impact / Event #1)

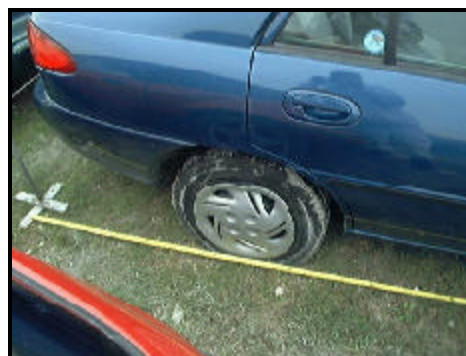
Figure 7. Right, rear tire damage (curb impact / Event #2)

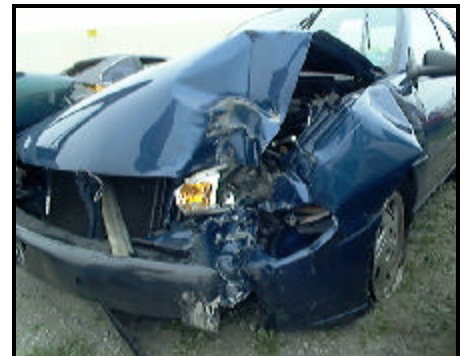
Figure 8. Primary impact to left corner (pole impact / Event #3)

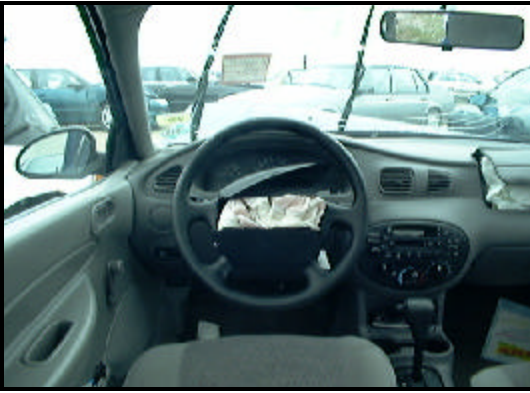
Figure 9. Front, Left view showing interior of case vehicle

The interior of the Ford Escort maintained its integrity with minor intrusion which was isolated to 4cm (1.6 in.) of longitudinal displacement of the toe pan located at the left, front seated position. There was a small scuff mark located at the upper left A-pillar and lower left knee/bolster. There was a small contact mark noted to the lower right quadrant of the drivers air bag. The passenger air bag module cover flap broke the laminated windshield glazing upon air bag deployment.

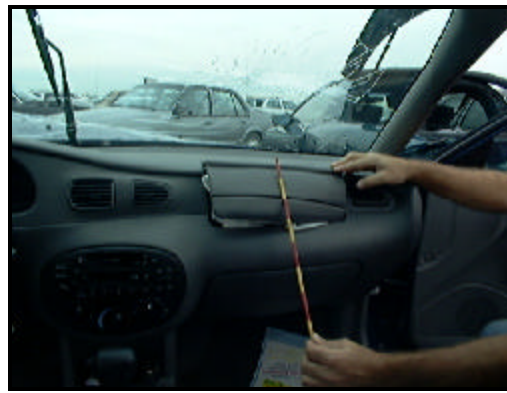
Figure 10. Front, right view showing interior of case vehicle

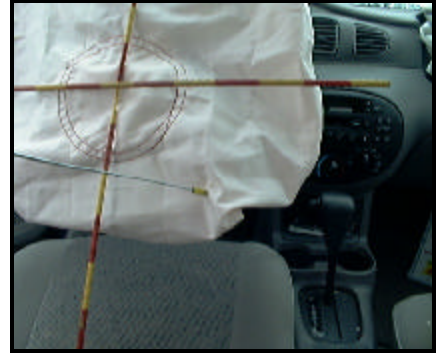
The lower instrument panel is equipped with a rigid plastic knee bolster. A scuff mark was documented to the lower left area of the knee bolster panel. There was a small scuff contact noted to the lower right quadrant of the air bag nylon fabric.

Figure 11. Occupant contact to drivers air bag

The initial right side tire impacts did not significantly displace him from his seated position. He responded to the 12 o'clock primary impact with the light pole by moving directly forward. The shoulder belt webbing restricted extended forward motion of his upper torso, however, he sustained a left side neck abrasion (AIS-1) from the shoulder belt webbing. As the vehicle rotated in a rapid counterclockwise direction, the right side of his face and shoulder dipped and pitched downward. His right shoulder (glenohumeral joint) was reportedly dislocated (AIS-2) due to his

interaction with the deploying driver's air bag³. His left knee contacted the knee bolster which resulted in a scuff mark to the rigid plastic cover, but did not result in injury. The air bag deployment caused his left hand to flail upward making contact with the upper left A-pillar molding. This contact did not result in injury. The case occupant rebounded into the seatback support, where he came to rest and remained in his respective seated position.

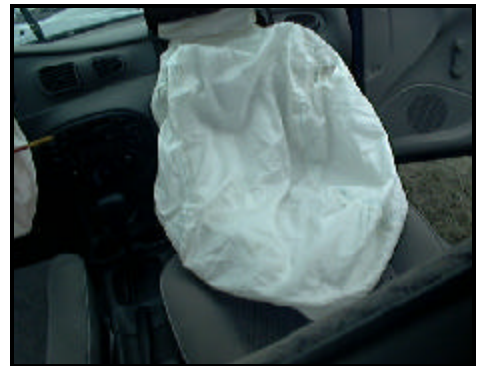
The front, right passenger air bag was located on the instrument panel (mid-mount type). The module deployment door is rectangular in shape and equipped with a tear seam that is designed to allow the door to hinge outward during deployment. The nylon air bag is inflated with nitrogen after the chemical reaction of sodium azide and copper oxide combusts. The inflator unit is supported by a metal reaction housing unit. There was no residual damage to the air bag and the module cover deployment door opened at the designated tear point. The deployment door cover opened with enough force to break the laminated windshield.

Figure 12. View showing deployed passenger (front, right) air bag
