Remote, Redesigned Air Bag Special Study

Dynamic Science, Inc., Case Number (1998-049-807E)

1998 Saturn SL 4-door sedan

September, 1998

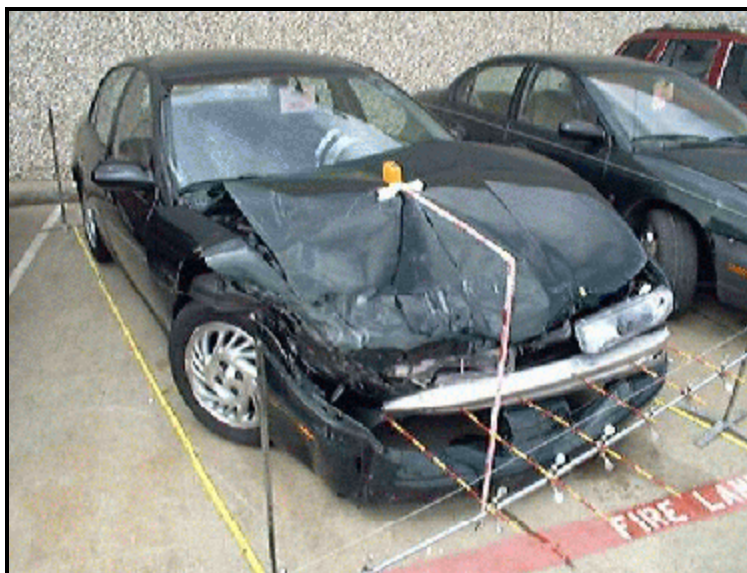
Figure 1. Exterior, Vehicle 1(Saturn SL)

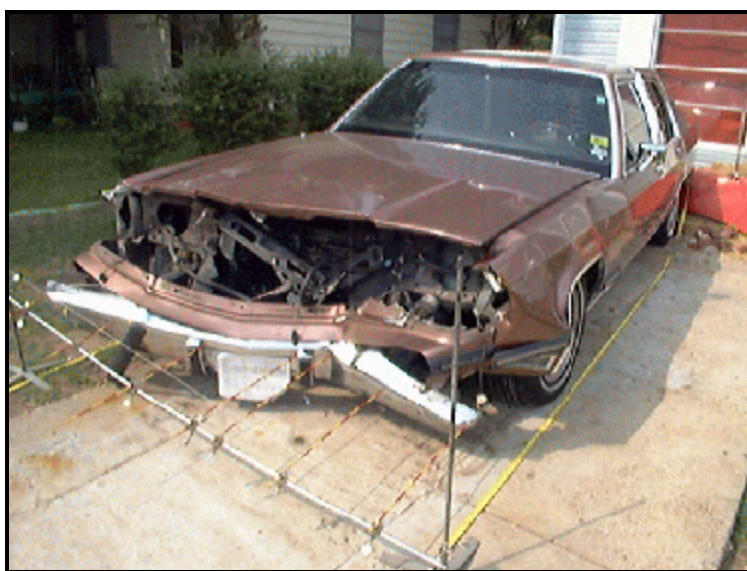
Figure 2. Exterior, Vehicle 2 (Mercury Grand Marquis)

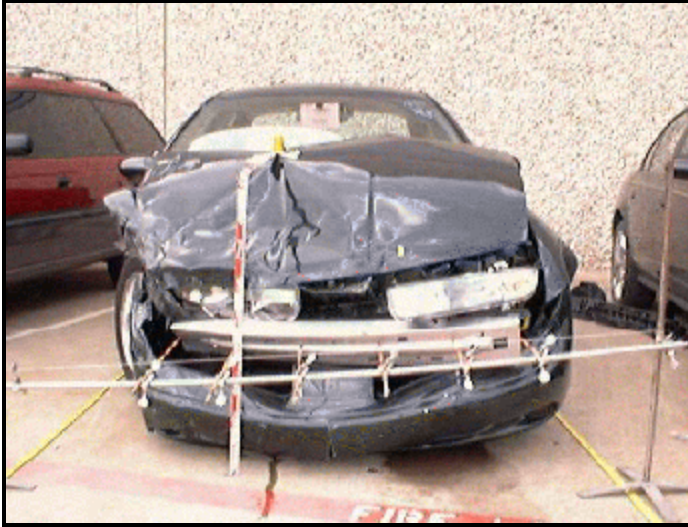
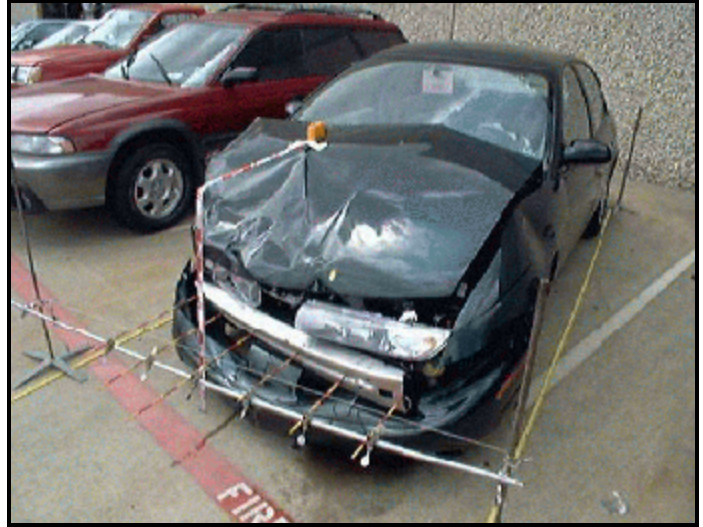
The driver of Vehicle 1 attempted a left turn at the intersection on a solid green traffic signal as Vehicle 2 approached from the opposite direction, also on a solid green traffic signal. The driver of Vehicle 1 failed to yield the right-of-way and entered the path of Vehicle 2. The front plane of Vehicle 1 (01FZEW2) struck the front plane of Vehicle 2 (12FYEW2) in the intersection.

Figure 3. Exterior, Vehicle 1 (1998 Saturn SL 4-door sedan)

Figure 4. Exterior, Vehicle 1 (1998 Saturn SL 4-door sedan)

Plane of Impact	Field L cm/in.	C1 cm/in.	C2 cm/in.	C3 cm/in.	C4 cm/in.	C5 cm/in.	C6 cm/in.
Bumper	106	0	3	10	16	20	27
	41.7	0	1.2	3.9	6.3	7.9	10.6

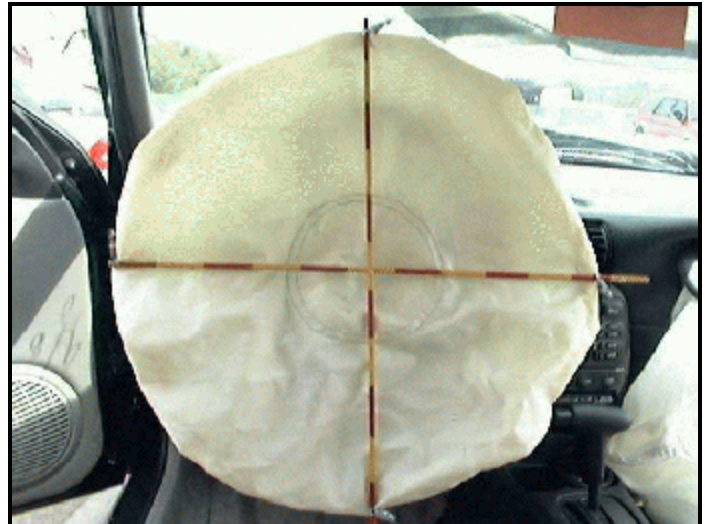
The front left air bag was housed in the steering wheel hub and was concealed by symmetrical I-configuration cover flaps. The circular air bag was equipped with four tether straps and two vent ports and was not damaged in the crash. Smudges were found in various locations of the front of the bag indicative of occupant contact.

Figure 5. Interior, case vehicle. Driver's side air bag.

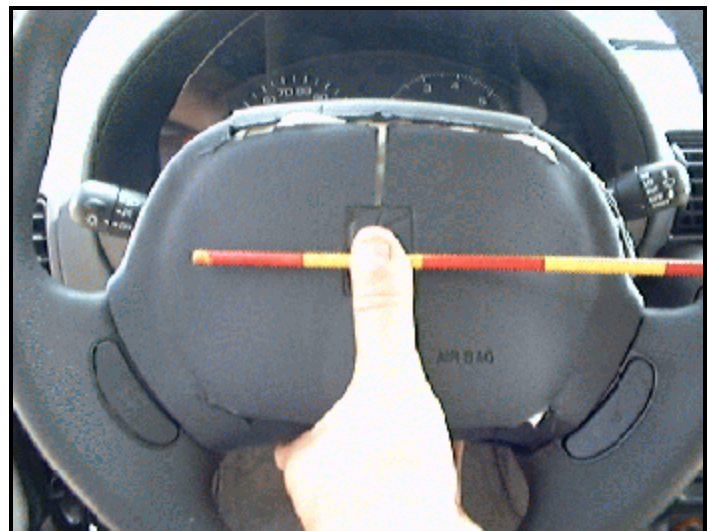
Figure 6. Interior, case vehicle. Driver's side air bag flaps.
