Remote, Redesigned Air Bag Special Study

Dynamic Science, Inc., Case Number (1998-49-809E)

1998 Ford Taurus

Texas

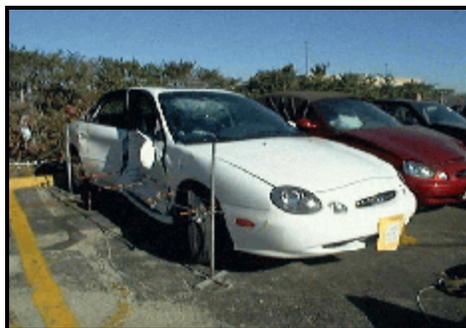
Figure 3. Right Side Damage to Vehicle 1

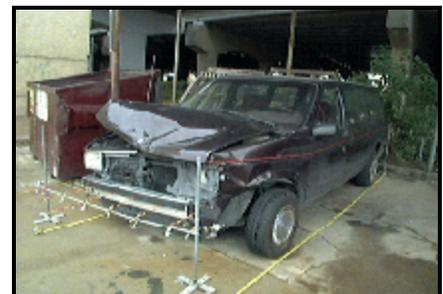
Figure 4. Frontal Damage to Vehicle 2

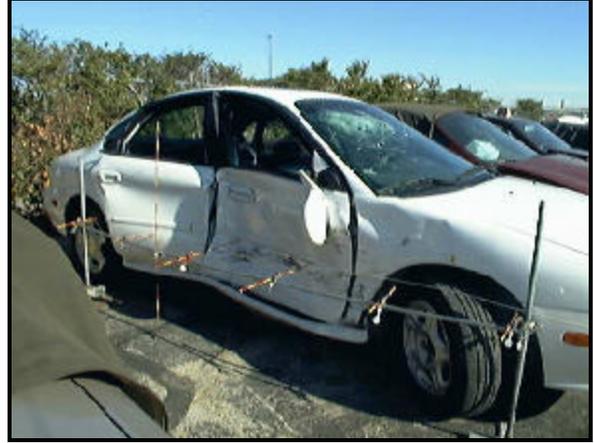
Figure 7. Close-up Showing Right Side Impact to Vehicle 1

The interior of the Ford Taurus sustained moderate damage mostly due lateral intrusion from right side components. The right B-pillar, both right side door panels, lower sill area and the right roof side rail were all displaced laterally due to the right side impact. The intruded values are reported in Table 4. Occupant contact scuff marks were documented to the knee bolster, right A-pillar and front, right door arm rest area.

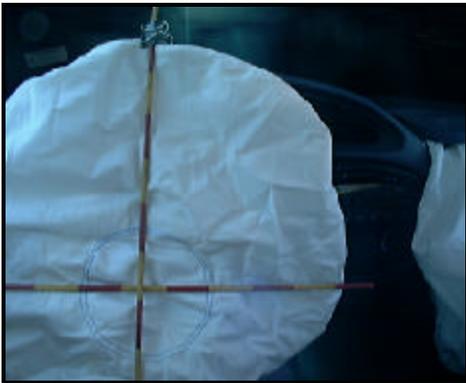
The front, left air bag was housed in the steering wheel hub and was concealed by symmetrical double horizontal module cover flaps. The circular air bag had two tether straps and two exhaust vent port holes. The lower instrument panel is equipped with a rigid plastic knee bolster. A small scuff mark was noted to the lower right area of the knee bolster.

Figure 9. View showing deployed drivers air bag

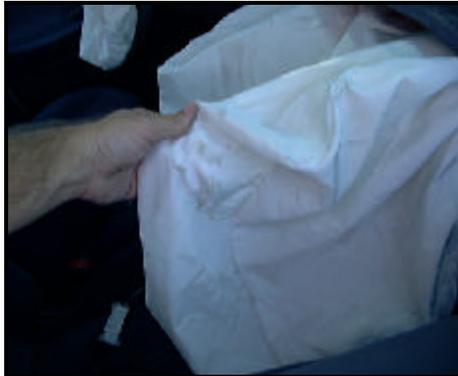
The front, right air bag was located on the instrument panel, top surface plane. The module cover flap is symmetrical and oblong with rounded flap corners. The module cover and air bag broke the laminated windshield glazing upon impact. There were small tears located on the right side of the air bag due to flying side window glazing fragments. There were blood fluid deposits noted to the bottom surface of the air bag and were likely due to the injured passenger coming into contact with the fabric post-impact. The passenger had a scalp laceration and a right elbow laceration.

Figure 10. Right lateral views of passenger air bag showing small tears

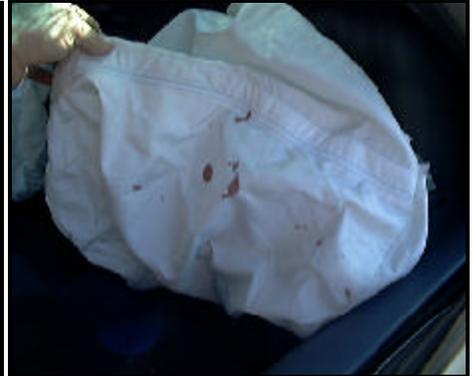
Figure 11. View of blood deposits to bottom of passenger air bag

The 22 year old male who occupied the front, right seated position was also wearing the available three-point manual lap and shoulder belt. He responded to the 1 o'clock direction of force by moving forward and slightly to the right. He loaded the lap belt webbing which secured his lower torso from continued forward motion. His right elbow was lacerated (AIS-1) when it came into contact with the intruding right front door panel/ armrest and hardware. He also sustained a laceration (AIS-1) to the right side of his scalp due to flying glass fragments. At some point (post-crash), his bleeding right elbow came into contact with the bottom surface of the passenger air bag fabric. Residual blood stains were noted to the air bag fabric.
