Remote, Redesigned Air Bag Special Study

Dynamic Science, Inc., Case Number (1998-49-811G)

1999 Pontiac Firebird Trans Am

November/1998

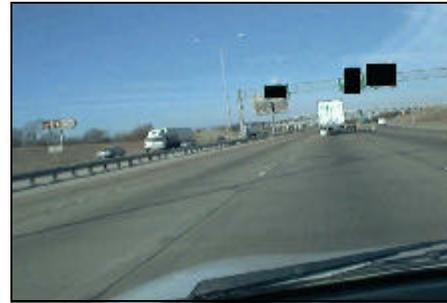
Vehicle 1, a 1999 Pontiac Firebird/Trans Am, three-door hatchback, was being driven by a fully restrained 25-year-old male (178 cm/70 in., 79 kg/174 lbs.) who was traveling in lane three of the westbound travel lanes at an undetermined rate of speed. A Dodge Ram pick-up truck (non-contact vehicle) was traveling in lane 2, adjacent to Vehicle 1. The driver of the pick-up truck attempted a lane change maneuver with the intention of moving to lane 3. In an attempt to avoid impacting the pick-up truck, Driver 1 applied a left steering input. The aggressive steering input initiated a counterclockwise rotation as Vehicle 1 traversed lanes 4 and 5. The case vehicle (Trans Am) traversed the center median shoulder, rotating approximately 75 degrees counterclockwise before impacting the center median, W-beam guardrail barrier with its frontal plane (81FDEW1).

Figure 1. Pre-Impact Trajectory of Vehicle 1

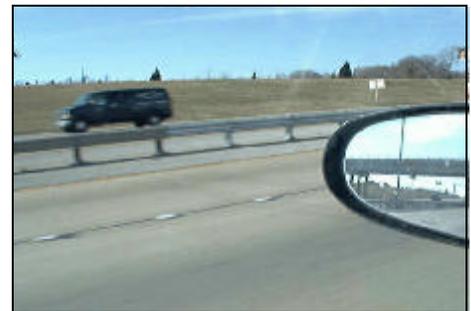
Figure 2. Guardrail impact location

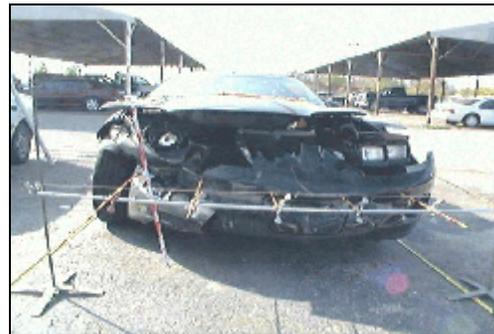
Figure 3. Frontal Impact to Vehicle 1

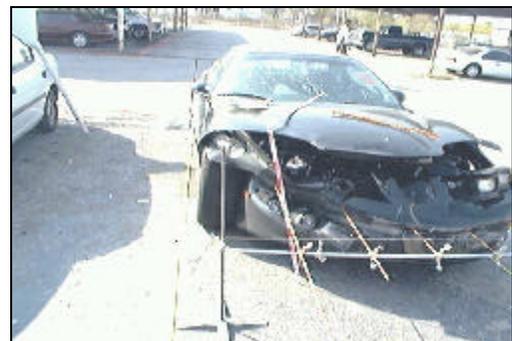
Figure 4. View Showing Frontal Shift

The 40 degree (1 o'clock) impact force was incremented by 80 for frontal shift to the left. Both the driver and passenger air bags deployed. The total delta V was calculated at 18.8 km/h (11.7 mph). The longitudinal delta V of -14.4 km/h (8.9 mph) was at the borderline threshold necessary for air bag deployment.

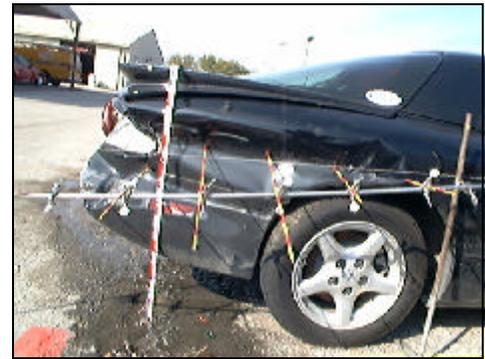
After the initial front, right bumper corner impact, Vehicle 1 continued to rotate counterclockwise as its right quarter-panel impacted the guardrail in a secondary impact (03RZEW3). The total and lateral delta V for the secondary right side impact was computed at 8.4 km/h (5.2 mph)¹. The case vehicle came to rest on the shoulder, in the center median area and was facing east. The driver of the Firebird/Trans Am was uninjured in the crash and did not receive medical attention.

Figure 5. View Showing Secondary Guardrail Impact to Right Quarter-Panel

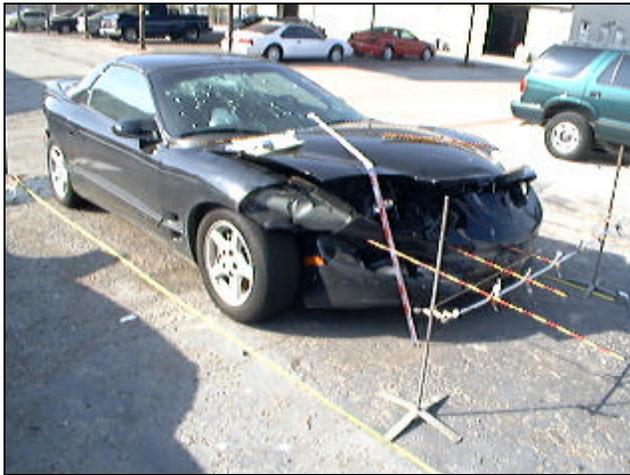
Figure 6. View Showing Initial Front Right Corner Impact, Vehicle 1 (1999 Firebird)

Plane of Impact	Field L cm/in.	C1 cm/in.	C2 cm/in.	C3 cm/in.	C4 cm/in.	C5 cm/in.	C6 cm/in.
Front Bumper	155	17	13	16	17	21	21
	61	6.7	5.1	6.3	6.7	8.3	8.3

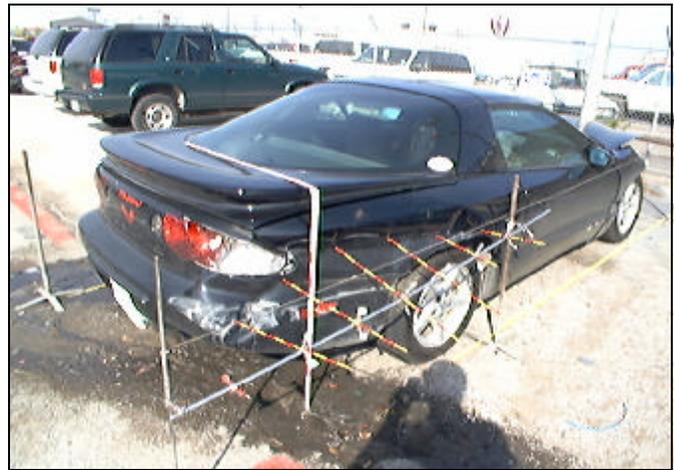
Figure 7. View Showing Secondary Right Quarter-Panel Impact to Firebird/Trans Am

Plane of Impact	Field L cm/in.	C1 cm/in.	C2 cm/in.	C3 cm/in.	C4 cm/in.	C5 cm/in.	C6 cm/in.
Right Side	112	10	13	12	9	6	0
	44.1	3.9	5.1	4.7	3.5	2.4	0

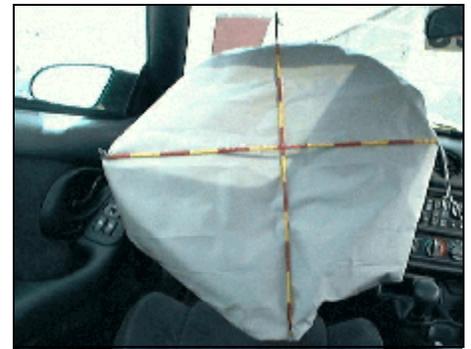
The front left air bag was housed in the steering wheel hub and was concealed by symmetrical double vertical module cover flaps. The circular air bag was an untethered design equipped with two exhaust vent port holes. The lower instrument panel is equipped with a rigid plastic knee bolster. There was no discernible contact damage to the knee bolster, air bag or module cover flaps.

Figure 8. View Showing Deployed Drivers Air Bag

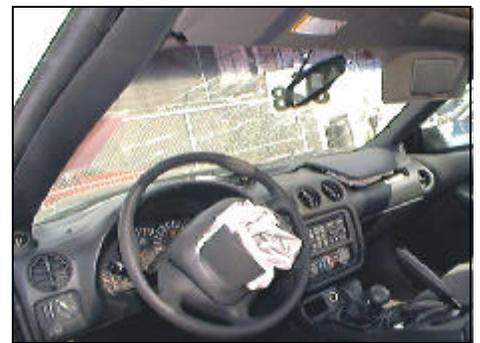
Damage to the interior of the 1999 Pontiac Firebird/Trans Am was isolated to windshield glazing damage. The damage to the windshield was due to the passenger side air bag module flap contacting the windshield during deployment. There were no intruding components and no discernible areas of occupant contact.

Figure 9. Interior of Case Vehicle

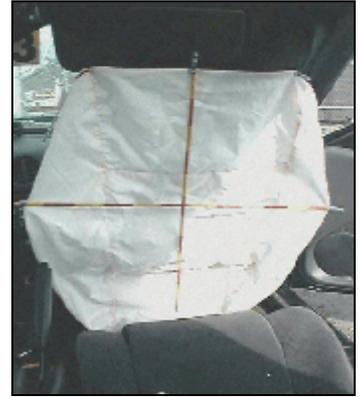
Figure 10. Deployed Passenger Air Bag

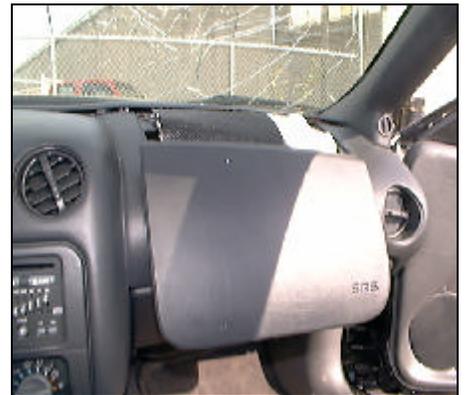
The front, right air bag was located on the instrument panel, top surface plane. The module cover flap was basically rectangular in design and was tethered by a fabric hinge. The module flap cover broke the laminated windshield glazing upon deployment. The air bag was not tethered, but was equipped with two vent port holes. There were no indications of damage or contact to the air bag. The module cover appeared to have overextended its intended hinging mechanism (refer to Figure 11).

Figure 11. Passenger Air Bag Module Cover

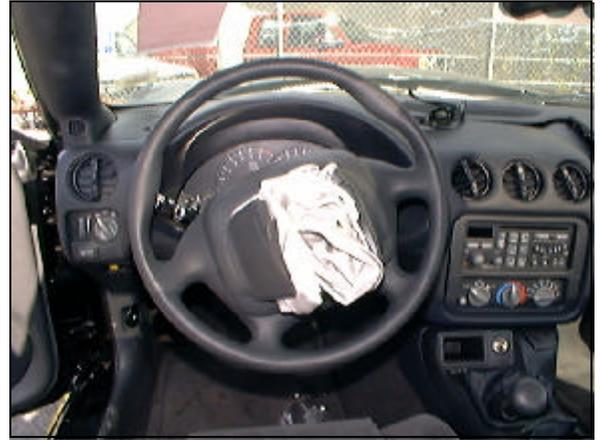
Figure 12. Interior, case vehicle/ windshield and instrument panel

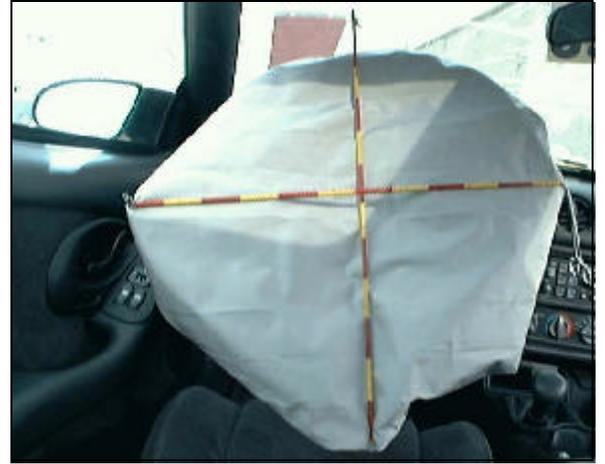
Figure 13. View showing deployed drivers air bag
