SCI/NASS COMBINATION CASE REPORT

CASE NUMBER - NASS-98-73-097B

VEHICLE - 1998 DODGE NEON

CRASH DATE - July 1998

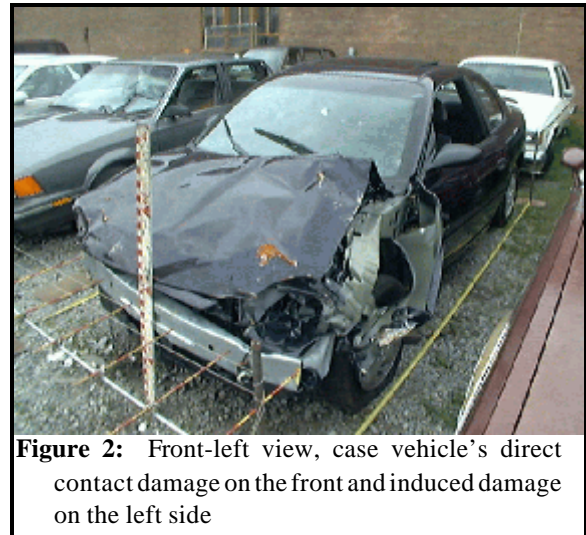
The case vehicle sustained direct contact damage across the entire front with induced damage on the left and right sides (**Figures 2 and 3**). The CDC was determined to be **81-FDEW-1** with direction of principal force 30 degrees and reflecting the NASS investigator's judgement that the vehicle sustained frame shift to the left. Maximum crush was 14 centimeters [5.5 inches] at the front left corner. The winSMASH reconstruction program was used to calculate Delta V based on the crush profile of both vehicles. The results for the case vehicle indicate total, longitudinal and lateral Delta V, respectively: 52 km.p.h [32 m.p.h.], -45 km.p.h. [-30 m.p.h.] and -26 km.p.h. [-16 m.p.h.].

Figure 2: Front-left view, case vehicle's direct contact damage on the front and induced damage on the left side

The bumper cover was torn off, the grille and headlight assemblies were shattered and the hood was crumpled. The right front axle was broken. Both front tires were deflated with the wheels displaced and their rotation restricted. The left fender outer panel was separated from the wheel well liner and folded rearward. The window glazing in both doors was shattered (kernelized) and the windshield had stress cracks. The sunroof panel was slightly displaced. Both doors remained closed and operational. There was minor intrusion by the toe pan at the left and right front seat positions with no other crash damage to the interior noted by the NASS researcher.

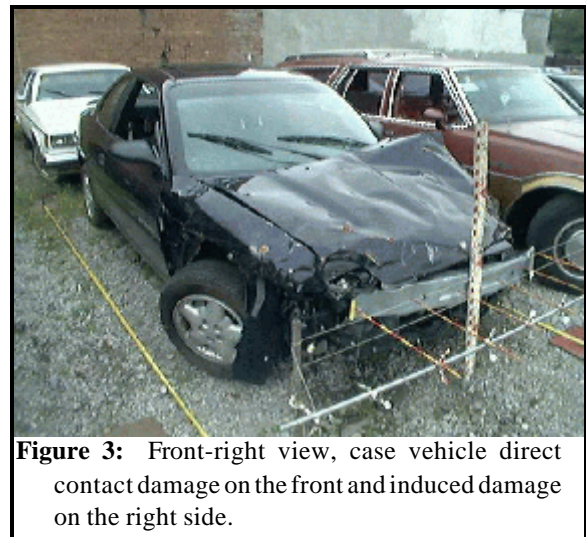
Figure 3: Front-right view, case vehicle direct contact damage on the front and induced damage on the right side.

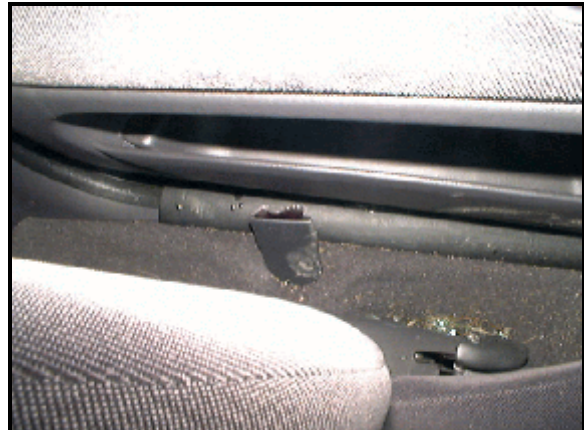
The driver's manual safety belt system had been cut out of the vehicle. The lap end of the belt was cut off at the point of attachment on the driver's door sill (**Figure 4**). The latch tongue component that slides along the belt was nowhere to be found and the shoulder portion of the belt had retracted onto the

spool, leaving only the empty slot in the B-pillar (**Figure 5**). The driver exited the vehicle under his own power and was ambulatory at the scene, and there is no reason to think that rescue personnel cut the belt. There was no feature of the vehicle's damage to suggest crash damage to the belt nor that the tow operator had any reason to cut the belt. The Police Crash Report indicates "air bag" for the driver's restraint status but is silent about of safety belt use. During the interview, the driver claimed that he had been belted, but he didn't remember anything else about the crash and his measured Blood Alcohol Concentration was 0.163 mg/dl. Accordingly, this contractor is led to the conclusion that the driver's safety belt system had been cut out prior to the crash and the driver was not restrained.

Figure 4: Looking down on driver's door sill, showing cut end of driver's continuous loop belt

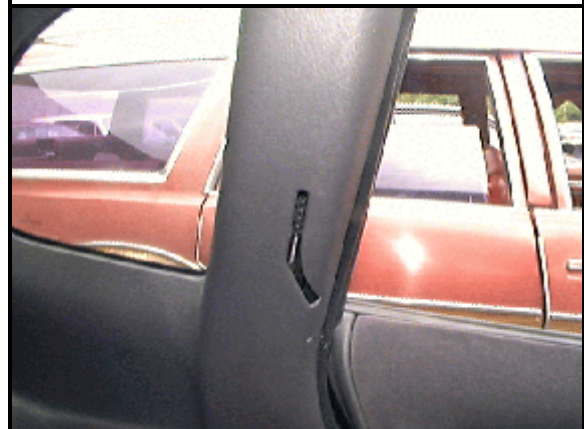
Figure 5: Left B-pillar showing empty slot where cut driver's belt retracted

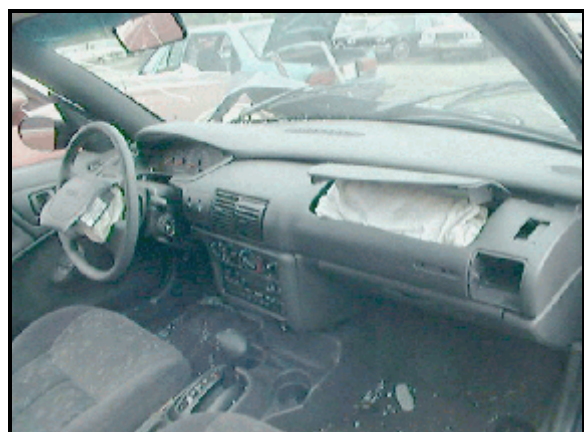
The driver air bag was located in the steering wheel hub with a one-piece cover flap hinged at the top (**Figure 6**). The flap opened along the seams and there was no damage to the air bag or the cover flap. The deployed driver air bag was round with a diameter of 50 centimeters [20 inches] (**Figure 7**). It had two tethers, and two vent ports at the 11 and 1 o'clock positions. The NASS researcher identified some smudges on the front of the air bag, but no other evidence of contact.

The front right passenger air bag was located in the top of the instrument panel (**Figure 6**). The module cover flap opened along the seams, with no apparent damage to the cover flap or the air bag. The deployed front right passenger air bag was rectangular, 50 centimeters [20 inches] high and 45 centimeters [18 inches] wide (**Figure 8**). The NASS researcher identified some smudges near the center on the front of the air bag, but no other evidence of contact.

Figure 6: Instrument panel from right, showing driver and passenger air bag cover flaps

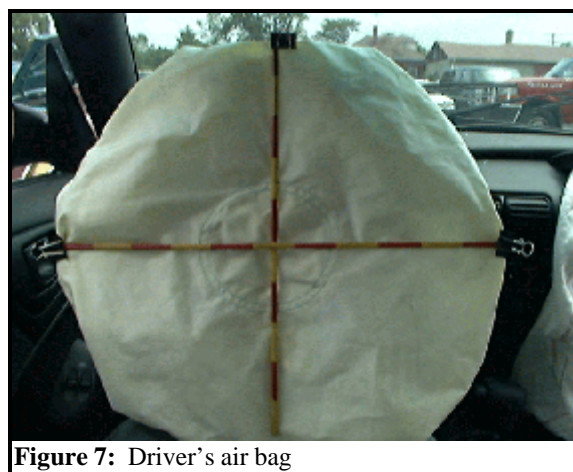
Figure 7: Driver's air bag

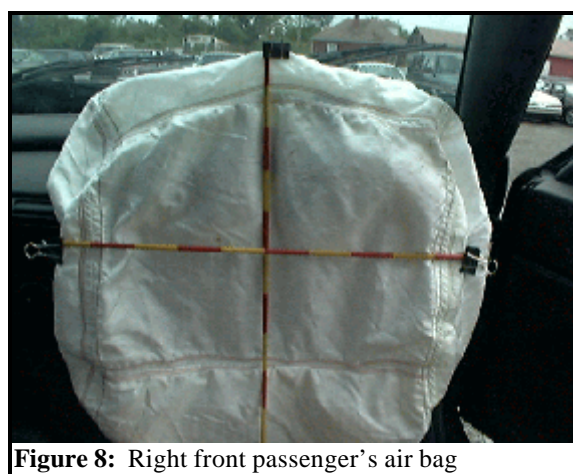
Figure 8: Right front passenger's air bag

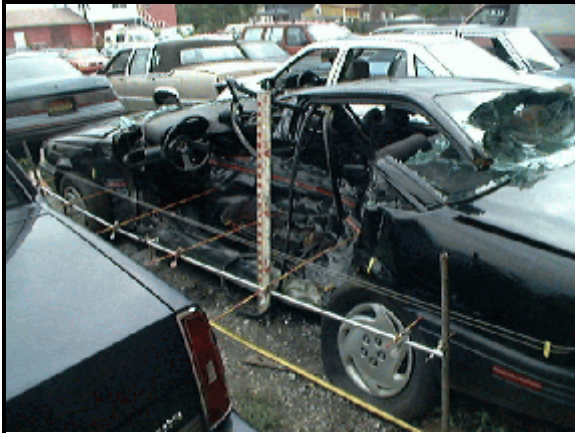
Vehicle #2 sustained an impact with the direct damage centered on the driver's door, extending forward into the left fender and rearward into the left quarter panel. Maximum crush was 80 centimeters [31 inches], approximately at the A-pillar. The entire left side collapsed inward, resulting in massive intrusion into the driver's seat area. The CDC was determined to be **10-LDAW-5**, with direction of principal force 300 [-60] degrees. The winSMASH reconstruction algorithm indicated total, longitudinal and lateral Delta V, respectively: 52 km.p.h. [32 m.p.h.], -26 km.p.h. [-16 m.p.h.] and +45 km.p.h. [+28 m.p.h.]. Vehicle #2's unrestrained driver (43-year-old male, Black, unknown if Hispanic, 190 centimeters, 136 kilograms [75 inches, 300 pounds]) was declared dead at the scene.

Figure 9: Vehicle #2's left side damage, looking forward

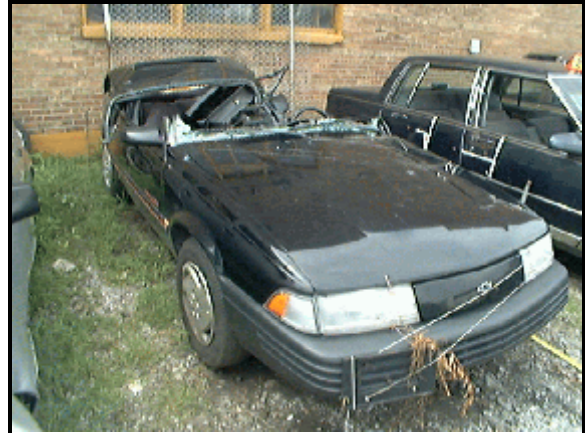
Figure 10: Vehicle #2, front right oblique view;
NOTE: pillars cut for extrication of victim
