Remote, Redesigned Air Bag Special Study

Dynamic Science, Inc., Case Number (1998-074-089E)

1998 Chevrolet Cavalier

1. Report No. 1998-074-089E		2. Government Accession No.		3. Recipient Catalog No.	
4. Title and Subtitle				5. Report Date September 15, 1999	
				6. Performing Organization Report No.

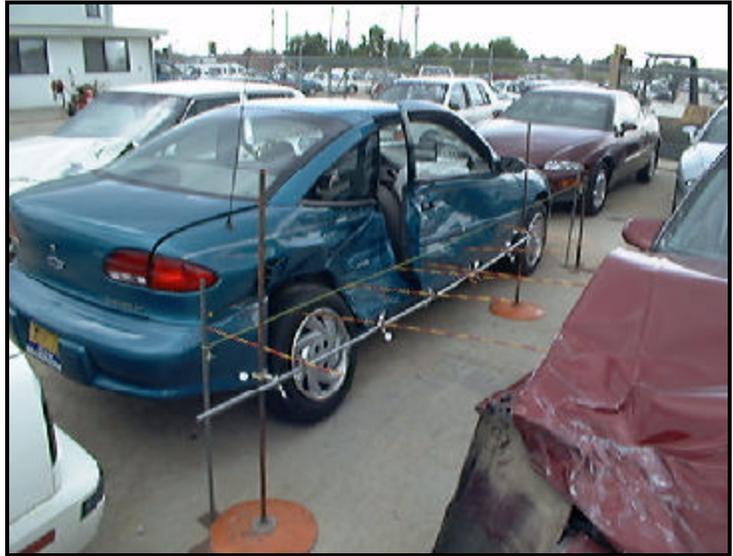
Figure 1. Exterior, Vehicle 2 (Chevrolet Cavalier)

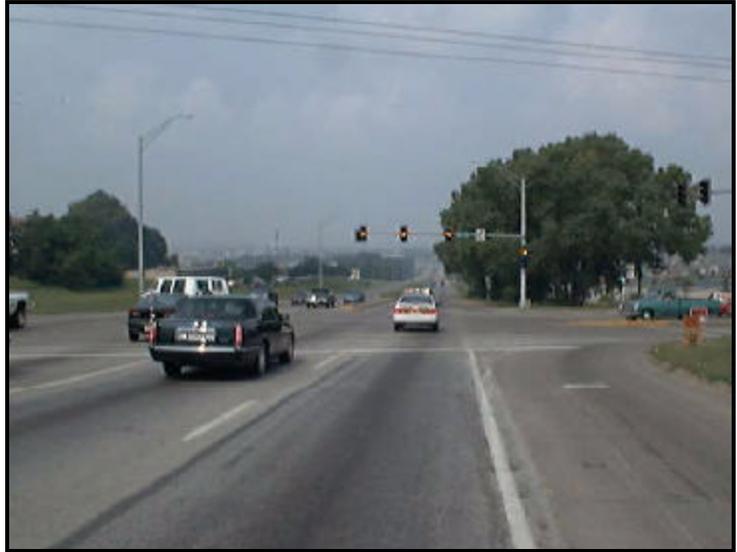
Figure 2. Crash scene, Vehicle 2 approach to impact.

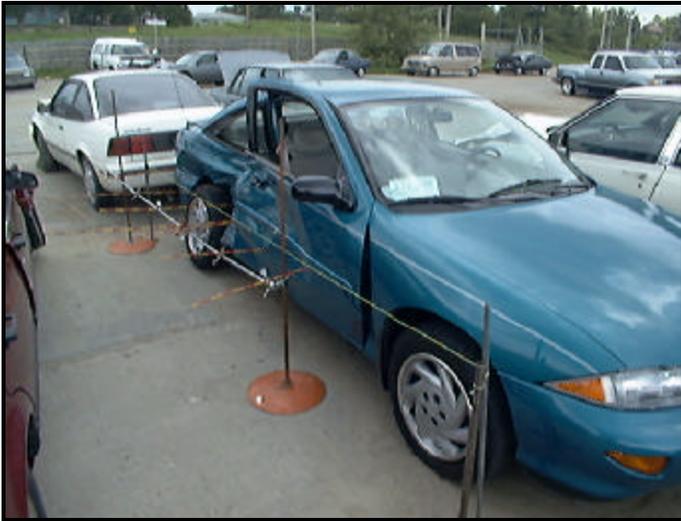
Vehicle 1 entered the intersection against the red traffic signal. Vehicle 2 entered the intersection with the green traffic signal. Vehicle 2 crossed the path of Vehicle 1 and was struck. The front plane of Vehicle 1 (unknown CDC) struck the right plane of Vehicle 2 (01RZEW3) in the intersection.

Figure 3. Exterior, Vehicle 2 (1998 Chevrolet Cavalier)

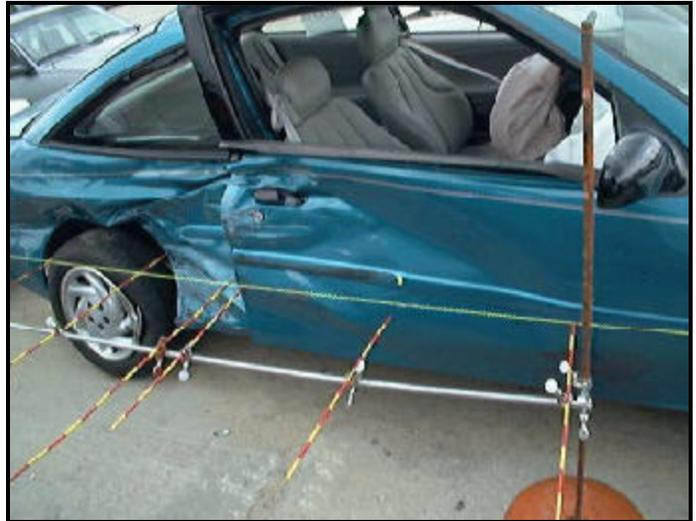
Figure 4. Exterior, Vehicle 2 (1998 Chevrolet Cavalier)

The interior of the Chevrolet Cavalier sustained no damage from occupant contact. There were several areas of significant intrusion into the passenger compartment on the right side of the vehicle. See Table 4 for intruded values.

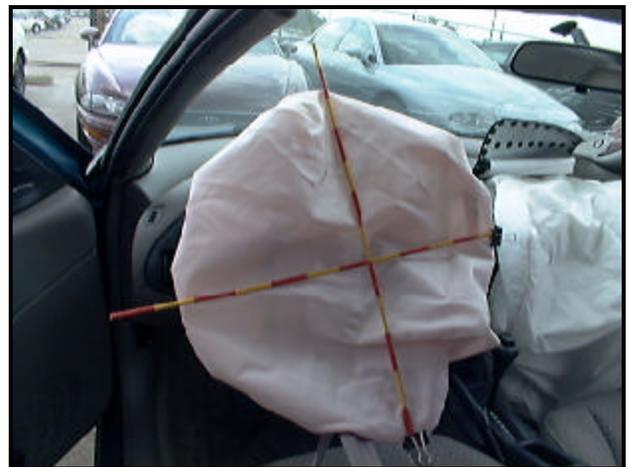
The front left air bag was housed in the steering wheel hub and was concealed by symmetrical I-configuration cover flaps which were not damaged. The circular air bag was equipped with one vent port and no tether straps. No contact evidence was found on the bag and the bag was not damaged.

Figure 5. Interior, case vehicle. Driver's frontal air bag)
