Remote, Redesigned Air Bag Special Study

Dynamic Science, Inc., Case Number ( 1998-74-139J)

1998 Nissan Altima

Nebraska

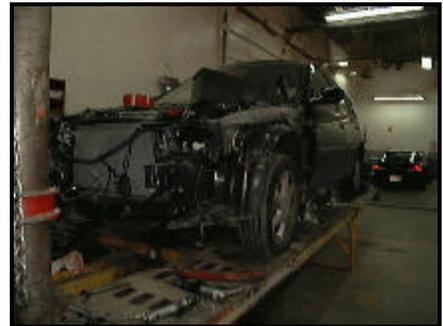
**Figure 3.** Vehicle 1 Under Repair

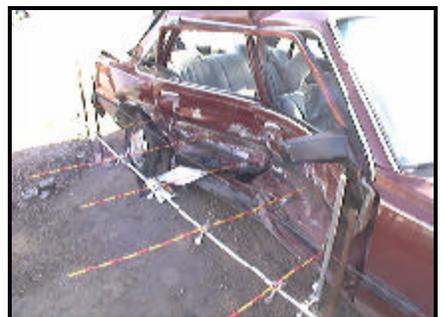
**Figure 4.** Right Side Impact Damage to Vehicle 2

The frontal plane of Vehicle 1 (unknown CDC/ vehicle under repair) impacted the right side plane of Vehicle 2 (02RPEW3) in a “T”-type impact configuration. The calculated delta V was 36.6 km/h (22.7 mph) for Vehicle 1 with a longitudinal delta V of -36 km/h (22.3 mph)<sup>1</sup> which was of sufficient force to deploy both frontal air bags. Vehicle 1 continued north and was deflected slightly to the right, before coming to rest adjacent to the northeast intersection quadrant. Vehicle 2 rotated approximately 103 degrees in a clockwise direction before impacting the base of the overhead traffic signal pole with its rear plane (07BCEW2). A delta V was calculated for the secondary rear plane impact to Vehicle 2 at 18.9 km/h (11.7 mph)<sup>2</sup>. Vehicle 2 came to rest with its rear plane against the pole and facing in a southwesterly direction.

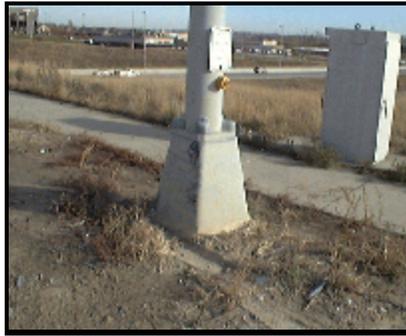
**Figure 5.** Impacted Traffic Signal Pole (Vehicle 2, Second Impact)

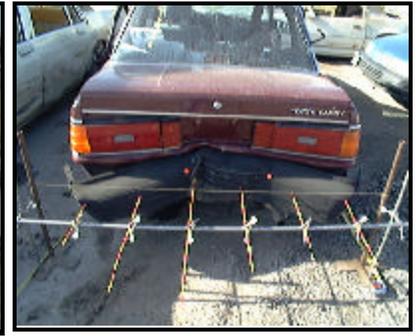
**Figure 6.** Impact Damage to Rear Plane of Vehicle 2

Plane of Impact	Field L cm/in.	C1 cm/in.	C2 cm/in.	C3 cm/in.	C4 cm/in.	C5 cm/in.	C6 cm/in.
Rear Plane	133	0	5	25	15	6	0
	52.4	0	2	9.8	5.9	2.4	0

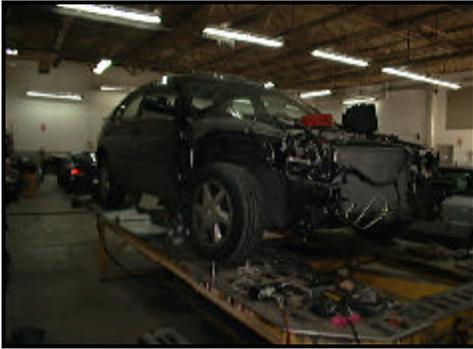
Model year, make and model	1998 Nissan Altima
VIN	1N4DL01D8WC
CDC	Unknown (Frontal Components removed / Vehicle Under Repair)

**Figure 7. Vehicle 1 Under Repair**

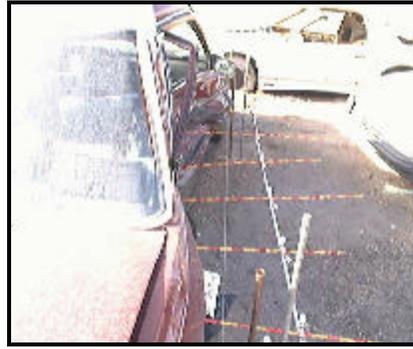
**Figure 8. Right Side Impact Damage to Vehicle 2**

Plane of Impact	Field L cm/in.	C1 cm/in.	C2 cm/in.	C3 cm/in.	C4 cm/in.	C5 cm/in.	C6 cm/in.
Right Side	211	5	27	46	62	44	2
	83.1	2	10.6	18.1	24.4	17.3	0.8

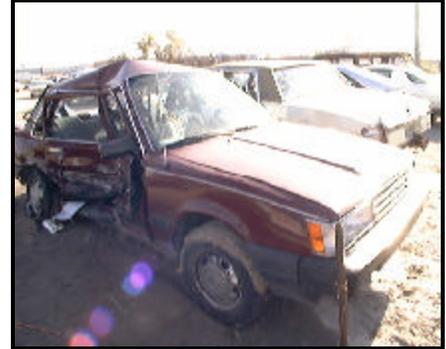
**Figure 9. Three-quarter View Showing Right Side Damage to Vehicle 2**

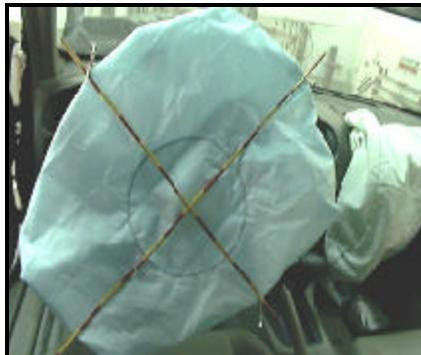
The driver's air bag is housed in the steering wheel hub and encases the nylon air bag unit. The double asymmetric, horizontal module cover flaps opened at their designated tear points and revealed no damage. The circular air bag is tethered by two straps and two exhaust vent ports. The lower instrument panel is equipped with a padded knee bolster. There were no detectable occupant contacts to either the knee bolster or the air bag nylon fabric.

**Figure 13.** View showing deployed drivers air bag

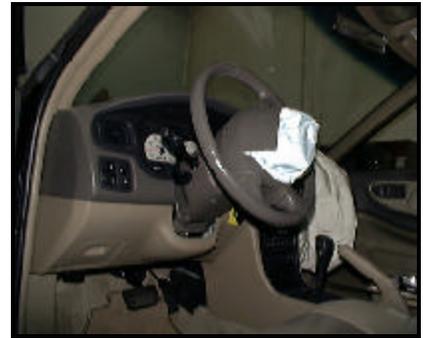
The interior of the Nissan Altima was void of damage due to occupant contacts. The laminated windshield and tempered side window glazing also was undamaged. The passenger compartment remained in its original pre-crash condition as there were no intruding components.

**Figure 10.** Front, left view showing case vehicle interior

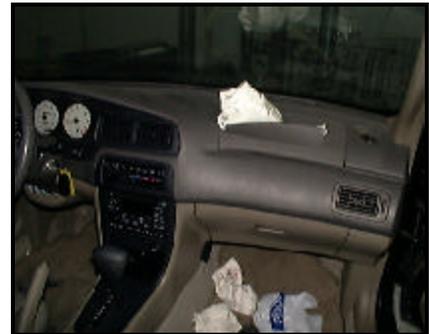
**Figure 11.** Front, right view showing case vehicle interior

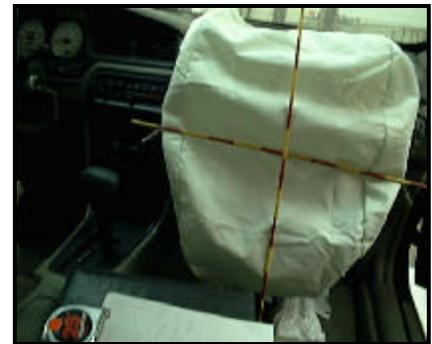
**Figure 14.** View showing deployed passenger (front, right) air bag

The front, right passenger air bag is located on the instrument panel (top mount). The module deployment door is rectangular in shape and constructed with molded seam tear points which opened at the designated area. The non-tethered air bag was undamaged and was equipped with two exhaust vent port holes.
