Remote, Redesigned Air Bag Special Study

Dynamic Science, Inc., Case Number (1998-074-802G)

1998 Ford Crown Victoria

September/1998

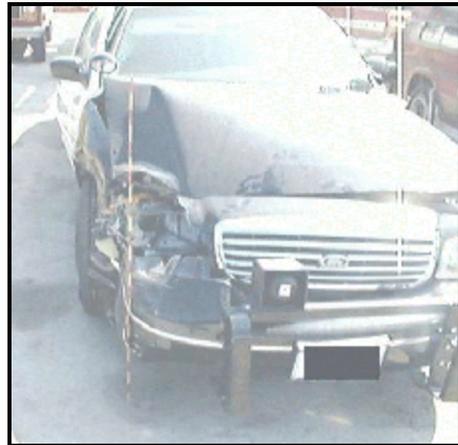
Figure 3. Direct damage, Vehicle 1 (1998 Ford Crown Victoria)

Plane of Impact	Field L cm/in.	C1 cm/in.	C2 cm/in.	C3 cm/in.	C4 cm/in.	C5 cm/in.	C6 cm/in.
Bumper	142	7	8	10	11	11	19
	55.9	2.8	3.1	3.9	4.3	4.3	7.5

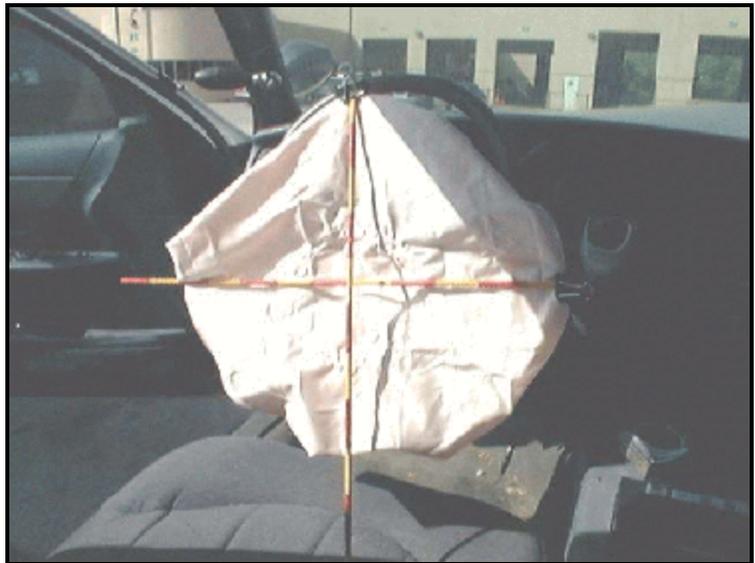
The front left air bag was housed in the steering wheel hub and was concealed by a singular inverted D-shaped cover flap which was not damaged in the crash. The circular air bag was equipped with two vent ports and no tether straps. No contact evidence was found on the bag and the bag was not damaged.

Figure 4. Interior, case vehicle. Driver's frontal air bag.

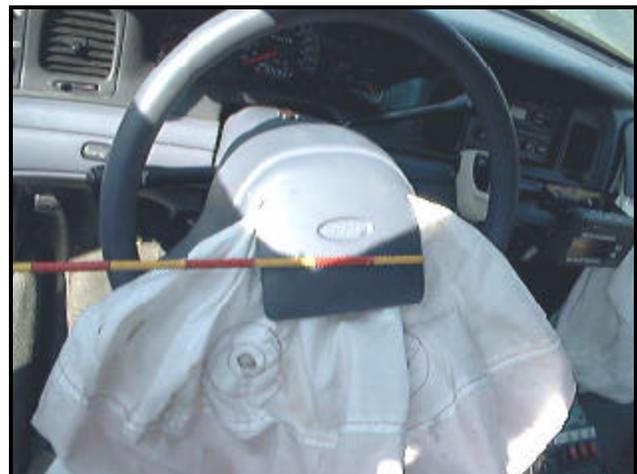
Figure 6. Interior, case vehicle. Driver's frontal air bag cover flap.
