Remote, Redesigned Air Bag Special Study

Dynamic Science, Inc., Case Number (1998-074-803G)

1998 Chevrolet Astro Van

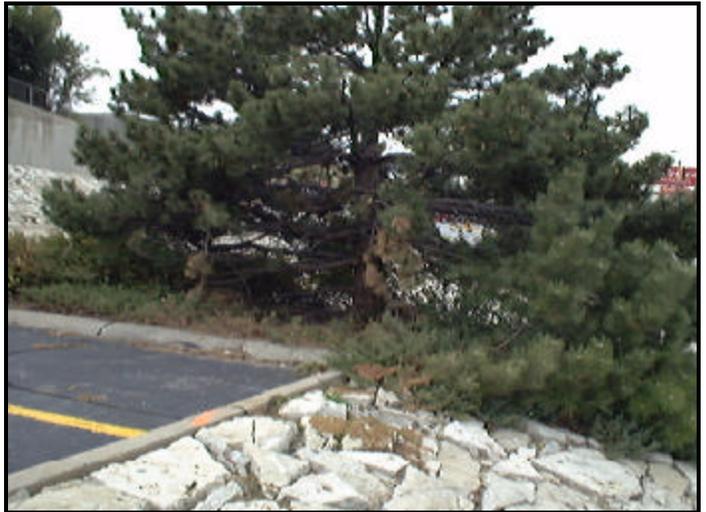
Figure 2. Crash scene, approach to tree impact.

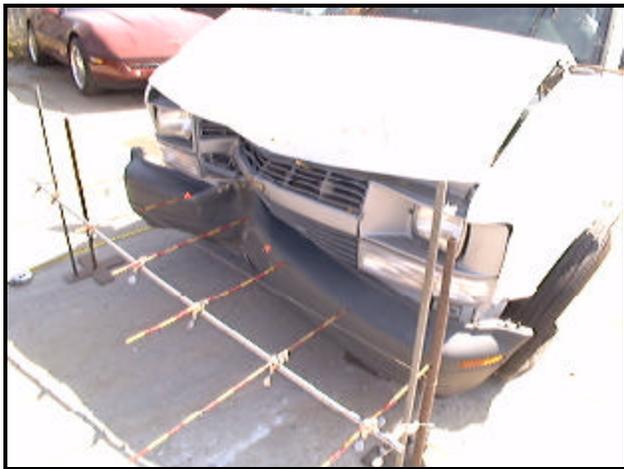
Figure 3. Exterior, Vehicle 1 (1998 Chevrolet Astro)

Plane of Impact	Field L cm/in.	C1 cm/in.	C2 cm/in.	C3 cm/in.	C4 cm/in.	C5 cm/in.	C6 cm/in.
Bumper	160	1	10	18	32	22	4
	63	0.4	3.9	7.1	12.6	8.7	1.6

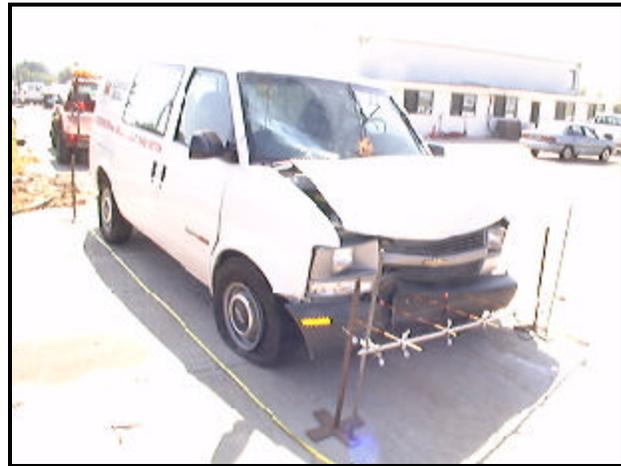
Figure 4. Exterior, Vehicle 1 (1998 Chevrolet Astro)

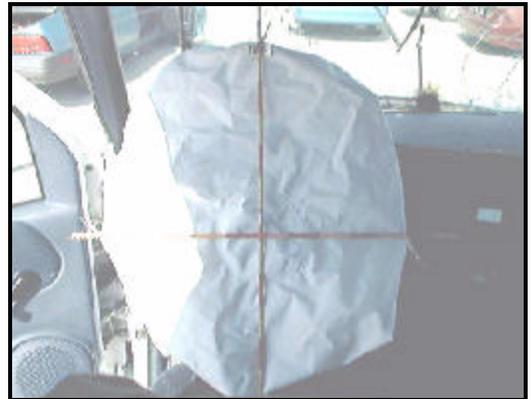
The front left air bag was housed in the steering wheel hub and was concealed by symmetrical I-configuration cover flaps which were not damaged. The circular air bag was equipped with two vent ports and two tether straps. No contact evidence was found on the bag and the bag was not damaged.

Figure 5. Driver's frontal air bag.

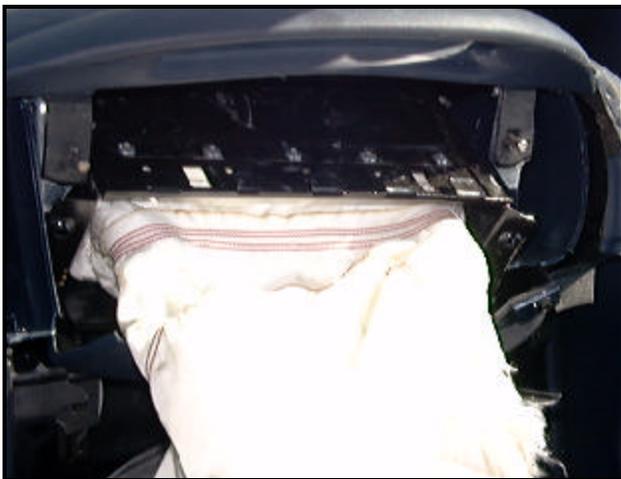
The front right air bag was housed in the mid instrument panel position and was concealed by symmetrical H-configuration cover flaps which were damaged. The top flap came completely disconnected from the console and was found on the floor of the vehicle. The rectangular air bag was equipped with two vent ports and two tether straps. No contact evidence was found on the bag but the bag was torn in several places primarily to the right side. The air bag module became separated from the instrument panel and pulled partially outward and down. The module anchorage bolts became detached. According to the driver, this was the original air bag and the bag had not been serviced. Figures 6 and 7 show this damage.

Figure 6. Passenger's frontal air bag. Module pulled out from instrument panel.

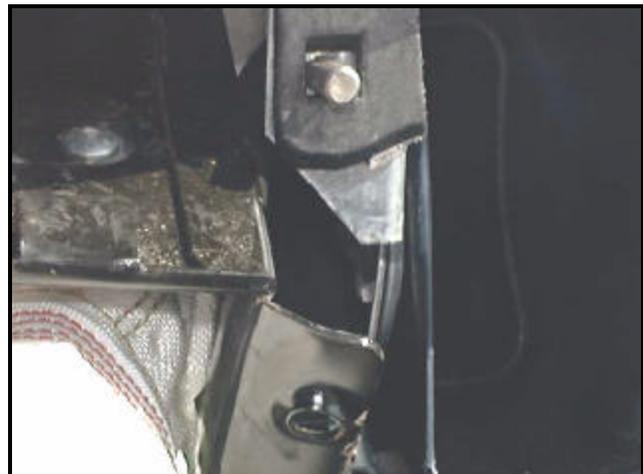
Figure 7. Passenger's frontal air bag. Close up of module retaining bolt failure.

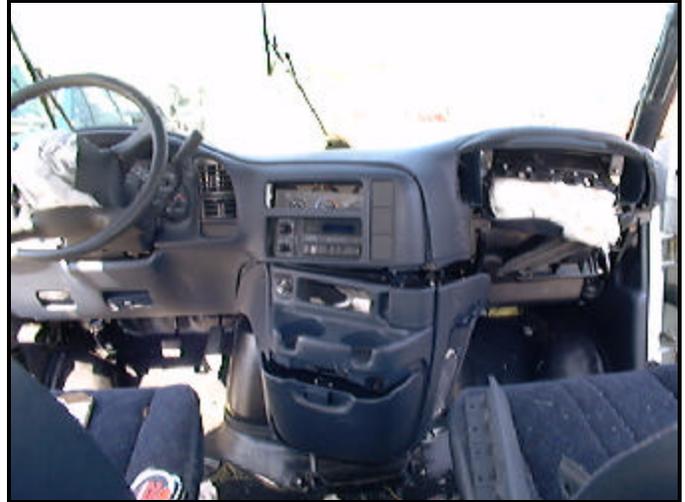
Figure 8. Interior, case vehicle

The interior of the Chevrolet Astro sustained minor damage from occupant contact. There were no areas of intrusion into the passenger compartment. There was occupant contact evidence to the left instrument panel consisting of a scuff. This was consistent with right knee contact.
