Remote, Redesigned Air Bag Special Study

Dynamic Science, Inc., Case Number (1998-74-804E)

1998 Mercury Sable

Nebraska

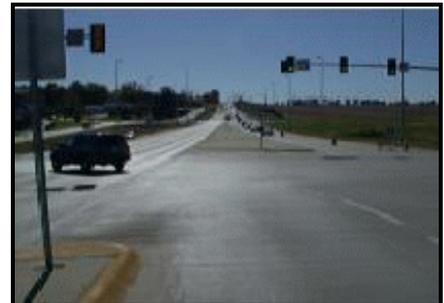
Figure 1. Pre-impact trajectory of Vehicle 1

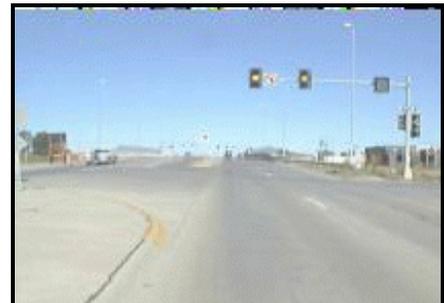
Figure 2. Pre-impact trajectory of Vehicle 2

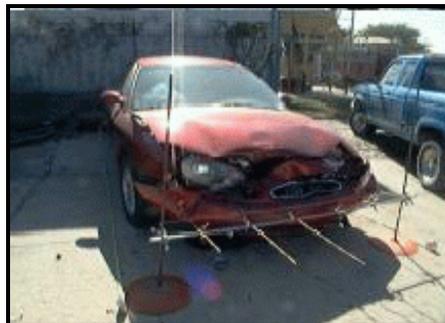
Figure 3. Exterior deformation to Vehicle 1 (Mercury Sable)

Plane of Impact	Field L cm/in.	C1 cm/in.	C2 cm/in.	C3 cm/in.	C4 cm/in.	C5 cm/in.	C6 cm/in.
Front Bumper	152	10	4	6	9	14	24
	59.8	3.9	1.6	2.4	3.5	5.5	9.4

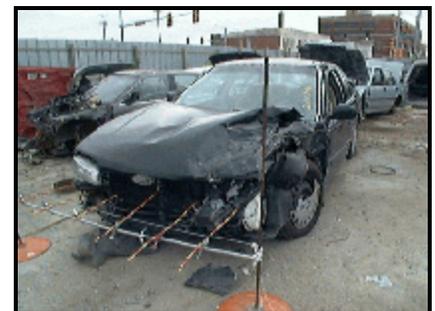
Figure 4. Exterior deformation to Vehicle 2 (Honda Accord)

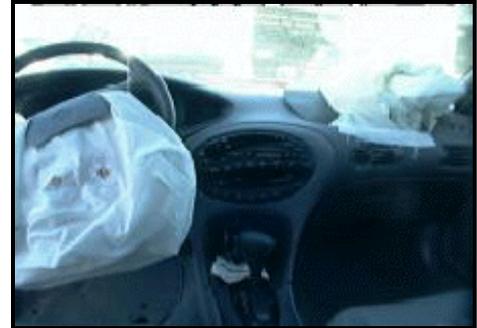
The interior of the Mercury Sable sustained minor damage which can be attributed to the passenger side, air bag deployment. The front, right passenger air bag module flap (top mount) impacted and broke the laminated windshield glazing. The passenger air bag apparently impacted and dislodged the center, rear view mirror during the deployment. The passenger compartment maintained its integrity and there were no intruding components. The case vehicle is equipped with front bucket seats with a rear bench seat with a folding seatback. The driver's seat was adjusted to the rearmost track position while the right, front seat was adjusted at the middle position. The front seats have adjustable head restraints which were not damaged during the collision. The rear, outboard seated positions are equipped with integral head restraints.

Figure 7. Interior of case vehicle

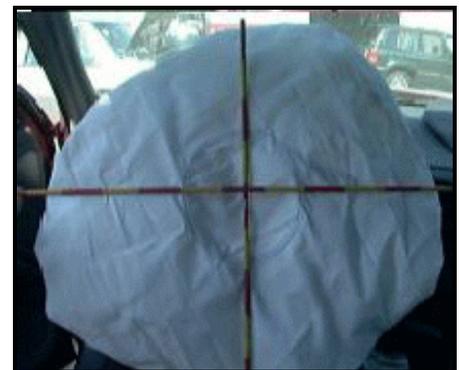
Figure 8. View showing the deployed driver's air bag

The front, left air bag was housed in the steering wheel hub and was concealed by asymmetrical H-configuration cover flaps. The concentric air bag was 672 mm (26.5 in.) in diameter and was equipped with two tether straps and two exhaust vent ports. At full inflation, the air bag volume is 2.0 cubic feet and fully inflates in approximately 40 milliseconds. The nylon air bag fabric was void of any detectable occupant contact points.

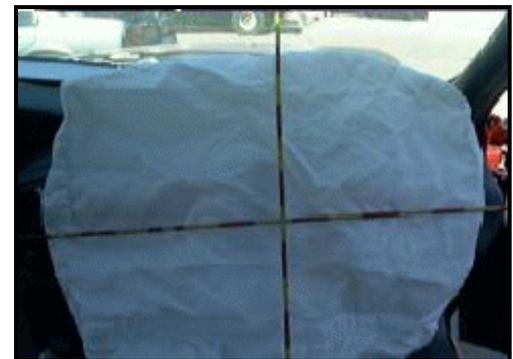
Figure 9. View showing the deployed passenger air bag

The front, right air bag unit was located on the top surface plane of the instrument panel, above the glove compartment. The module flap cover is a “D”-shape and opened at its designated tear points. The porous nylon air bag material is not equipped with tethers or vent ports. The air bag fills to a total volume of 5.1 cubic feet. There were no indications of damage or contact to either the air bag or the module cover flap.

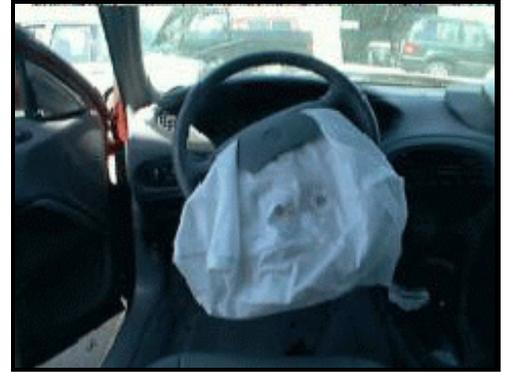
The driver's most serious injuries came as a result of her left foot significantly loading the toe pan. She sustained a comminuted fracture of her left distal fibula (AIS-2) and an oblique fracture of her left distal tibia (AIS-2). She rebounded back into the seatback support as she came to rest.

Figure 10. View showing driver's seated position

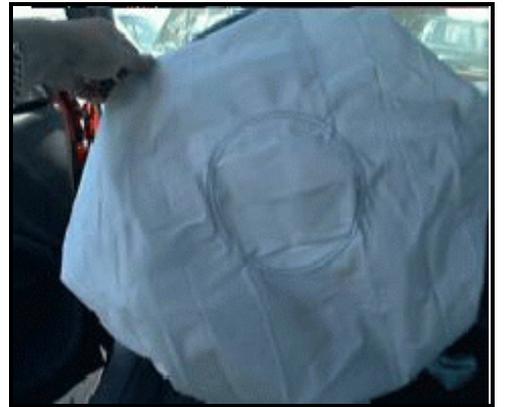
Figure 11. Deployed driver's air bag
