Remote, Redesigned Air Bag Special Study  
Dynamic Science, Inc., Case Number ( 1998-075-802C)  
1998 Honda CR-V  
Colorado  
August/1998

1. Report No. 1998-075-802C		2. Government Accession No.		3. Recipient Catalog No.	
4. Title and Subtitle				5. Report Date April 18, 2000	
				6. Performing Organization Report No.

**Summary**

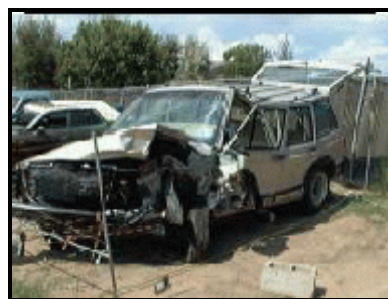
**Figure 4.** Exterior, Vehicle 1 (Jeep)

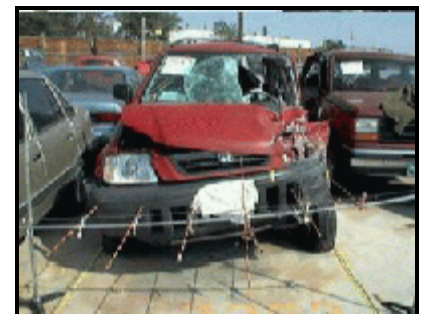
**Figure 5.** Exterior, Vehicle 2 (Honda)

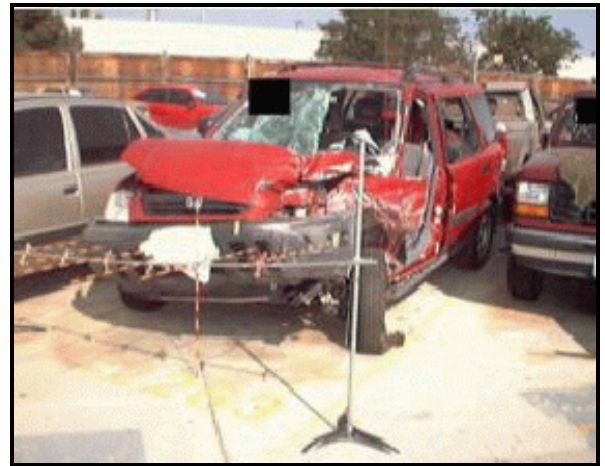
**Figure 6.** Three quarter frontal view of Vehicle 2

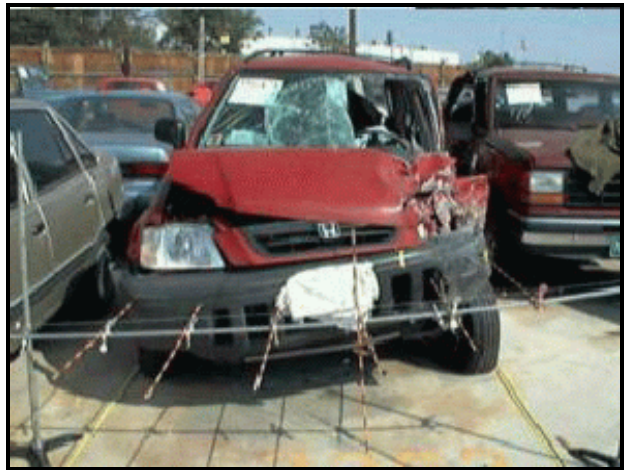
**Figure 7.** Exterior, Vehicle 2

Plane of Impact	Field L cm/in.	C1 cm/in.	C2 cm/in.	C3 cm/in.	C4 cm/in.	C5 cm/in.	C6 cm/in.
Front Bumper	153	46	48	38	23	17	10
	60.2	18.1	18.9	15	9.1	6.7	3.9

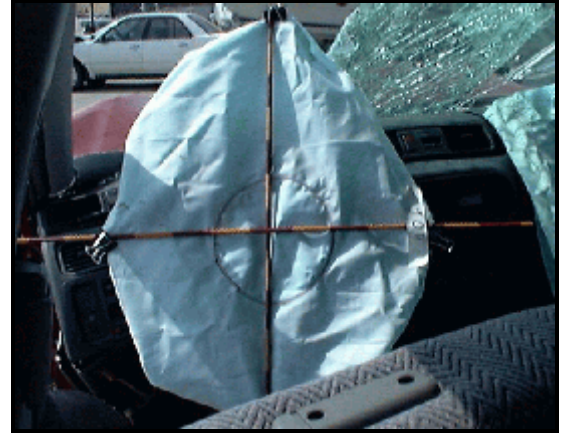
The driver's air bag is housed in the steering wheel hub and encases the nylon air bag unit. The double, horizontal module cover flaps are asymmetric in design and opened at their designated tear points. The circular air bag is 62 cm (24.4 in.) in diameter and is equipped with two tether straps and two exhaust vent port holes. The vent ports are located at the 11 and 1 o'clock positions. The rigid plastic knee bolster was dented due to driver knee loading.

**Figure 8.** Deployed driver's air bag

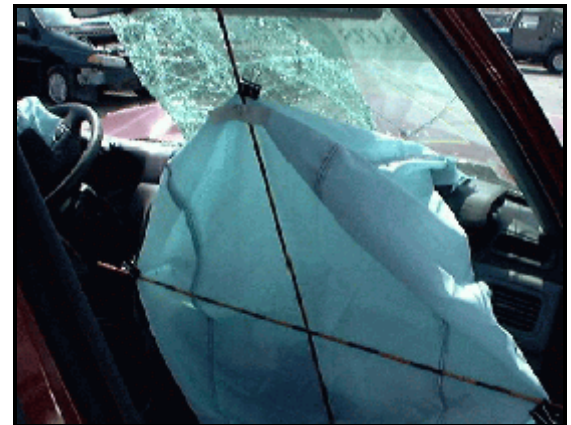
The front, right passenger air bag is located on the instrument panel (top mounted). The module deployment door is rectangular in shape and is equipped with double horizontal cover flaps that are symmetrical in design (23 cm wide x 4.7 cm in height). The non-tethered air bag deployed and was undamaged. The passenger air bag is equipped with two vent port holes which are at the 10 and 2 o'clock positions respectively.

**Figure 9.** Deployed passenger air bag (upper half)

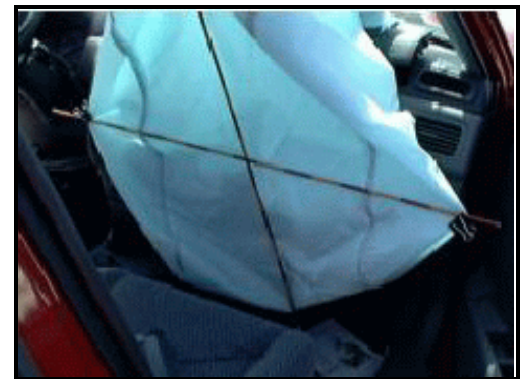
**Figure 10.** Deployed passenger air bag (lower half)
