Remote, Redesigned Air Bag Special Study

Dynamic Science, Inc., Case Number (1998-075-803E)

1998 Buick Century

October, 1998

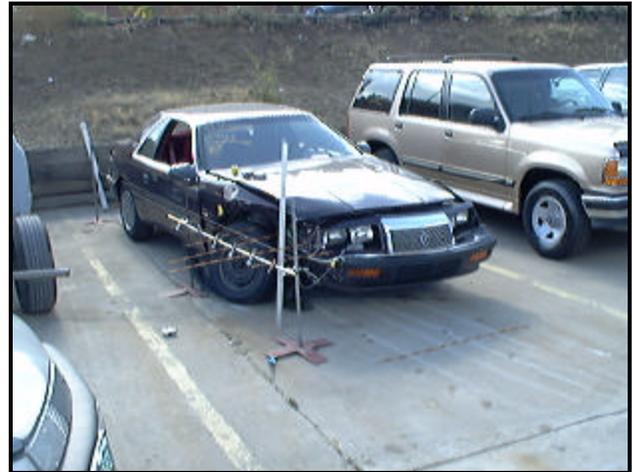
Figure 1. Exterior, Vehicle 1 (1992 Chrysler Lebaron)

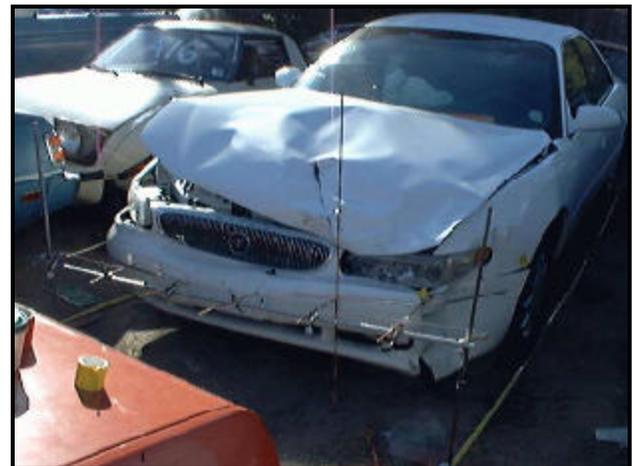
Figure 2. Exterior, Vehicle 2 (1998 Buick Century)

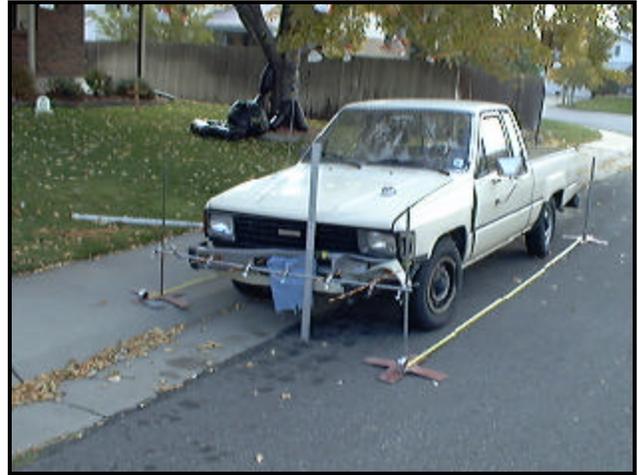
Figure 3. Exterior, Vehicle 3 (1985 Toyota Pickup)

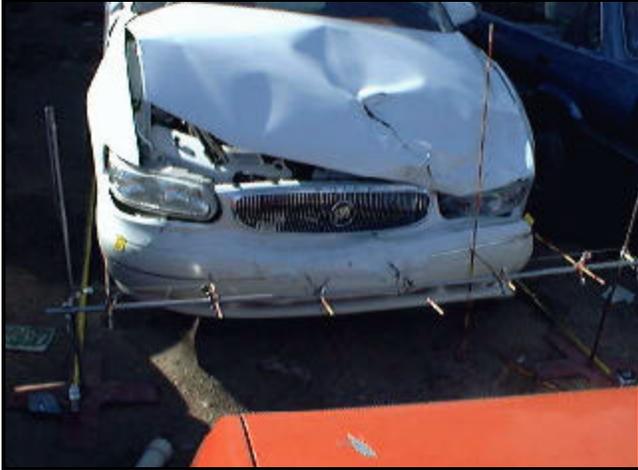
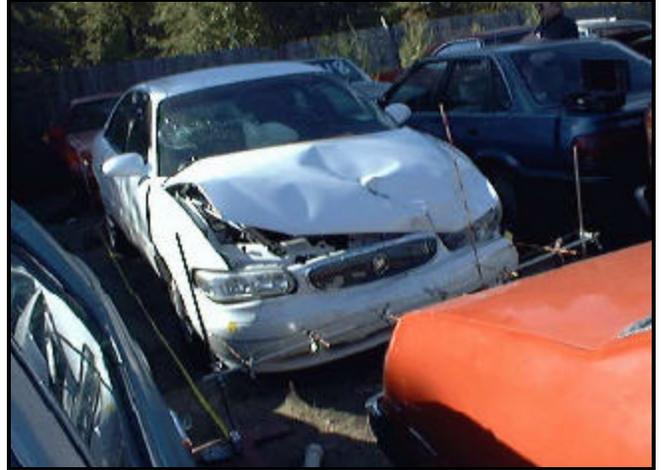
| CDC | 11FYEW1 |

Figure 4. Exterior, Vehicle 2 (1998 Buick Century)

Figure 5. Exterior, Vehicle 2 (1998 Buick Century)

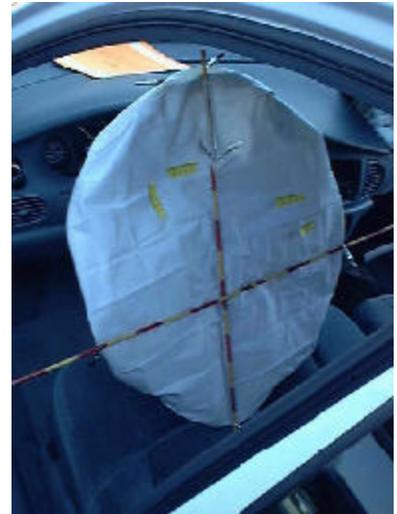
The front left air bag was housed in the steering wheel hub and was concealed by symmetrical I-configuration cover flaps which were not damaged. The circular air bag was equipped with two tether straps and two vent ports. Contact evidence consisting of what appeared to be black cloth transfers was found on the front of the bag. The air bag was not damaged in the crash.

Figure 6. Interior, case vehicle. Driver's side frontal air bag.

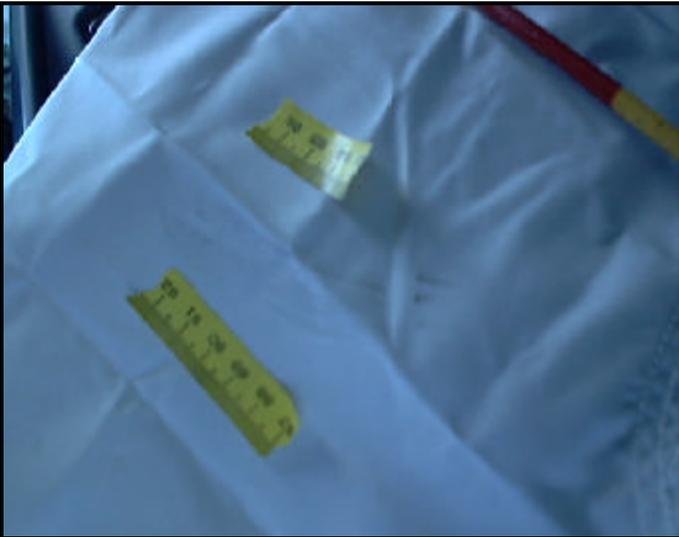
Figure 7. Interior, case vehicle. Driver's side frontal air bag contact evidence.

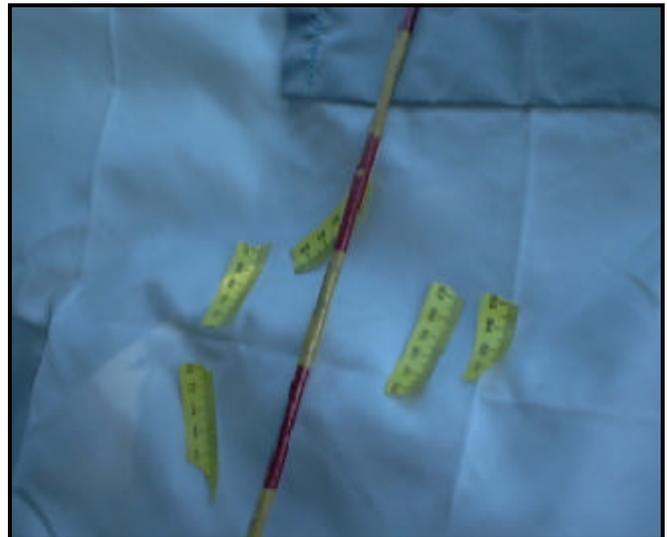
The front right air bag was housed in the top-instrument panel position. The single air bag module cover flap was a rectangular configuration. The bottom edge of the flap was damaged slightly from impacting the windshield. The rectangular air bag was not equipped with tether straps or vent ports. Contact evidence consisting of black cloth transfers and blood was found on the front of the bag. The air bag was not damaged in the crash.

Figure 8. Interior, case vehicle. Passenger's side frontal air bag contact evidence.
