Remote, Redesigned Air Bag Special Study

Dynamic Science, Inc., Case Number (1998-075-805G)

1998 Mazda Pickup

November/1998

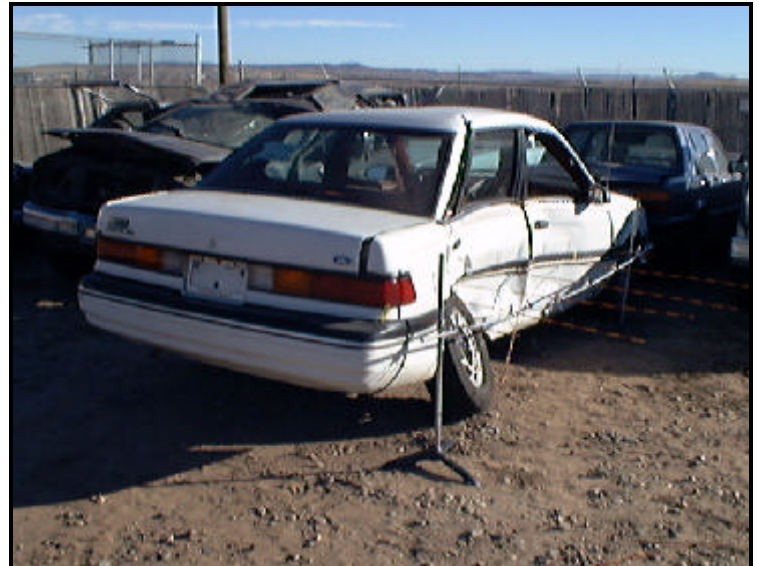
**Figure 1.** Exterior, Vehicle 1 (1991 Ford Tempo)

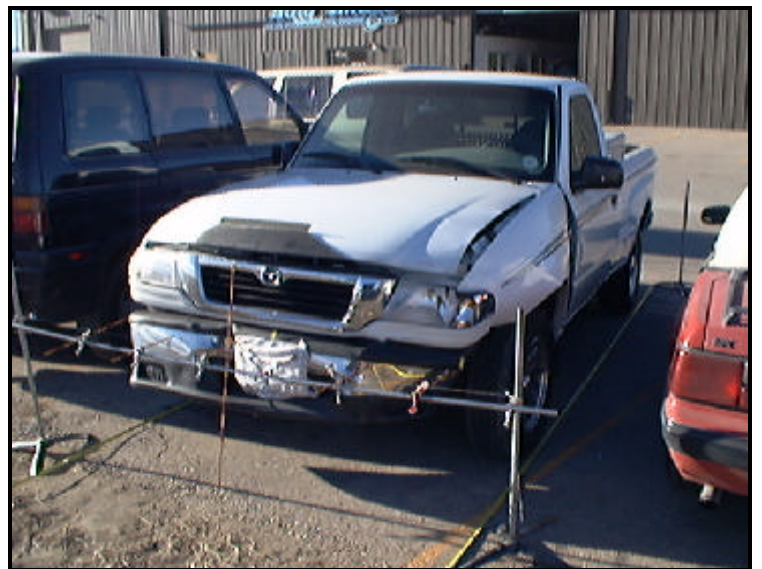
**Figure 2.** Exterior, Vehicle 2 (1998 Mazda Pickup)

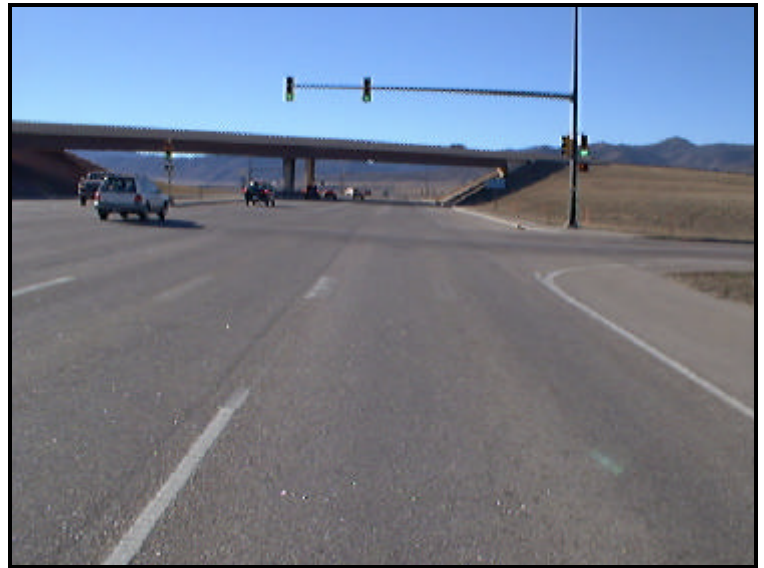
Figure 3. Crash scene. Vehicle 2 approach path.

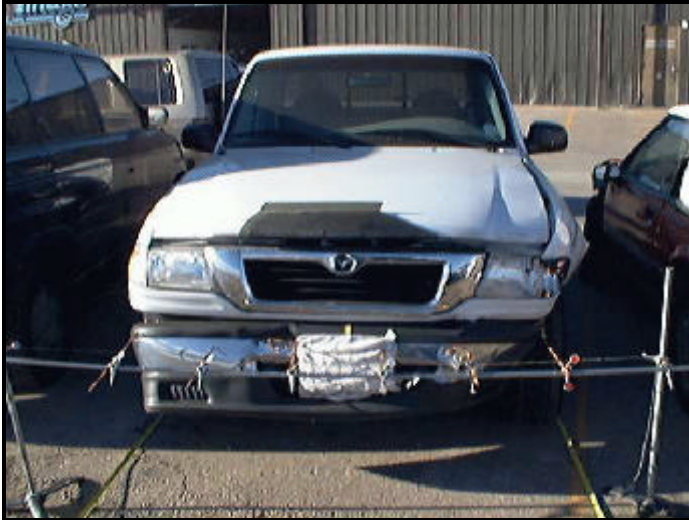
**Figure 4.** Exterior, case vehicle (1998 Mazda Pickup)

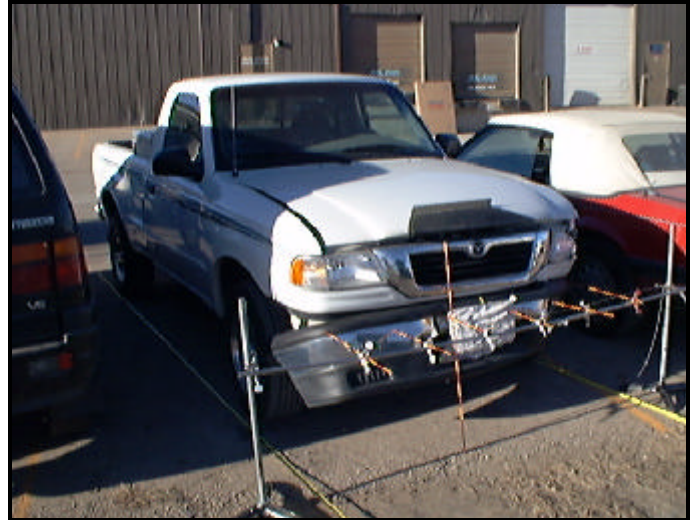
**Figure 5.** Exterior, case vehicle (1998 Mazda Pickup)

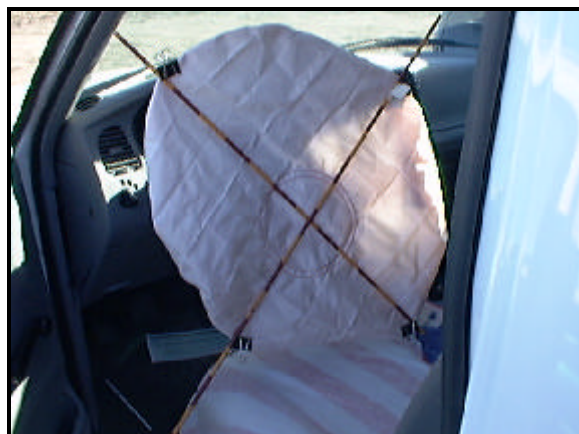
The front left air bag was housed in the steering wheel hub and was concealed by asymmetrical H-configuration cover flaps which were not damaged in the crash. The circular air bag was equipped with two tether straps and two vent ports. No contact evidence was found on the bag and the bag was not damaged.

**Figure 6.** Interior, case vehicle. Driver's air bag.

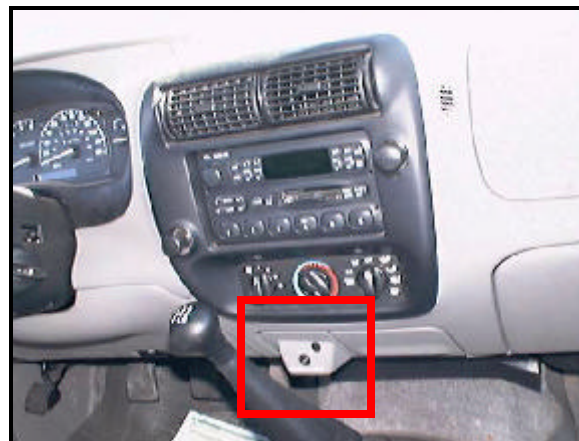
The front right air bag shut off switch was located on the center instrument panel. The switch is key activated and was turned to the "off" position during the crash.

**Figure 7.** Interior, case vehicle. Box indicates location of passenger's air bag shut off switch.

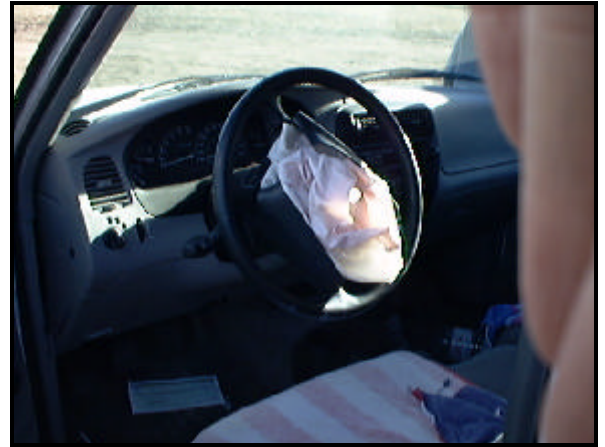
**Figure 8.** Interior case vehicle. Case occupant seating position.
