## SCI/NASS COMBINATION CASE REPORT

CASE NUMBER - NASS-98-79-046A

VEHICLE - 1998 CHEVROLET GEO METRO

CRASH DATE - March 1998

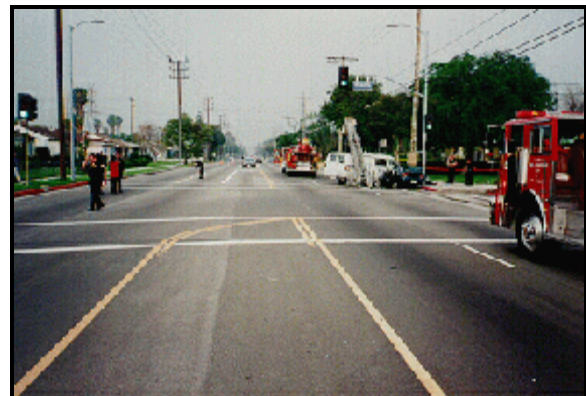
**Figure 1:** Case vehicle's westbound approach toward impact, with vehicles at approximate final rest (police photo)

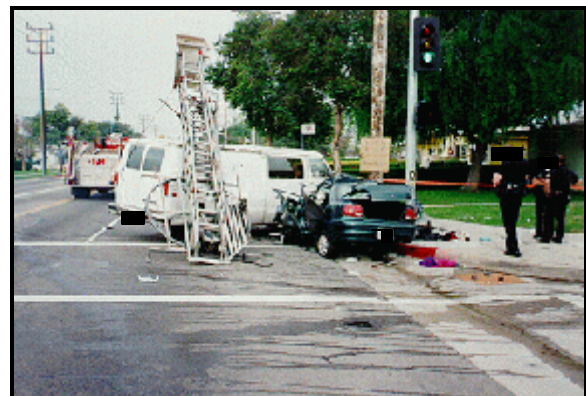
**Figure 2:** Vehicles at approximate final rest; NOTE: ladder device fell from van's roof; rescue workers put case vehicle back on its wheels (police photo)

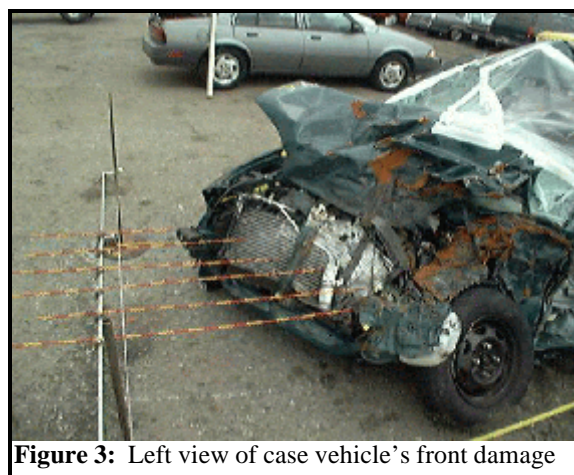
The case vehicle sustained underride-type damage at the front left corner resulting in direct contact damage across the left two-thirds of the front and on the left side from the front corner almost to the left B-pillar, including direct contact to the left A-pillar above the belt line and the driver’s door window frame and glazing. The impact involved sustained contact while the two vehicles were rotating, with substantial grinding and tearing of the case vehicle’s body panels. Maximum crush was 69 centimeters [27 inches] at the front left corner (**Figure 3**). The CDC for the case vehicle’s impact with vehicle #2 is **12-FDEW-4** (direction of principal force 350 [-10] degrees). The WinSMASH reconstruction program was used to estimate Delta V based on the measured crush profiles for the two vehicles. This is a complex crash scenario and these results provide a borderline reconstruction. The results seem low for the amount of visually apparent crush. The estimated total, longitudinal and lateral Delta Vs for the case vehicle are, respectively, 67 km.p.h. [42 m.p.h.], -66 km.p.h. [-41 m.p.h.] and 12 km.p.h. [7 m.p.h.].

**Figure 3:** Left view of case vehicle’s front damage

The front bumper and cover were torn away and the hood was folded double and forced rearward into the windshield. The windshield was fractured across its entire width and separated from its mounting along the left A-pillar and along the windshield header on the left. The left front axle was broken with the wheel tilted inward at the top. The wheelbase was shortened to 190 centimeters [75 inches] on the left but was relatively unchanged at 234 centimeters [92 inches] on the right. The left lower A-pillar was forced rearward, the left upper A-pillar sustained direct contact damage above the belt line and the entire A-pillar was

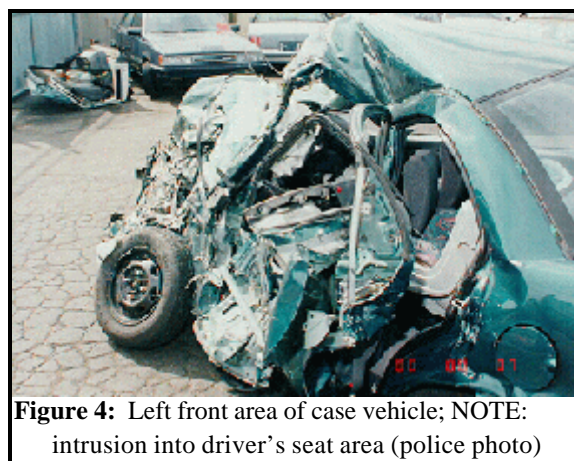
**Figure 4:** Left front area of case vehicle; NOTE: intrusion into driver’s seat area (police photo)

displaced rearward and inward. The left B-pillar was collapsed inward and the left roof rail and left side of the roof were buckled downward in the area of the driver's door opening (**Figure 4**, above). The two door openings on the left were distorted and the glazing in both doors was shattered (**Figure 5**). The right rear wheel was tilted inward at the bottom, resulting from contact with the high barrier curb. There was abrading and red paint transfers on the right rear quarter panel, along the right rocker panel and the lower edges of the two right doors from contact with the curb and sidewalk as the case vehicle rolled to the right upon impacting the curb (**Figure 6**). The CDC for the curb impact, estimated from photographs<sup>1</sup>, is **03-RDLW-2**. (The Police Crash Report indicates that the case vehicle was found lying on its right side but rescue personnel had rolled it back onto its wheels.) The CDC for the rollover is **00-RDAO-2**. The two right doors were forced open during extrication, with pry marks on the doors and adjacent body structures.

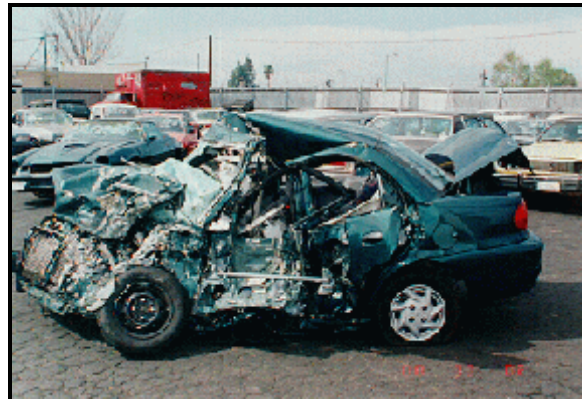
**Figure 5:** Case vehicle's entire left side (police photo)

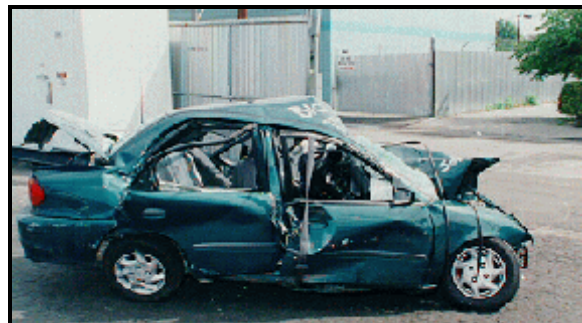
**Figure 6:** Right side of case vehicle showing curb impact and rollover damage (police photo)

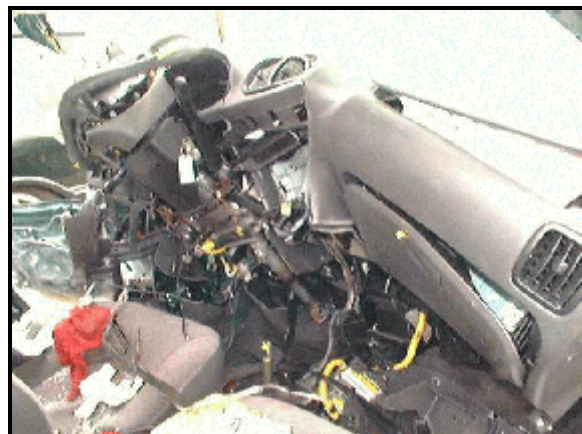
The instrument panel was displaced rearward along its entire width, with upward buckling at the middle (**Figure 7**). The driver's instrument cluster and the controls at the center instrument panel were shattered. The lower end of the steering column was forced downward and rearward while the upper end was forced upward and against the instrument panel. The steering wheel rim and spokes were bent and twisted. Longitudinal intrusion by the left A-pillar and lateral intrusion by the left roof rail were each measured as 42 centimeters [17 inches], with 40 centimeters [16 inches] longitudinal intrusion by the left toe pan. There was significant intrusion by the windshield header, instrument panel and floor on the right. The two front bucket seats were forced rearward such that the front seat backs were nearly touching the back seat cushion. There was a child safety seat in the back seat, but there was no child occupant present at the time of the crash.

**Figure 7:** Case vehicle's front seat row and instrument panel viewed from right

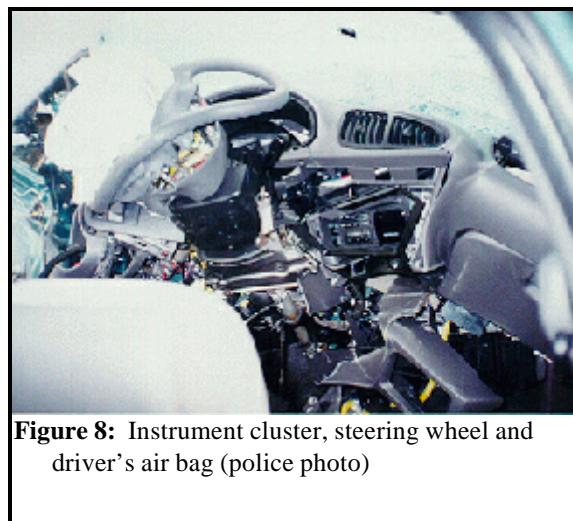
The case vehicle was equipped with redesigned air bags for the driver and front right passenger seat positions. The driver's air bag was located in the steering wheel hub (**Figure 8**). The module cover flaps opened along the seams, with no damage to the flaps. The deployed air bag was round, with diameter 60 centimeters [24 inches] and vent ports at the 11 and 1 o'clock positions. It is not known if the driver's air bag was tethered. The back of the air bag was torn, possibly due to contacting the intruding shattered windshield. The NASS case coding indicates the researcher judged the tearing of the air bag as an indication of possible air bag failure. There was some light scuffing on the upper left quadrant of the front of the driver's air bag, but no other evidence of contact was recorded.

**Figure 8:** Instrument cluster, steering wheel and driver's air bag (police photo)

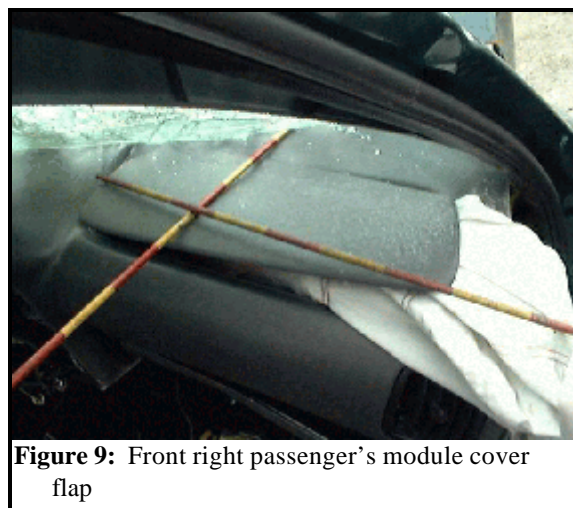
The front right passenger's air bag was located in the top of the instrument panel. The module's single cover flap opened along the seams, with no damage to the flap (**Figure 9**). The deployed air bag was rectangular, 60 centimeters [24 inches] wide and 65 centimeters [26 inches] high, with no tethers or vent ports. There were some spots of blood in the center-left area and several small tears near the top on the front of the air bag, with no other evidence of contact.

**Figure 9:** Front right passenger's module cover flap

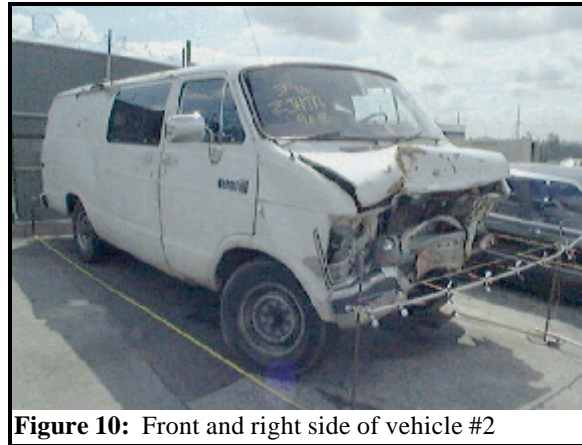
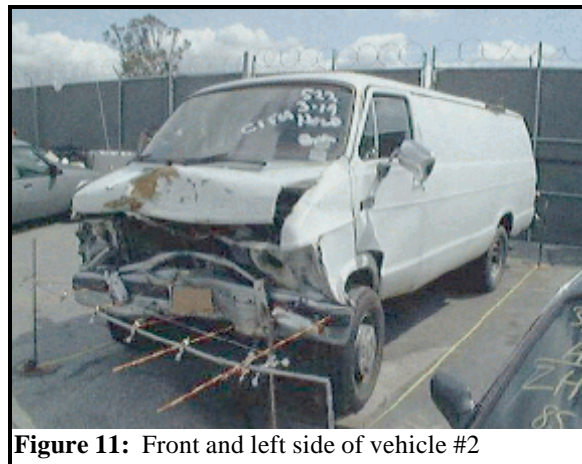
Vehicle #2 was a 1990 Dodge B350 cargo van (VIN: 2B7KB31Z4LK-----) with extended rear overhang (the “Maxi Van” model). Vehicle #2's damage consisted of direct contact across the left two-thirds of the front, with direct contact to the bumper, grille, hood and the front axle and suspension on the left (**Figures 10 & 11**). The left front wheel and tire were forced rearward, against the trailing edge of the wheel well. The left front fender and door sustained induced damage and the windshield separated from its gasket/mounting around most of its perimeter. The windshield did not fracture or crack and there was no other glazing damage. The CDC for vehicle #2's impact with the case vehicle is **01-FDEW-4**, with direction of principal force 20 degrees. Vehicle #2 was equipped with an extension ladder on a rotating platform (“cherry picker”) mounted on its roof (**Figure 12**). This device was broken loose during the collision and fell to the ground without making contact with the case vehicle. The WinSMASH reconstruction program was used to estimate Delta V based on the measured crush profiles for the two vehicles. This is a complex crash scenario and these results provide a borderline reconstruction. The results appear low for the visually apparent amount of crush. The estimated total, longitudinal and lateral Delta Vs for vehicle #2 are, respectively, 31 km.p.h. [19 m.p.h.], -30 km.p.h. [-18 m.p.h.] and -11 km.p.h. [-7 m.p.h.].

**Figure 10:** Front and right side of vehicle #2

**Figure 11:** Front and left side of vehicle #2

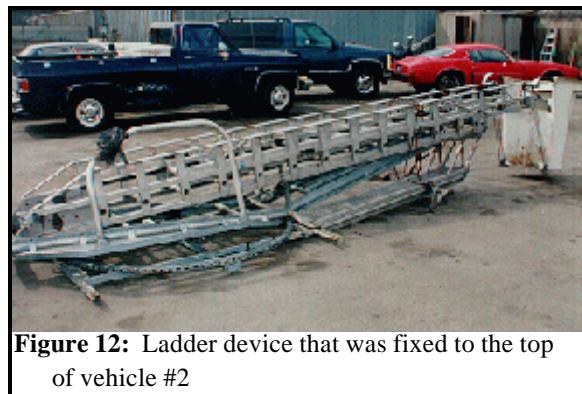
picker”) mounted on its roof. This device was knocked loose and fell to the ground. Police reconstructionists estimated the case vehicle’s immediate pre-crash travel speed as 95 km.p.h. [59 m.p.h.]. The driver of vehicle #2 estimated his at-impact travel speed as 32 km.p.h. [20 m.p.h.].

**Figure 12:** Ladder device that was fixed to the top of vehicle #2
