Remote, Redesigned Air Bag Special Study

Dynamic Science, Inc., Case Number ( 1998-079-802E)

1998 Toyota Corolla

***Summary***

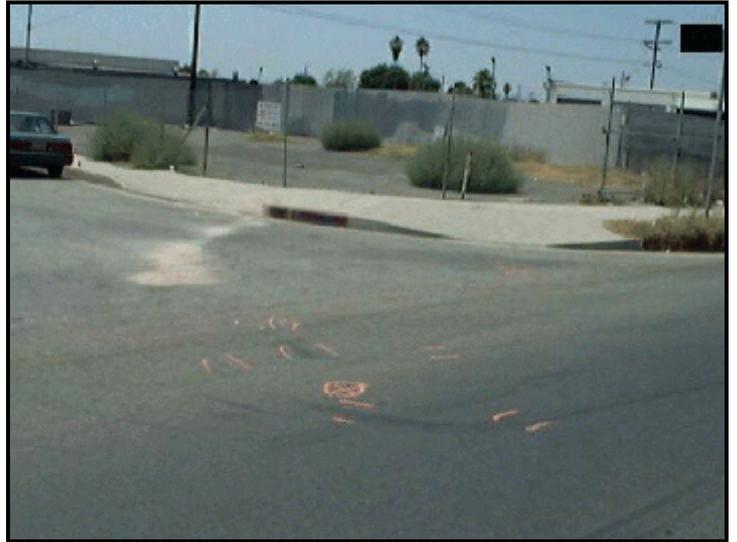
**Figure 1.** View showing Vehicle 1's Point of Impact & Final Rest Location (curb)

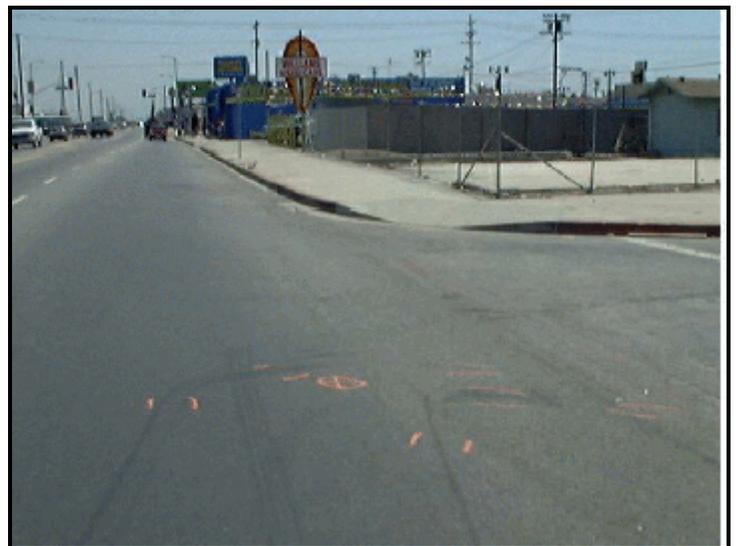
**Figure 2.** View showing Vehicle 2's (case vehicle) Point of Impact

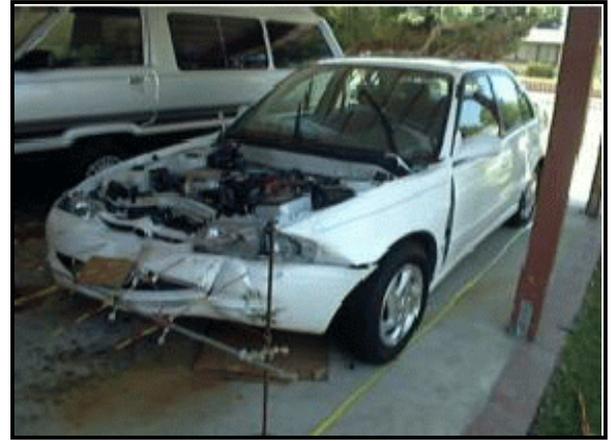
**Figure 3.** Exterior, left front of Vehicle 2

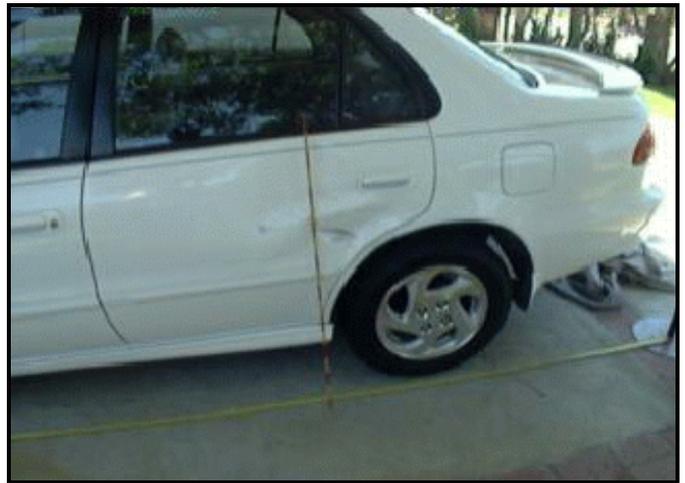
The involved vehicles engaged in a secondary side-slap as the right quarter-panel area of Vehicle 1 impacted the left rear door of Vehicle 2 (09LPEW1).

**Figure 4.** Left side view of Vehicle 2 showing side slap impact

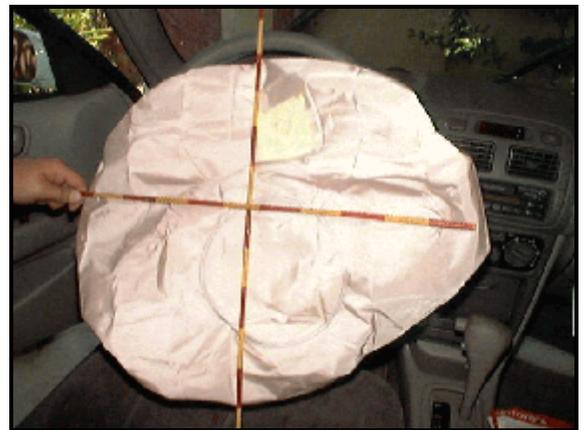
The front left air bag was housed in the steering wheel hub and was concealed by asymmetrical double horizontal module cover flaps. The circular air bag was tethered by four separate tether straps and was equipped with two vent ports. The lower instrument panel is equipped with a rigid plastic knee bolster. There was no discernible residual contact damage to the knee bolster, air bag, or module cover flaps.

**Figure 8.** Deployed driver's air bag

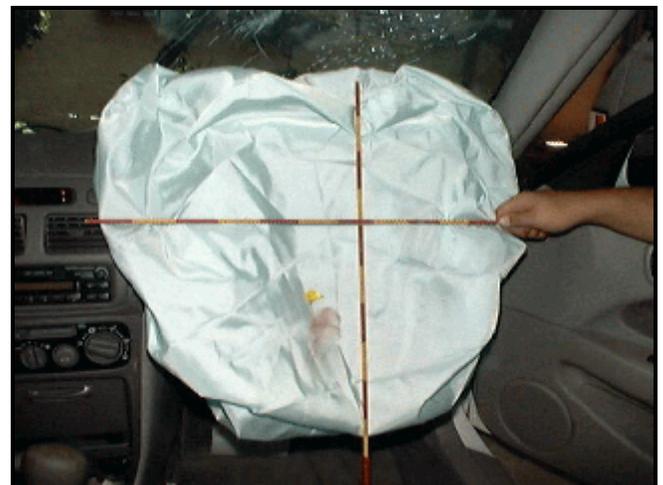
**Figure 9.** Deployed passenger's air bag

The front right passenger air bag was located on the instrument panel, top surface plane. The module cover flap is rectangular in design and the air bag broke the laminated windshield glazing upon deployment. The air bag was not tethered and was equipped with two vent port holes. There was a documented residual scuff mark located to the glove compartment door/ knee bolster and a lipstick transfer to the air bag fabric. There were no indications of damage to either of the air bags and their respective module covers.

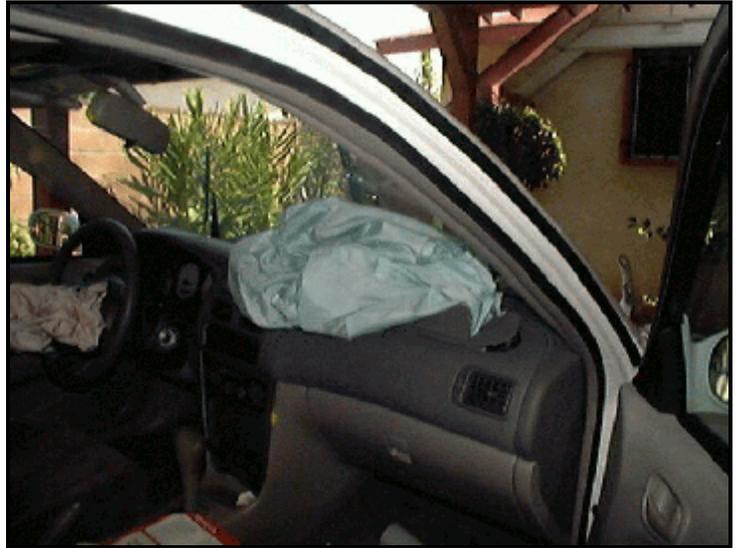
Damage to the interior of the 1998 Toyota Corolla consisted of windshield glazing damage due to the passenger side air bag contacting the windshield during deployment. The front, right passenger's left knee contacted the center instrument panel resulting in a permanent residual scuff mark. The front, right passenger also contacted the passenger air bag with her face as evidenced by a lip stick transfer to the air bag fabric. There were no intruding components to the case vehicle.

**Figure 10.** Front right passenger area

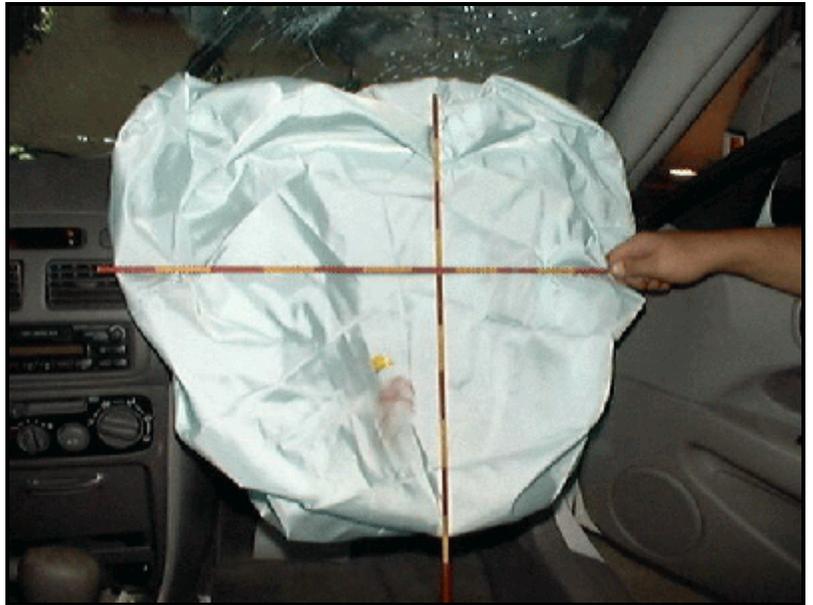
The front right seat was occupied by a fully restrained 23 year old female. She responded to the 11 o'clock direction of force (320 degrees) by moving forward and to her left. She loaded the lap and shoulder belt webbing which prohibited extended forward motion, however, there was a submarining element to her movement. Her left knee contacted the glove compartment door/ knee bolster as evidenced by a documented scuff mark and a left knee contusion (AIS-1), Her chest came into contact with the deploying air bag resulting in a chest contusion (AIS-1). Her face contacted the air bag fabric as evidenced by a lip stick transfer. Although her face contacted the deploying air bag, she did not sustain any reported facial injuries.

**Figure 11.** Passenger air bag (note contact at bottom left)

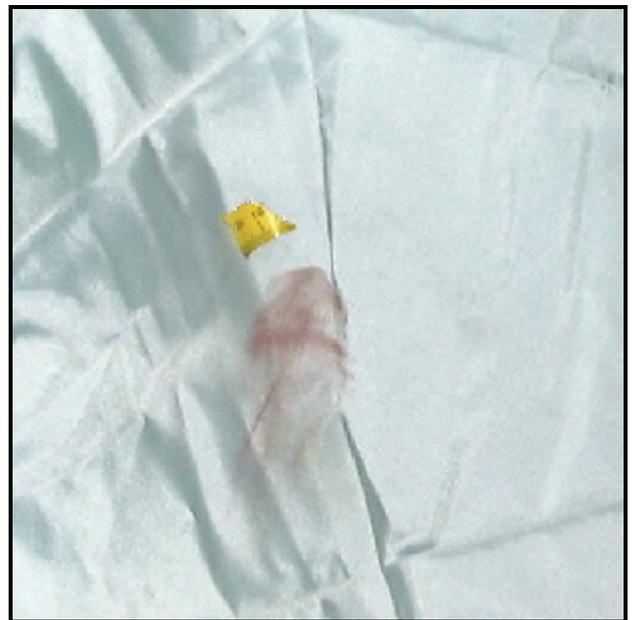
**Figure 12.** Close up of air bag contact
