**CALSPAN AIR BAG DEPLOYMENT INVESTIGATION**

**CALSPAN CASE NO. CA98-002**

**PASSENGER SIDE AIR BAG RELATED FATALITY**

1. <i>Report No.</i> CA98-002	2. <i>Government Accession No.</i>	3. <i>Recipient's Catalog No.</i>	
4. <i>Title and Subtitle</i> Calspan On-site Air Bag Deployment Investigation Vehicle #1 - 1992 Lincoln Continental Location - State of Pennsylvania		5. <i>Report Date:</i> March, 1998

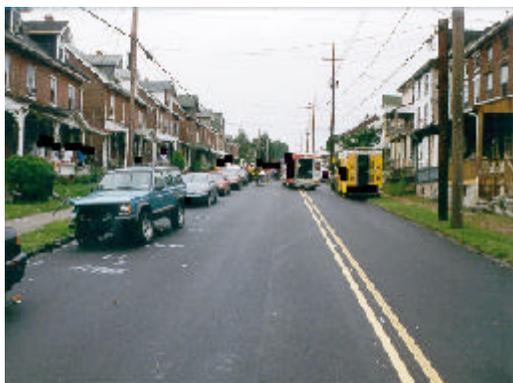
**Figure 1** On-scene view of the Lincoln Continental's trajectory prior to impact with the first parked vehicle

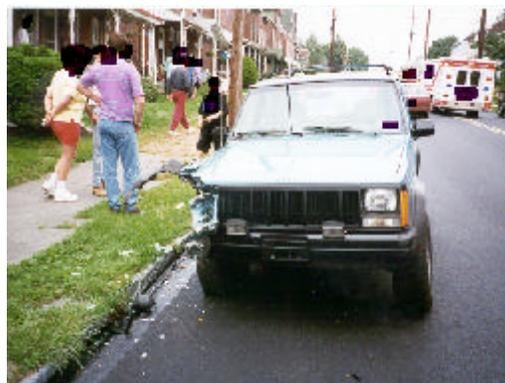
**Figure 2** View of the Jeep at the final rest position and the Lincoln's continued trajectory onto the adjacent sidewalk

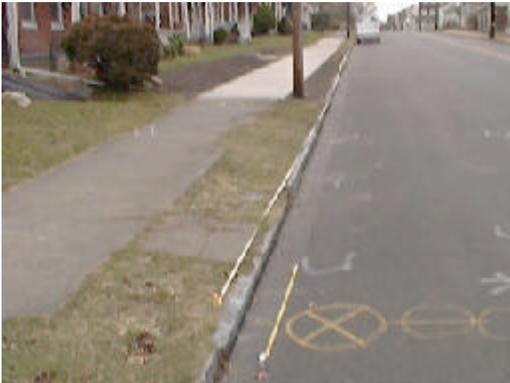
**Figure 3** Trajectory of the Lincoln which traversed the side walk and continued along the lawn area

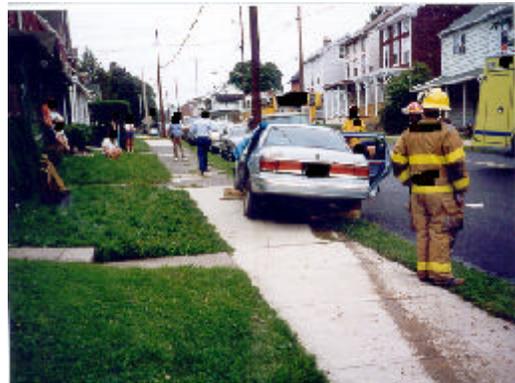
**Figure 4** View of the Lincoln's trajectory as it returned toward the roadway edge

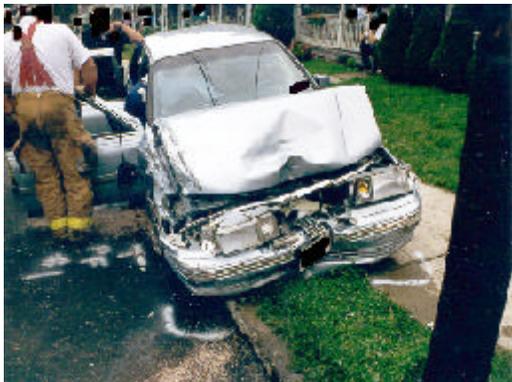
**Figure 5** View of the Lincoln at the final rest position

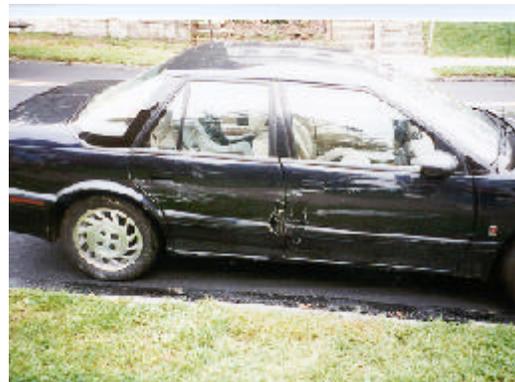
**Figure 6** View of the damage along the right side plane of the Saturn which was parked in the vicinity of the Lincoln's impact with the pole

adjacent to the south curb edge (**Figure 6**). Vehicle #1 came to the FRP heading in a westerly direction with the right side tires on the roadway surface and the left tires on the sidewalk.

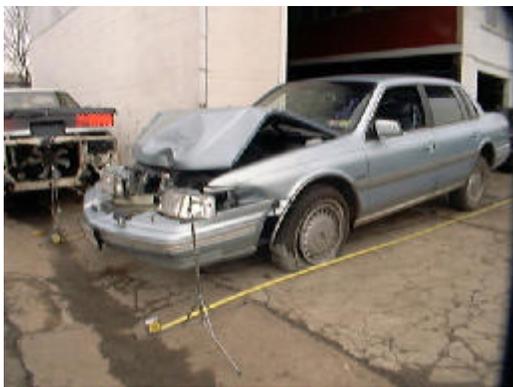
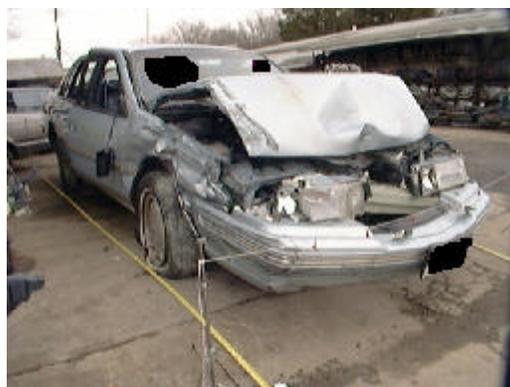
Vehicle #1 Crush			
Impact with wooden utility pole	$C_1 = 0$	$C_2 = 15.2\text{cm (6.0")}$	$C_3 = 43.2\text{ cm (17.0")}$
	$C_4 = 30.5\text{ cm (12.0")}$	$C_5 = 7.6\text{ cm (3.0")}$	$C_6 = 0$

The vehicle impacted nine objects with the highest delta V impact occurring at the utility pole (**refer to Figures 8&9**) which resulted in a maximum crush of 50.2 cm (19.75"). The crash sequence and the related Collision Deformation Classifications (CDC) are shown in the following table:

**Figure 8** Left front corner view of the Lincoln

**Figure 9** Right front corner view

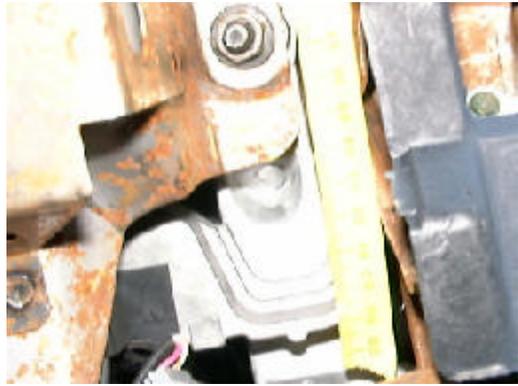
The driver side air bag sustained a 33.0 cm (13.0") lateral tear of the nylon fabric which was located across the lower quadrant along the instrument panel side of the air bag. The tear was the result of loading by the driver against the air bag module cover during the SRS actuation sequence. There was a blue striated pattern on the surface of the air bag below the tear which was attributed to contact with the underside of the air bag module cover. The lower flap traveled beyond the leading edge of the steering rim and became lodged along the instrument panel side of the rim. The steering column shear plate was displaced 6.0 cm (2.4") at the left shear capsule and 4.5 cm (1.75") at the right shear capsule (**Figure 10**).

**Figure 10** View of the shear capsule displacement

The driver then compressed the air bag and loaded the steering column which resulted in the displacement of the steering column shear plate of 6.0 cm (2.4") and 4.6 cm (1.8 ") at the left and right shear capsules, respectively. His left knee contacted the left side of the lower instrument panel adjacent to the left front door as noted by a scuff mark. His lower leg contacted the parking brake foot pedal as noted by the rotation of the pedal stage.

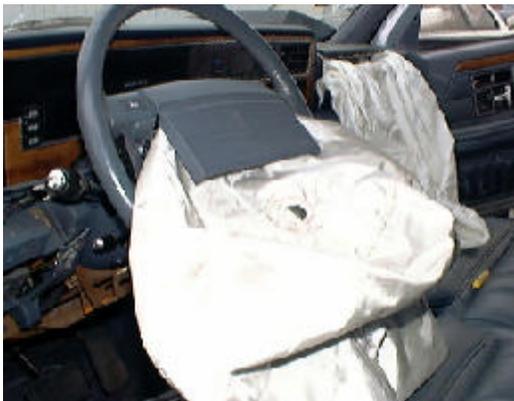
The front left driver side air bag had four tethers and two vent ports which measured 2.2 cm (0.875") in diameter. The module cover was a rectangular design which opened in the prescribed asymmetrical pattern (**Figure 11**) where the upper flap measured 12.7 cm (5.0") vertically and the lower flap was 4.4 cm (1.75"). There were no apparent occupant contact points on the cover surface.

**Figure 11** View of the front left air bag module cover flap and air bag

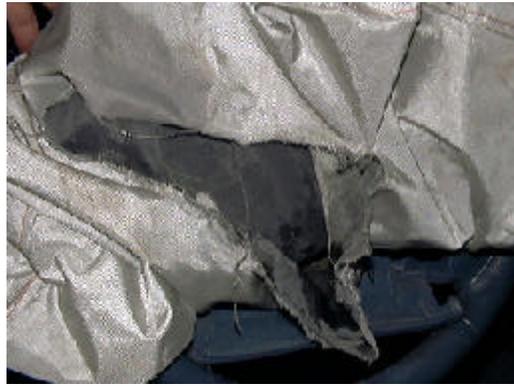
A lateral tear along the bottom rear surface of the air bag was attributed to driver loading against the air bag module cover during air bag expansion sequence (**Figure 12**). The blue transfer mark was noted adjacent to the bottom portion of the tear which was attributed to contact with the inside surface of

the module cover flaps. The rip and transfer were oriented laterally across the air bag and measured 33.0 cm (13.0") in length. There were no visible driver contact evidence on the air bag.

**Figure 12** View of the rip in the bottom rear surface of the front left air bag

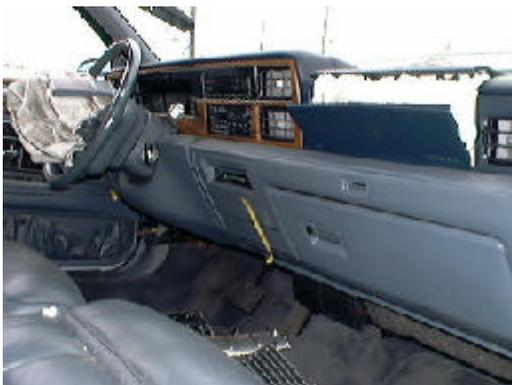
The front right passenger air bag module was a mid mount design which incorporated a top horizontal flap and a bottom vertical flap (**Figure 13**). The top flap measured 7.9 cm (3.125") longitudinally for the upper flap and 33.3 cm (13.125") laterally along the common separation seam. The vertical measurement for the bottom flap was of 9.5 cm (3.75"). There was no visible occupant contact evidence on either cover flap.

**Figure 13** Angular view of the instrument panel showing the front right air bag module cover

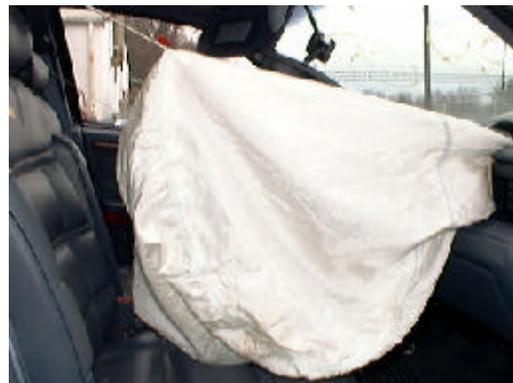
**Figure 14** View of the front right air bag manual expanded to illustrate bag excursion
