**CALSPAN ON-SITE ADAPTIVE CONTROL INVESTIGATION
CALSPAN CASE NO. CA98-04
VEHICLE: 1995 FORD E-150
LOCATION: NEW YORK
CRASH DATE: JANUARY 1998**

1. <i>Report No.</i> CA98-04	2. <i>Government Accession No.</i>	3. <i>Recipient's Catalog No.</i>	
4. <i>Title and Subtitle</i> Calspan On-Site Adaptive Control Investigation Vehicle: 1995 Ford E-150 Location: New York		5. <i>Report Date:</i> August, 1999

14. <i>Sponsoring Agency Code</i>	
15. <i>Supplementary Notes</i> On-site investigation of a run-off-road crash that involved a 1995 Ford E150 van that was equipped with adaptive controls.

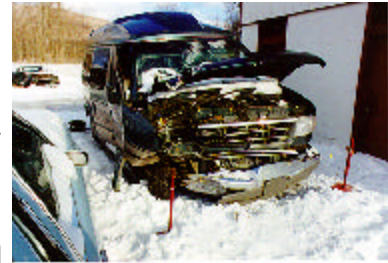
Figure 1. Front right three-quarter view of the Ford E150 van.

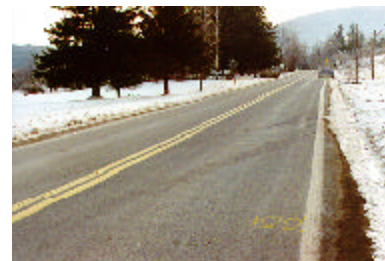
The crash occurred on a two-lane rural roadway in a residential area during nighttime hours (**Figure 2**). In the vicinity of the crash site, the road was straight and level with a posted speed limit of 56 km/h (35 mph). A left curve (relative to the vehicle's direction of travel) terminated at a point that was 131 m (430') north of the impending crash site. The asphalt travel lanes were bordered by 0.9 m (2.9') paved shoulders with low profile snow banks bordering the shoulders. There was no physical evidence at the crash scene due to precipitation of rain and snow which had fallen since the crash.

Figure 2. Overall view of the crash site and the pre-crash trajectory of the Ford E150 van.

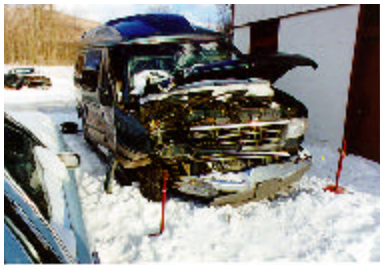
The front right area of the Ford E150 van impacted the tree. The initial contact involved the chromed steel front bumper area that was located outboard of the right frame rail. The lower grille, right headlight, and fiberglass hood subsequently impacted the tree. The direct contact damage began 47.0 cm (18.5") left of center and extended 41.9 cm (16.5") to the right front corner (**Figure 3**). The tree impact deformed the full width of the frontal structure which resulted in a combined direct and induced damage length of 170.2 cm (67.0"). Maximum crush was 59.1 cm (23.25") located at the lower radiator support level 74.9 cm (29.5") right of center. Two crush profiles were documented at the lower and upper levels of the radiator support due to separation of the front right bumper corner. The crush profile (**Figure 4**) at the lower radiator support was the best representation of crush profile and was documented as follows: C1=0 cm, C2=1.3 cm (0.5"), C3=3.6 cm (1.4"), C4=15.5 cm (6.1"), C5=38.7 cm (15.25"), and C6=56.9 cm (22.4"). The Collision Deformation Classification (CDC) was 12-FREW-4.

Figure 3. Overall view of the frontal damage.

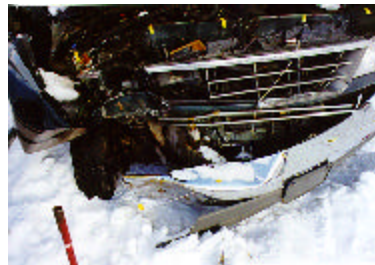
Figure 4. Close -up view of the crush profile.

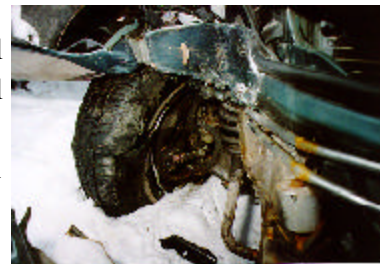
The frontal crush resulted in contact between the outboard aspect of the right front I-beam axle and the inner aspect of the right front wheel against the trunk of the tree. This contact deformed the alloy wheel (**Figure 5**) and rotated the steering system in a clockwise direction. As the right front wheel rotated to the lock position, the force load against the wheel and suspension components stripped the threads of the spindle nut and sheared the cotter key which resulted in separation of the outer bearing, washer, adjustment spindle nut, and the grease cap. The tow operator noted these components and the wheel hub cover lying adjacent to the right front wheel at the final rest position of the vehicle. (The driver/owner stated the front wheel bearings were re-packed with grease and the front-end was aligned on December 31, 1997. He further stated that he did not experience vibration or instability in the vehicle prior to the crash, therefore, this repair work was not a factor in the loss of control or the spindle nut separation).

Figure 5. Close-up view of the impact damage to the right front wheel.

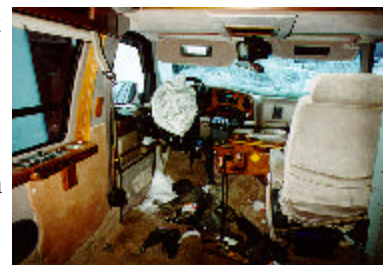
Figure 6. Overall view of the interior adaptive controls.

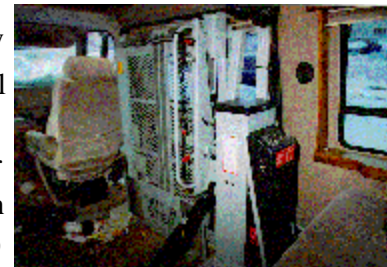
Figure 7. Platform lift.

right side doors. The platform lift was manufactured by Crow River Industries, Inc. and was identified by Serial No. 9509007 and Model No. 7684KAFF. The lift consisted of a fixed platform that rotated vertically within the vehicle for storage. When deployed, the driver would position the motorized chair on the lift at ground or van floor level, and activate the lift in a vertical motion to enter or exit the vehicle. The power unit of the lift was mounted at the OEM floor height of the vehicle adjacent to the right C-pillar. The overall dimensions of the lift platform were 68.6 cm (27.0") in width and 134.6 cm (53.0") in depth. There was no damage to the platform lift unit from the crash sequence.

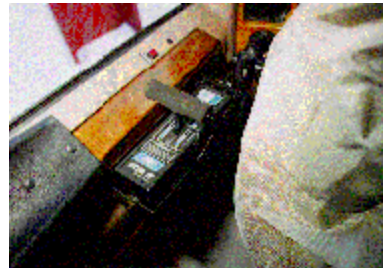
- The acceleration and braking functions of the vehicle were controlled by a left hand operated EGB II, Silver Edition Series adapted control that was manufactured by EMC Inc. The unit was mounted to a bracket attached to the left mid instrument panel adjacent to the left door and protruded 38.1 cm (15.0") rearward of the instrument panel (**Figure 8**). The mounting bracket of the unit was equipped with a hinge point at the forward end which allowed the unit to rotate forward and upward to gain access to the driver's position from the left front door. A locking pin secured the unit in a horizontal position which was required to correctly operate these functions. Acceleration was achieved by sliding a T-handle in a forward direction while braking was controlled by pulling the T-handle in a rearward direction. There was no damage to the EGB II unit. In addition to the EGB II, a form fitted rigid foam pad was mounted on the rear third of the top of the left front door panel. This form fitted pad held the left forearm in position for the driver to comfortably operated the acceleration and braking functions. The overall dimensions of the pad were 12.7 x 29.2 cm (5.0") x (11.5").

Figure 8. EGB II hand control for throttle and brake functions.

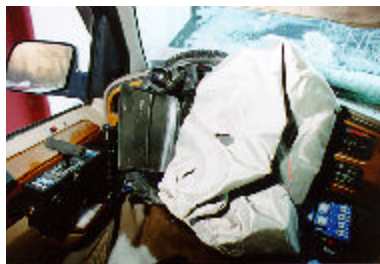
Figure 9. Engagement of the upper module cover flap against the spinner knob.

support the driver's frontal air bag system. Prior to the installation of the DS 2000 remote steering system, an MPD spinner knob was mounted to the inner aspect of the steering wheel rim at the 2 o'clock position, immediately above the right upper spoke. Mounting was achieved by two band clamps affixed to the circumference of the wheel. The spinner knob was 4.8 cm (1.875") in diameter and protruded 5.1 cm (2.0") above the profile of the steering wheel rim. The knob was not damaged and rotated freely on its shaft mount. It should be noted that the asymmetrical upper cover flap for the driver's side air bag system contacted the spinner knob during the deployment sequence (**Figure 9**), however, no damage resulted from the contact. At the time of our inspection of the vehicle, the upper flap was engaged with the mounting bracket of the spinner knob. An aftermarket rubberized steering wheel cover was positioned over the OEM wheel.

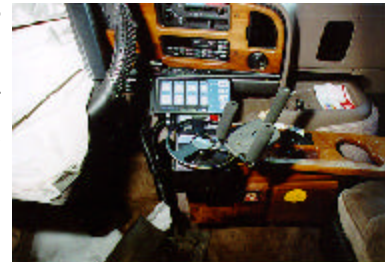
- The remote steering system was identified as a DS 2000, Digital Steering System by EMC, Inc **Figure 10**. The unit was mounted horizontally to the center mid instrument panel above the removable engine cover. The overall dimensions of the DS 2000 unit were 19.1 cm (7.5") in length and 11.4 cm (4.5") in width. A 15.2 cm (6.0") diameter 3-spoke horizontally mounted wheel was affixed to a steering shaft that extended from the center of the unit 5.7 cm (2.25") forward of the rear edge of the unit. The driver

Figure 10. DS 2000 remote steering system.

operated the DS 2000 with his right hand that was positioned in a tri-pin adapted control mounted to the right spoke area of the three-spoke wheel of the DS 2000. The tri-pin base was 8.9 cm (3.5") in width at the bottom of the control with an overall length of 13.3 cm (5.25"). The wrist pins of the tri-pin device were positioned on 7.6 cm (3.0") centers with the hand grip pin positioned 10.8 cm (4.25") forward of the wrist pins. The tri-pins were 2.2 cm (0.875") in diameter and 8.6 cm (3.375") in height. During the crash, the driver's right hand probably loaded the tri-pin adapted control which slightly deformed the pivot shaft of the device. His hand subsequently separated from the tri-pin and impacted the mid instrument panel. There was no damage to the DS 2000 unit.

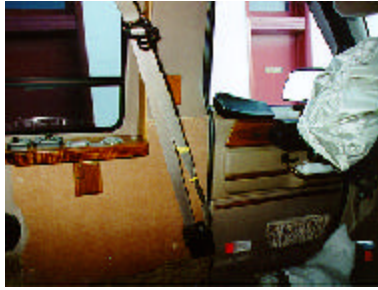
- The driver's manual restraint system had been altered from the OEM restraint. The driver's side restraint system (**Figure 11**) consisted of a 3-point belt continuous loop belt with an inertia activated locking retractor mounted to the lower aspect of the left B-pillar. The upper anchorage was tethered to the left roof side rail rearward of the B-pillar. The lower anchorage was mounted to the sill directly forward of the retractor. The buckle for the left front belt was mounted to a rigid steel strap that extended the buckle vertically from the floor (**Figure 12**). The strap was 3.8 cm (1.5") wide and 55.9 cm (22.0") in length and was formed with a 90 degree angle at the floor for the anchorage point. The strap was bolted to the drop floor with a single Grade 8, 11 mm (7/16") diameter bolt.

Figure 11. Configuration of the left front manual belt system.

The driver was properly belted at the time of the crash. The continuous loop belt webbing was extended over the left arm of the Quickie P200 wheelchair and under the right arm of the chair, buckled into the elevated buckle assembly. This belt path provided the driver with the “best fit” of the restraint system. The lap belt segment of the webbing was engaged against a vertical tube of the chair. This tube was covered with a black vinyl wrap which transferred onto the lower segment of the webbing. The diagonally oriented black transfer was located on the interior aspect of the webbing 33.0-45.7 cm (13.0-18.0”) above the lap belt sill anchorage. An abrasion/gouge mark was located on the webbing immediately below the transfer on the forward aspect of the webbing. There was no other damage or contact evidence on the belt system. The modified buckle strap remained intact with no separation or bending of the lower attachment point.

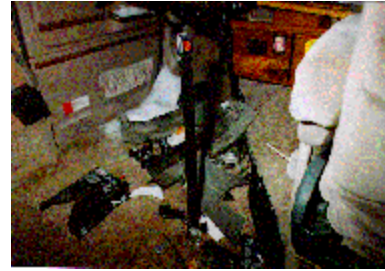
Figure 12. Rigid steel strap for vertical positioning of the belt buckle.

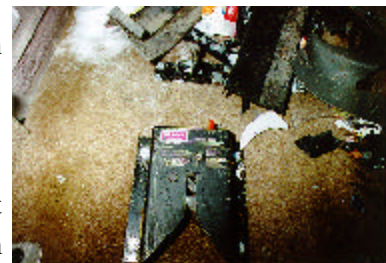
- The driver’s wheelchair was restrained by a electrically operated EZ Lock locking system (**Figure 13**) that was bolted to the drop floor of the vehicle. The system consisted of the mechanical locking unit and a front locator (inverted J-type hook). The EZ Lock base unit

Figure 13. EZ Lock wheelchair restraint system.

A 2.5 cm (1.0") diameter bolt was threaded into the base of the Quickie P200 motorized wheelchair. As the driver positioned the chair in the driver's position of the vehicle, the forward aspect of the chair engaged with the front locator as the protruding bolt engaged into the tapered slot and locking pawl for the EZ Lock restraint. There was no evidence of loading or damage on the EZ Lock system, or deflection of the wheelchair bolt.
